INFORMATION LETTER

212-21-73

3 February 2021

SUBJECT: TAIL ROTOR BLADES 212-010-750-ALL LEAK CHECK.

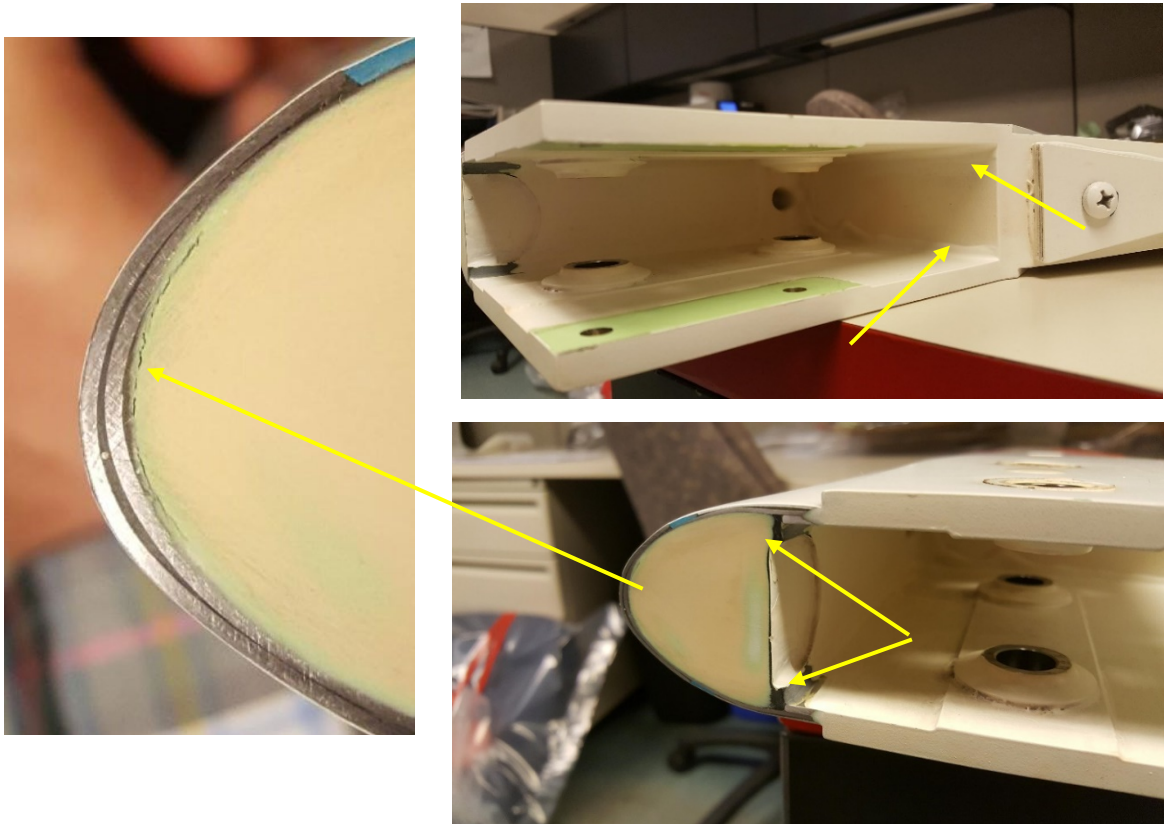
Bell has received reports of tail rotor blades failing the leak check required per the applicable Maintenance Manual (MM) when suspected cracks are found in the blade root end cuff area. In some cases, due to misinterpretation of the results, blades rejected due to indications of air bubbles were in fact serviceable. Figure 1 below shows some areas where cracks can be found. The cracks found in the root end cuff area are usually limited to the adhesive squeeze-out produced during manufacturing and are not necessarily an indication of a bonded joint failure.

Figure 1. Areas where cracks can be found.

The crack repair procedure found in the applicable MM and Component Repair and Overhaul Manual (CR&O), has also been changed. The adhesives (C-363) and (C-313) listed in the MM and the CR&O to repair cracks in the root end area are replaced by sealant (C-308). The flexibility of sealant (C-308) will allow the fine cracks to remain sealed and prevent further cracking with time in service.
