INFORMATION LETTER

407-21-124

TO: All owners and operators of model 407 helicopters

SUBJECT: THROTTLE CABLE ASSEMBLY 1608750-001, INTRODUCTION OF.

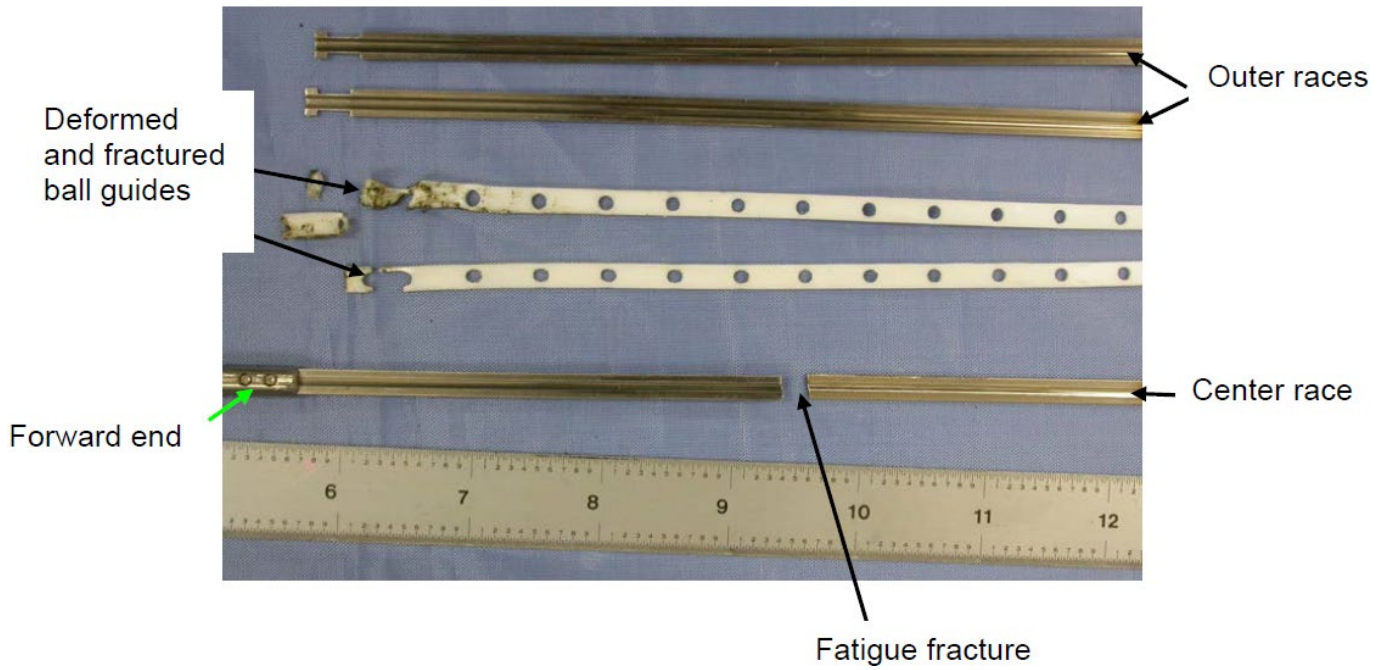
Following root cause investigations, several locations of the fractures of the center race material (Figure 1) occurred due to fatigue cracks that propagated over time. The majority of the failures occurred at the first bend under the pilot seat (Figure 2). During installation of the throttle cable assembly, it was noted that in certain areas the throttle cable assembly could have high stress loads applied, or kinked, while routing the cable assembly through the various areas of the airframe structure where the cable assembly could be exposed to high bend radii.

Figure 1 – Example of Failed Throttle Cable Assembly

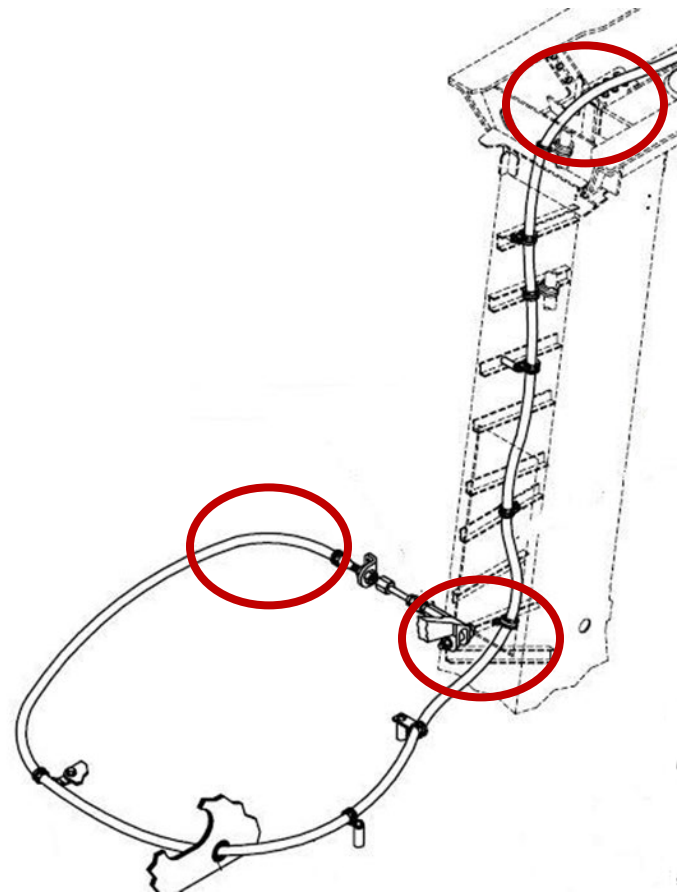
Figure 2 – Locations of Reported Throttle Cable Assembly Failures

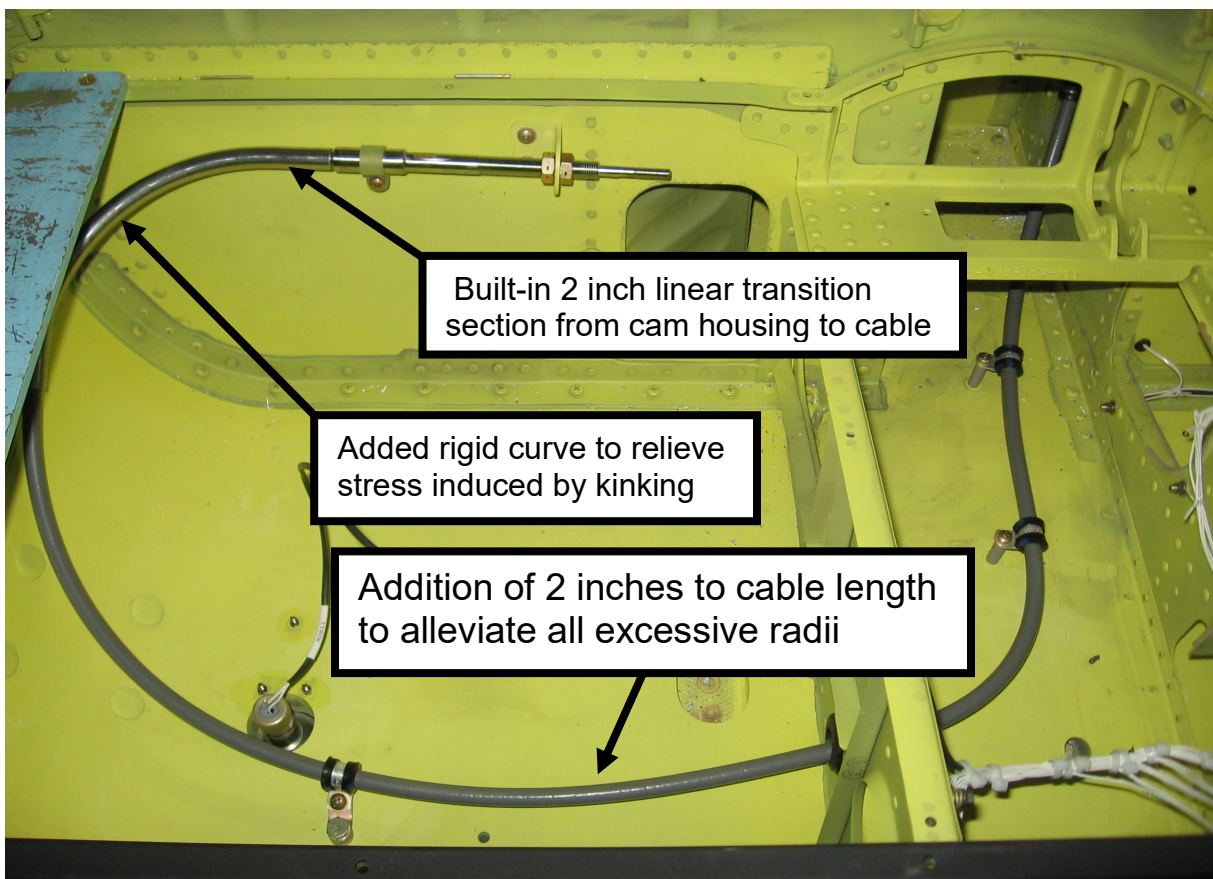
Figure 4 – Throttle Cable Assembly 1608750-001 Design Improvements (206L4 Installation Shown as Reference)

To minimize the possibility of future throttle cable assembly failures, Bell introduced the throttle cable assembly 1608750-001 into the production configuration of the 407 at serial number 54129 through 54166 (analogue 407) and 54388 through 54762 (407GX and 407GXP). In conjunction with the new design (Figure 4), improved installation procedures

[\(DMC-407-A-76-04-01-00A-720A-A\)](#) and handling procedures [\(DMC-407-A-76-04-01-00A-912A-A\)](#) were incorporated to the 407-MM Maintenance Manual.
