INFORMATION LETTER

412-21-90

3 February 2021

SUBJECT: TAIL ROTOR BLADES 212-010-750-ALL and 412-016-100-ALL LEAK CHECK.

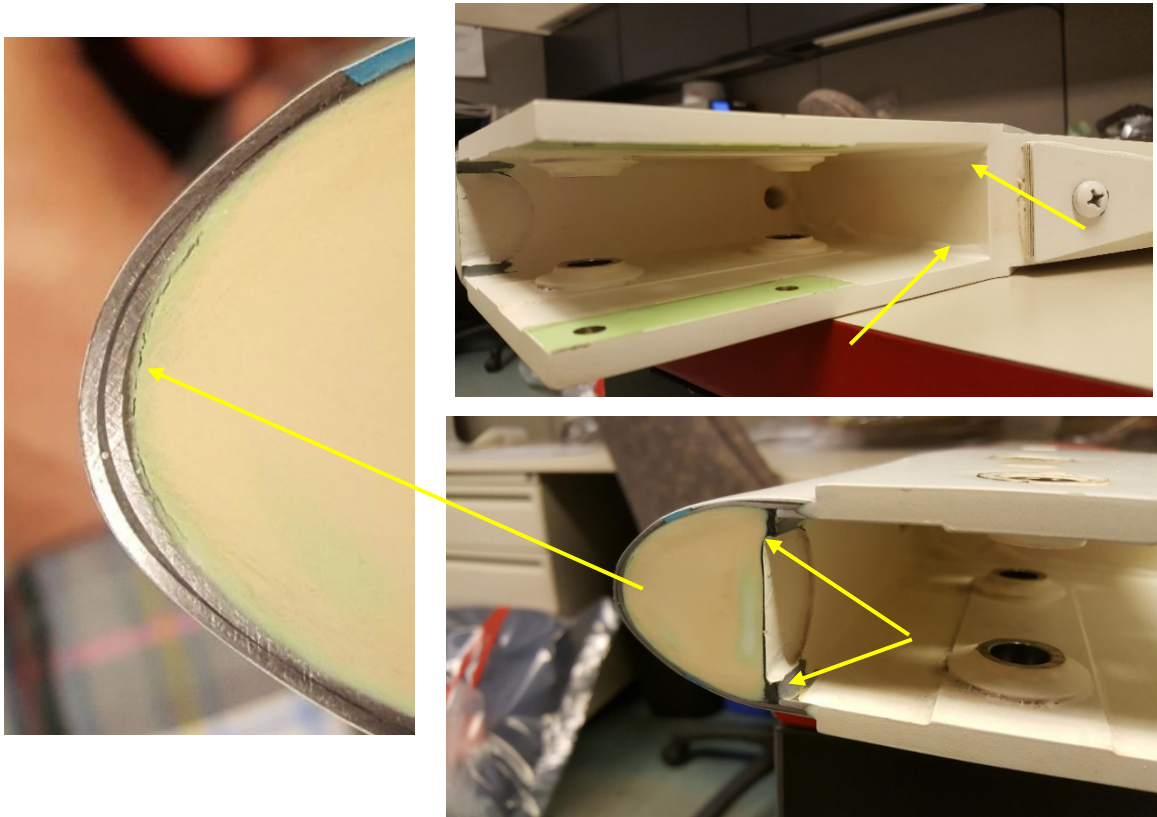
Bell has received reports of tail rotor blades failing the leak check required per the 412 Maintenance Manual (MM) when suspected cracks are found in the blade root end cuff area. In some cases, due to misinterpretation of the results, blades rejected due to indications of air bubbles were in fact serviceable. Figure 1 below shows some areas where cracks can be found. The cracks found in the root end cuff area are usually limited to the adhesive squeeze-out produced during manufacturing and are not necessarily an indication of a bonded joint failure.

Figure 1. Areas where cracks can be found.

The crack repair procedure found in the MM and the 412 Component Repair and Overhaul Manual (CR&O), has also been changed. The adhesives (C-363) and (C-313) listed in the MM and the CR&O to repair cracks in the root end area are replaced by sealant (C-308). The flexibility of sealant (C-308) will allow the fine cracks to remain sealed and prevent further cracking with time in service.
