## **INFORMATION LETTER**

**429-21-14**  
17 March 2021

**TO: All owners and operators of Model 429 helicopters**

**SUBJECT: MAIN ROTOR BLADE GROUND STRAP 429-015-021-101, INSPECTION OF**

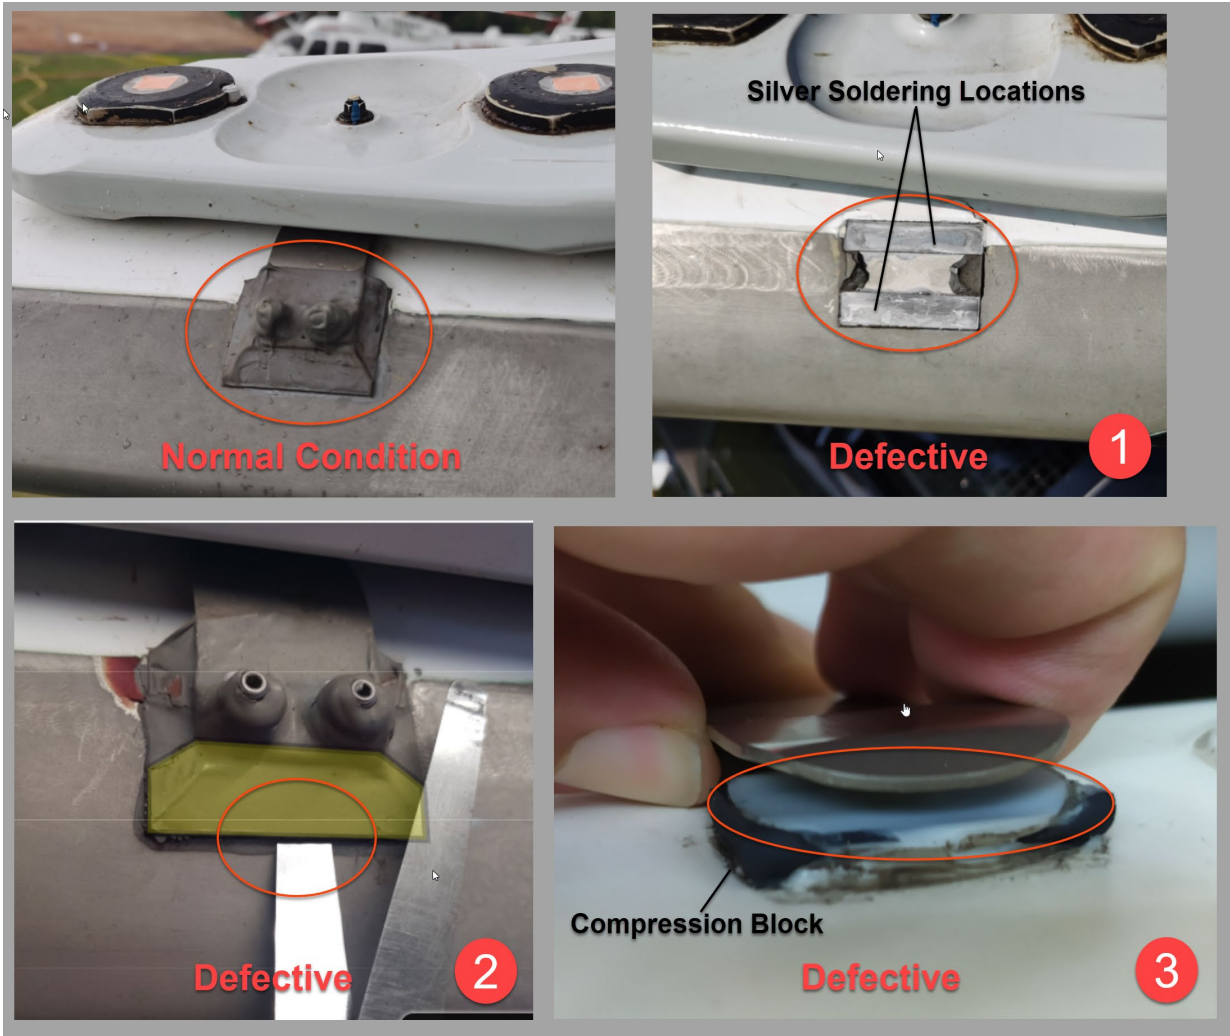
**Figure 1 – 429 Main Rotor Blade Ground Strap Findings**

Bell has received field reports concerning defective conditions of the Main Rotor Blade (MRB) ground strap (also known as a bonding clip) 429-015-021-101. There have been 3 types of findings reported (Figure 1):

1. Ground strap completely detached from the MRB
2. Ground strap partially detached at the silver soldering location
3. Debonding between the ground strap and the compression block

The ground strap is silver soldered to the leading edge abrasion strip of the blade at its forward end and bonded to the compression block at its aft end. For the type 1 finding mentioned above, to re-solder the ground strap, the leading edge abrasion strip must be lifted due to the heat generated during soldering. Hence, such repairs can only be done by an authorized blade repair facility. For the type 2 finding, contact Bell Product Support Engineering (PSE) with the details of the defect. Depending on the engineering evaluation, it may be possible to provide a temporary field repair, but eventually the blade will need to be sent to an authorized blade repair facility for a permanent repair. For the type 3 finding, contact Bell PSE for a field repair procedure.

We encourage operators to observe the maintenance manual requirements when installing or inspecting the main rotor blades. Paying attention to the tell-tale signs could help to identify this issue at an early stage, so that the necessary maintenance actions can be carried out to avoid AOG situations.
