TECHNICAL BULLETIN

505-18-13

MODEL AFFECTED: 505

SUBJECT: AFT ROOF PANELS AND CEILING AREA,
INSPECTION AND PROTECTION OF.

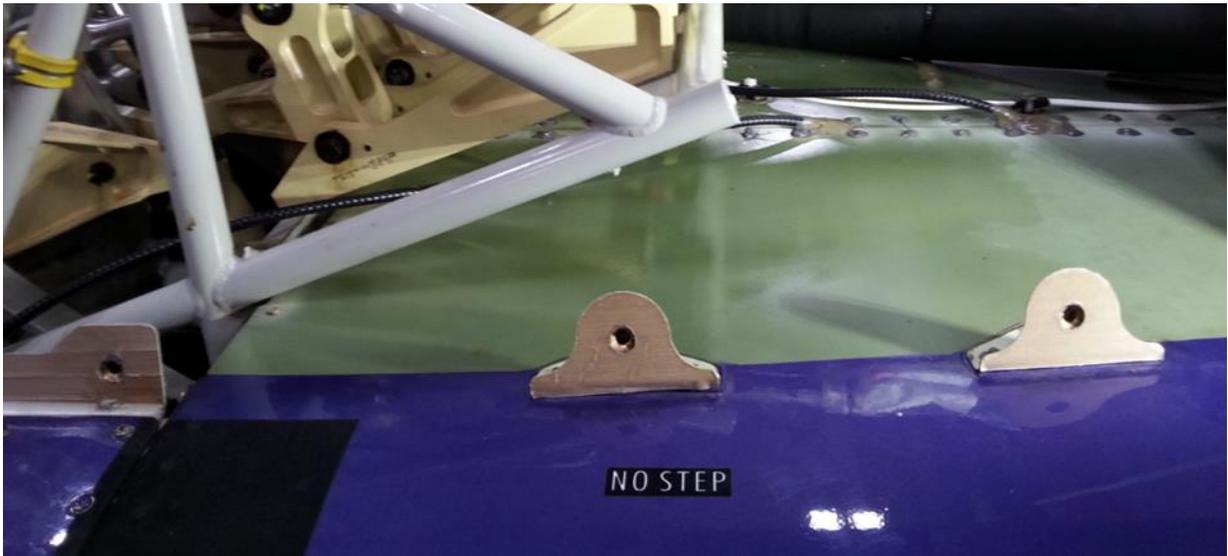
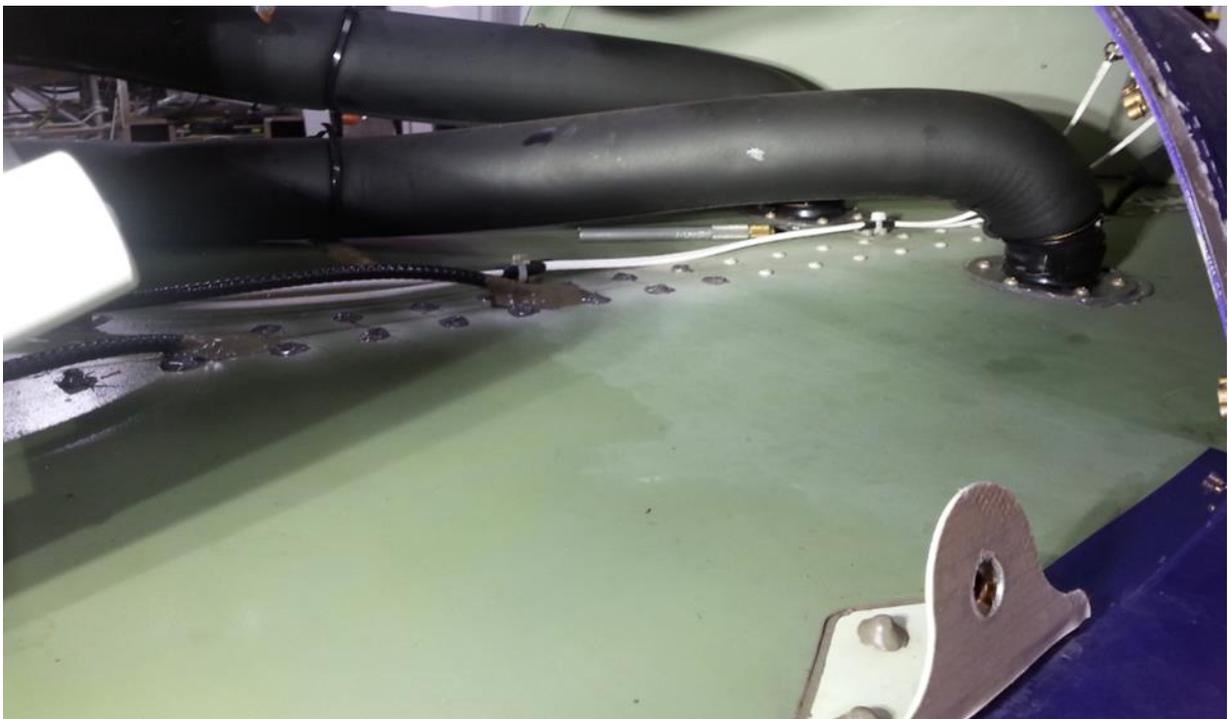
Figure 1 - Typical signs of fluid leakage (Sheet 1 of 2)

Bell is aware of a possible issue with hydraulic fluid pooling on the upper aft roof panels, migrating through the roof panels, and staining the underside. The intent of this Technical Bulletin (TB) is to permit the application of protective layers onto the roof panels.

Typical signs of fluid leakage on upper roof panels.

5. Inspect the left and right upper roof panels (Figure 1, Detail A, Sheet 1 of 2) and the interior ceiling panels in the passenger area (Figure 1, Detail B, Sheet 2 of 2) for wicking stains.

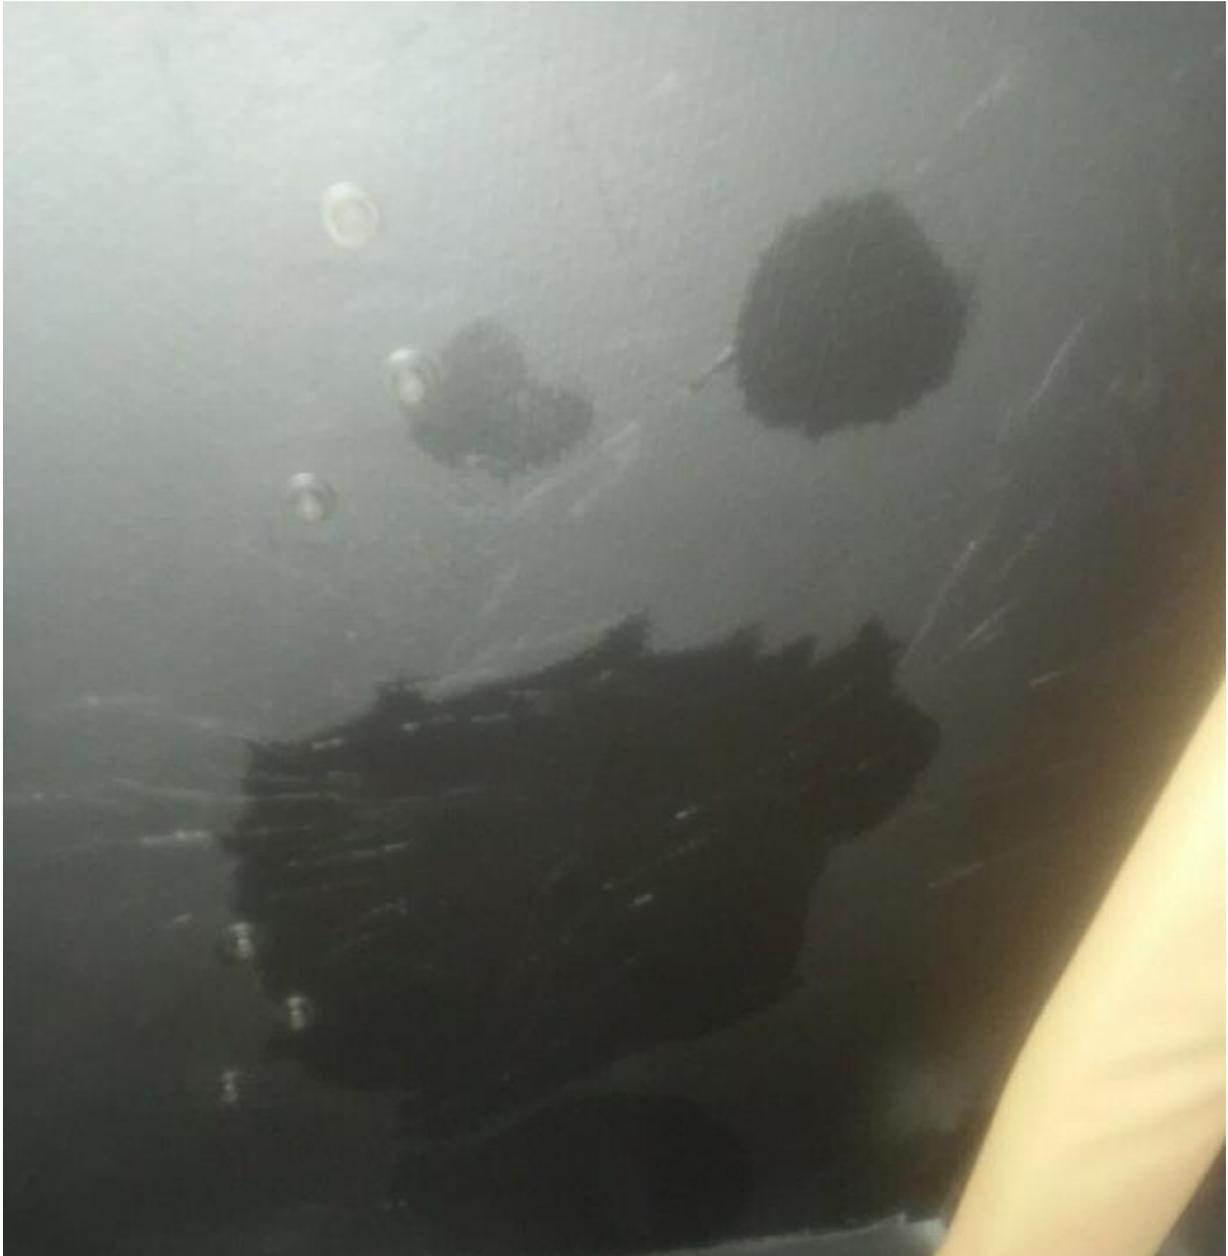
Figure 1 - Typical signs of fluid leakage (Sheet 2 of 2)

After accomplishment of this Technical Bulletin, wicking stains may be observed on the passenger cabin area ceiling panels for an undetermined period due to residual hydraulic fluid. Wipe clean as required the ceiling panels using the solvent mixture in accordance with this TB until wicking stops.

Typical sign of leakage ceiling panel (right side shown).

Wicking stains may be observed on the passenger cabin area ceiling panels for an undetermined period after accomplishment of this Technical Bulletin. As applicable, wipe clean the ceiling panels using the solvent mixture in accordance with this Technical Bulletin until wicking stops. The ceiling wipe clean method can be accomplished at any given time and/or during an inspection.

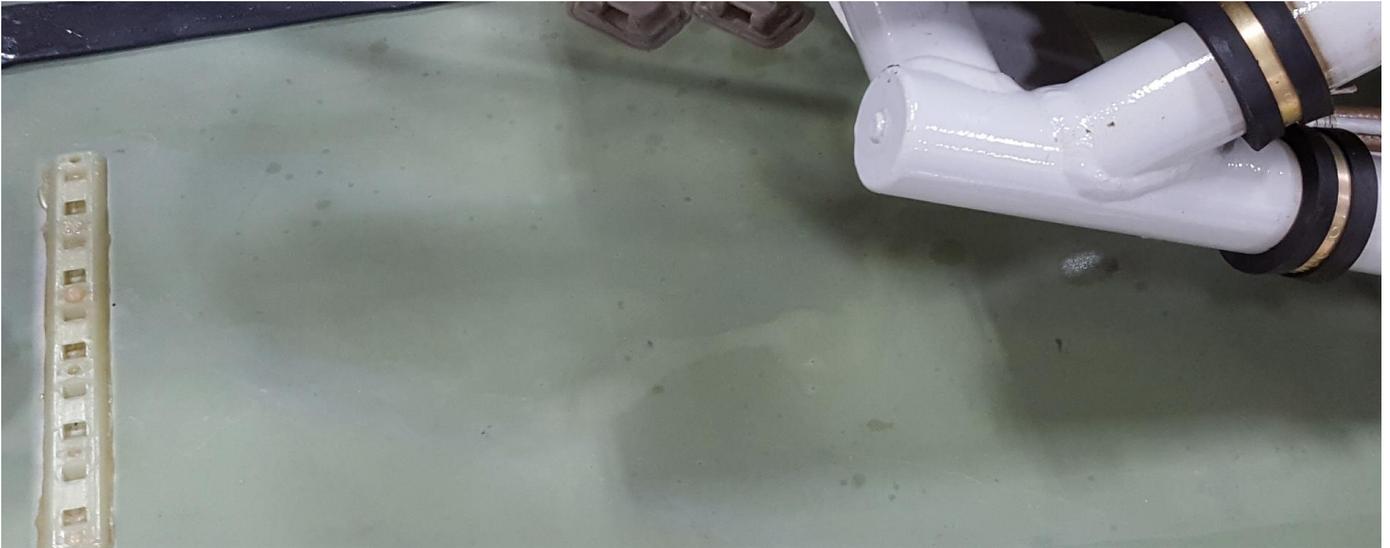
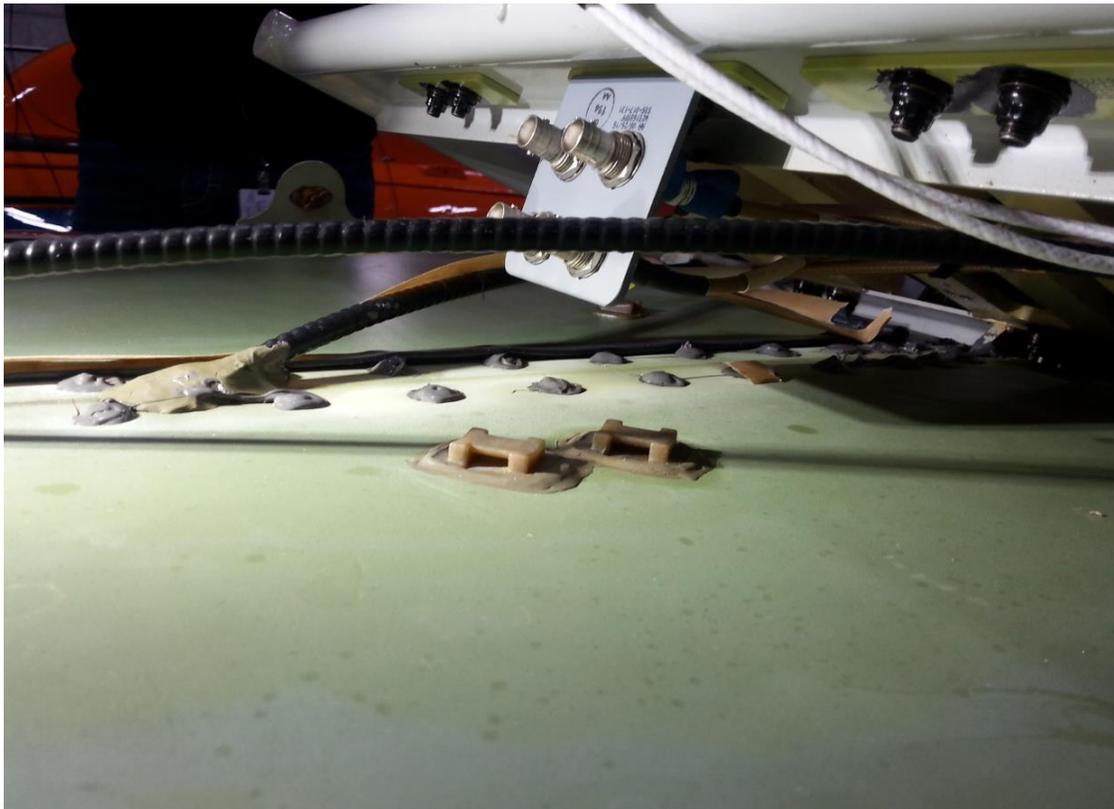
Figure 3 - Typical wicking stains (wet spots)

The word "wicking" is a term that is defined as "to move moisture by capillary action from an inside surface to the outside surface".

- c. Prepare the solvent mixture.
 - d. Wipe clean both upper roof panels (Figure 2) using cheesecloth (C-486), or equivalent, saturated with the solvent mixture.
 - e. Wait a minimum of 20 minutes prior to proceeding to the next step.
7. Inspect for wicking (Figure 3).
 - a. If wicking is observed, go to **PART II**.

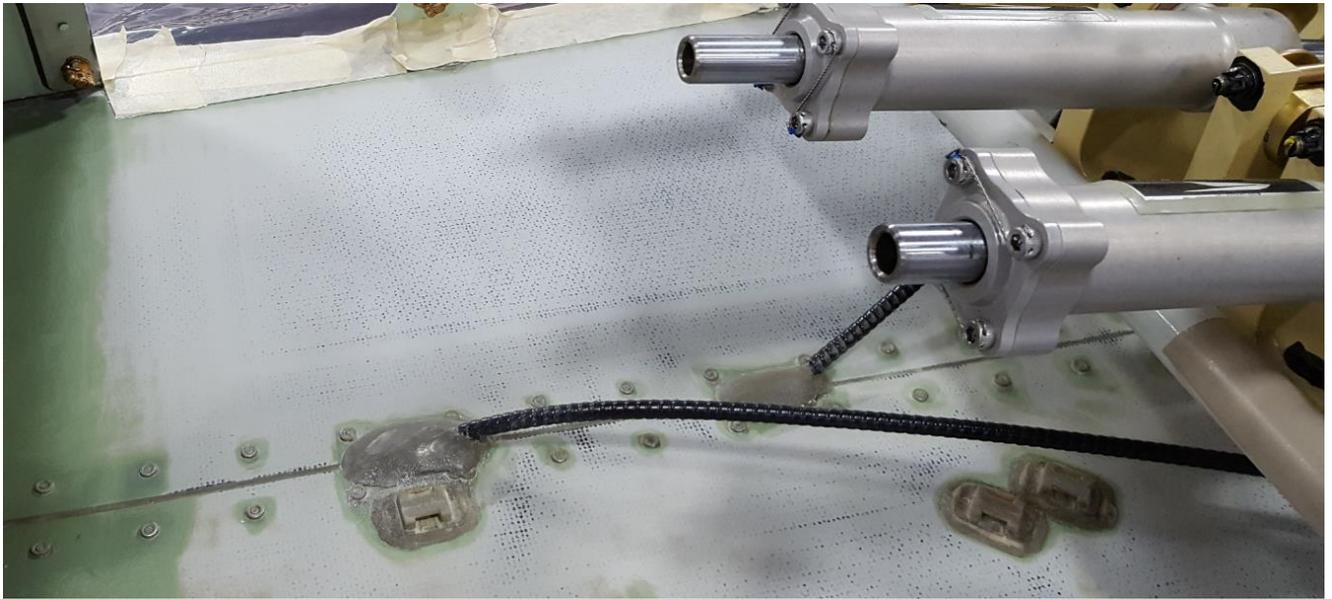
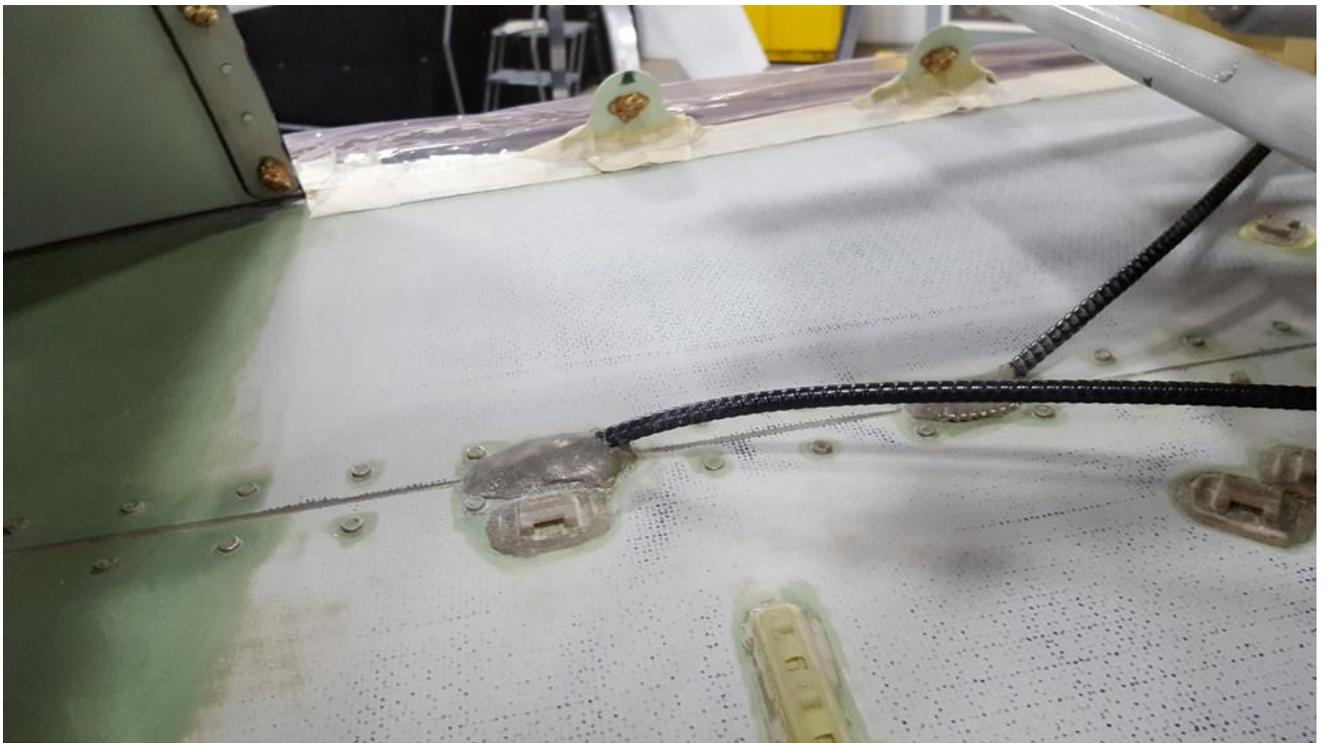
Figure 4 - Upper roof panels (Sheet 1 of 2)

After wet abrasion.

- a. Using 180 grit or finer abrasive paper or cloth (C-406) and the solvent mixture, wet abrade by hand the primer on both upper roof panels (Figure 4, Sheet 1 of 2) down to the pores.
 - i. Additional abrading of the roof surfaces may be required to open the panel pores using abrasive pad (RED), or equivalent, and as applicable. Do not sand into the fibers.
 - b. Wipe clean the surfaces using cheesecloth (C-486), or equivalent, wet with the solvent mixture.
 - c. Allow a minimum of 15 minutes for solvent to evaporate.
9. Seal the pores of the left and right upper roof panels as follows:

- a. Using 180 grit or finer abrasive paper or cloth (C-406) and the solvent mixture, wet abrade by hand the primer on the left upper roof panel (Figure 4, Sheet 1 of 2) down to the pores.
 - ii. Additional abrading of the roof surface may be required to open the panel pores using abrasive pad (RED), or equivalent, and as applicable. Do not sand into the fibers.
- b. Wipe clean the surface using cheesecloth (C-486), or equivalent, wet with the solvent mixture.
- c. Saturate the left upper roof panel with the solvent mixture. Wait one minute to let some of the mixture infiltrate the roof panel pores.

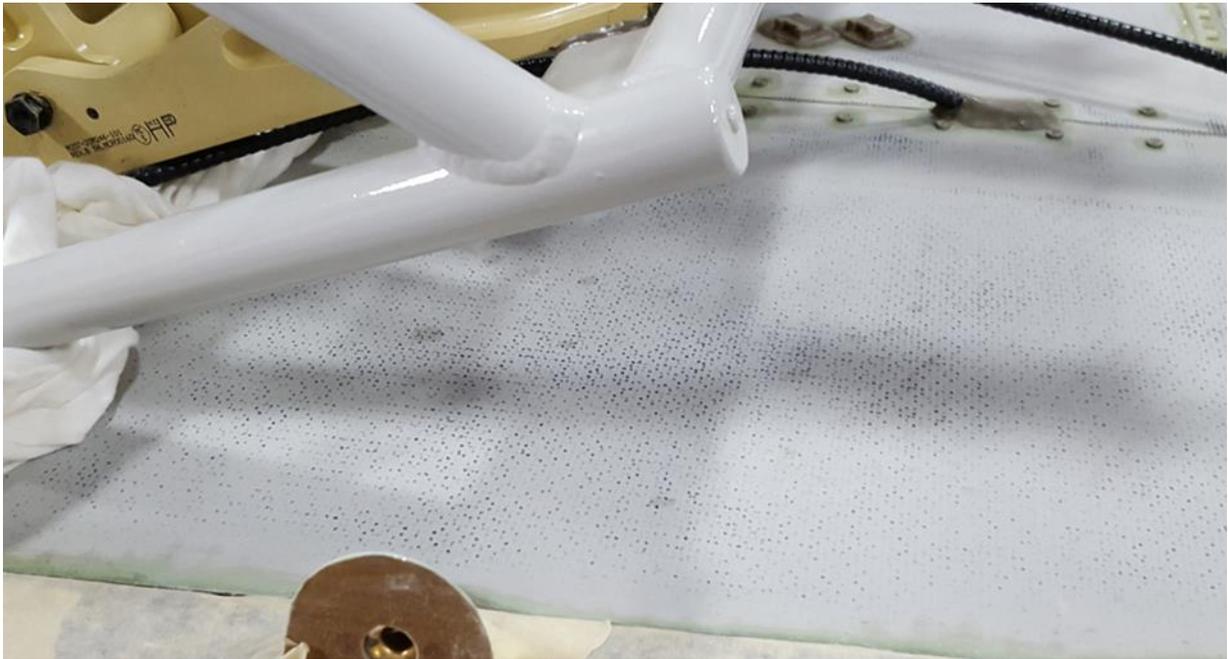
Figure 4 - Upper roof panels (Sheet 2 of 2)

Fluids may have infiltrated into only one side of the upper roof panel either the left or the right side panel, or into both panels. Fluid wicking may reappear up to 20 minutes after the wipe cleaning procedure done in step 4.d. above.

Signs of wicking appearing after wiping with the solvent mixture.

5. Check for wicking on the upper roof panels (Figure 4, Sheet 2 of 2) and accomplish the surface cleaning as follows:

- a. If wicking stains are limited in number (five or less) and in size (0.250 inch (6.35 mm) diameter or less), it is permissible to further abrade the area using abrasive pad (RED) to open the pores and to wipe clean the surfaces using the solvent mixture. Wait an additional 20 minutes to check for further wicking.
- b. As applicable, repeat this procedure until wicking is no longer observed for a minimum period of 20 minutes, or go to step 5.c.
