TECHNICAL BULLETIN

505-18-14

MODEL AFFECTED: 505

SUBJECT: FREEWHEEL ASSEMBLY HOUSING SEALANT,
APPLICATION OF

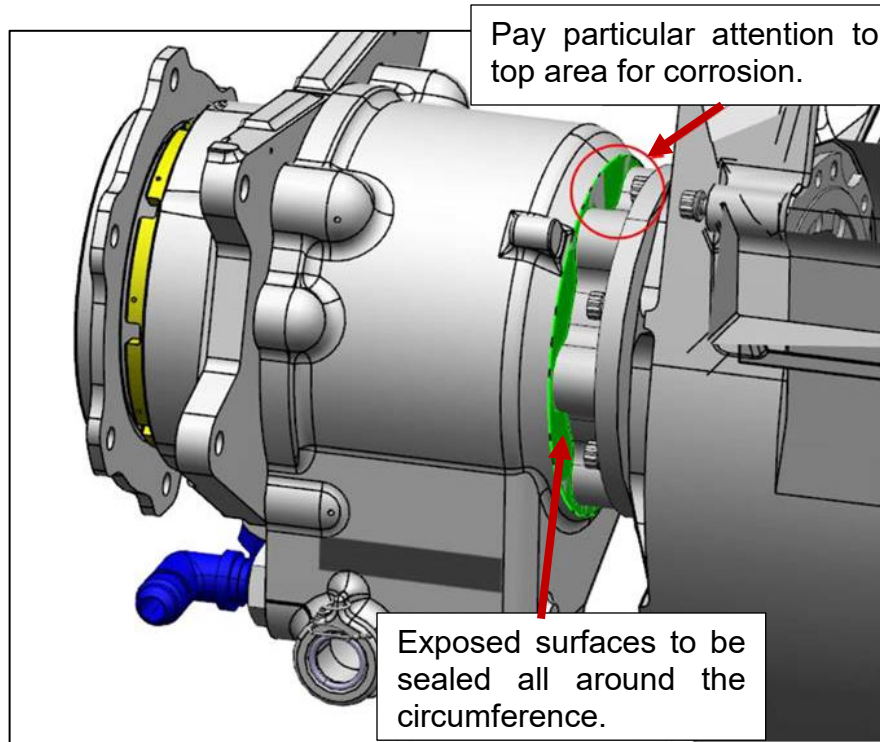
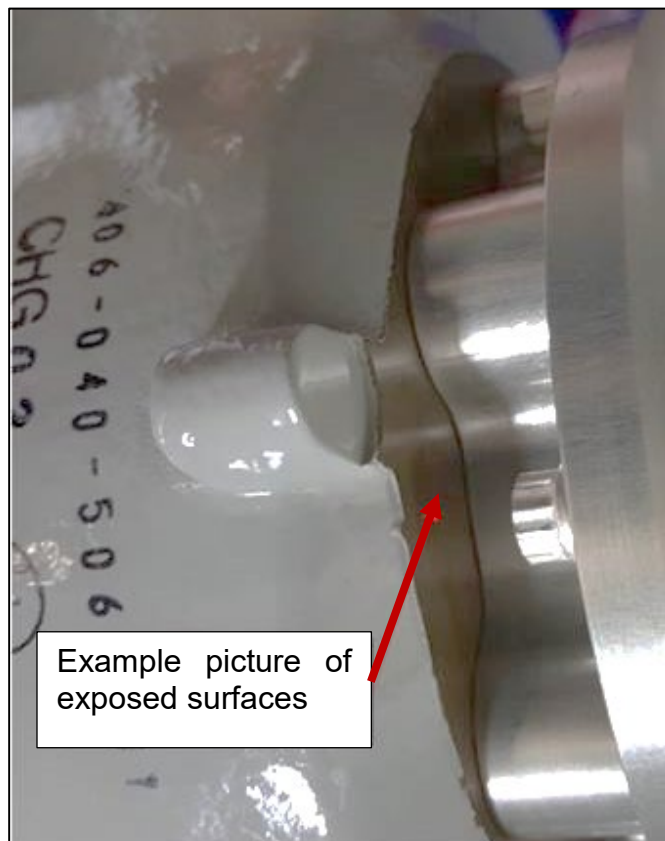
Figure 1 – Freewheel Housing Depicting Exposed Surfaces

Bell has been made aware of cases where corrosion has been found on the freewheel assembly housing surface to the engine gearbox interface. Following investigation, it was discovered that the surface paint masking of the interface of freewheel housing 406-040-500-107 is best adapted to fit on the model 206L4 and 407. This freewheel housing when fitted to the Arrius2R engine, as installed on the model 505, is not of the same imprint which allows for unpainted surfaces to be exposed to the environment. This bulletin introduces an immediate fix to apply sealant to these exposed surfaces to mitigate any potential for corrosion propagation.

5. With a bright light and mirror, inspect the housing bare metal surfaces for corrosion. Pay particular attention to top area for corrosion damage;
 - a. If corrosion appears to have migrated between the engine accessory gearbox flange and the freewheel assembly housing, then the housing requires removal ([DMC-505-A-63-10-02-00A-520](#)) to determine the extent of corrosion damage.

3. Gain access to the exposed bare metal surfaces of the freewheel housing (Figure 1).
4. Clean exposed surface and surroundings with Methyl Ethyl Ketone (C-309) and clean cloth (C-486).

- b. If corrosion damage is found not exceeding 0.010 inch (0.254 mm) in depth, clean up area with abrasive pad (C-407) and Brulin 815MX (C-318) diluted in water.

Rinse area clean with water. Repeat cleaning / rinsing as necessary to provide a clean surface. Apply chemical film to affected areas in accordance with brush-on method detailed in BHT-ALL-SPM Standard Practice Manual, Chapter 3, section 3-15, step 2. Two area repairs maximum permitted.

- c. If corrosion damage exceeds 0.010 inch (0.254 mm) in depth, contact Product Support Engineering to obtain a possible expanded repair. If an expanded repair is determined not possible due to excessive corrosion damage, the freewheel assembly housing 406-040-500-107 will require replacement.
