## **TECHNICAL BULLETIN**

**505-19-18**

**SUBJECT:** AIRFRAME TRUSS CORROSION PREVENTIVE MAINTENANCE PROGRAM, INTRODUCTION OF.

**HELICOPTERS AFFECTED:** Serial numbers 65011 and subsequent.

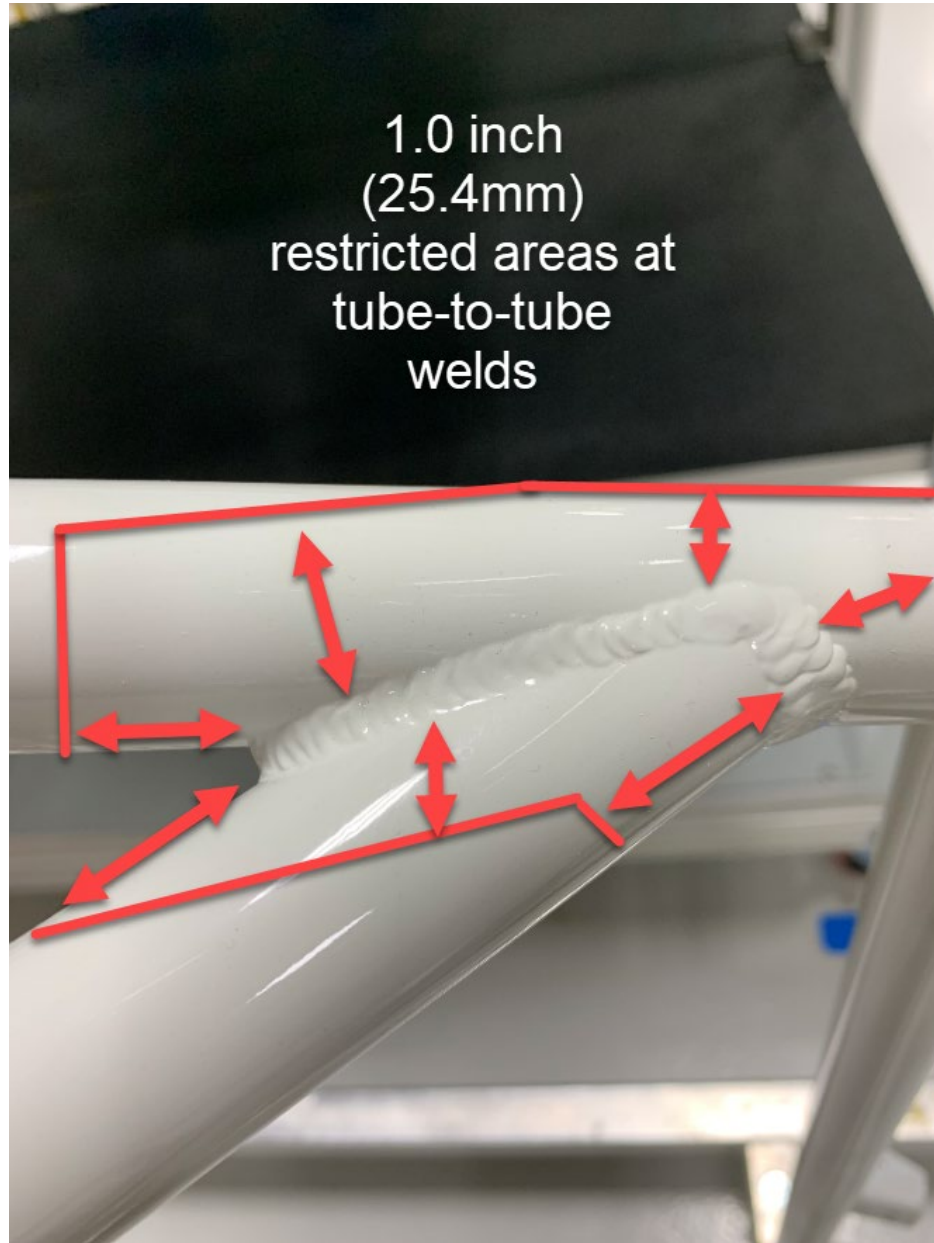
**Figure 1 – Restricted Areas at Tube-to-Tube Welds (Typical)**

Restricted areas of tubes where rework is not allowed are adjacent to welds attaching a tube to a tube, or near a tube vent rivet where limitation is 1.0 inch (25.4 mm) as seen in Figure 1 and Figure 2. Go to step 9 if corrosion is seen in these restricted areas.

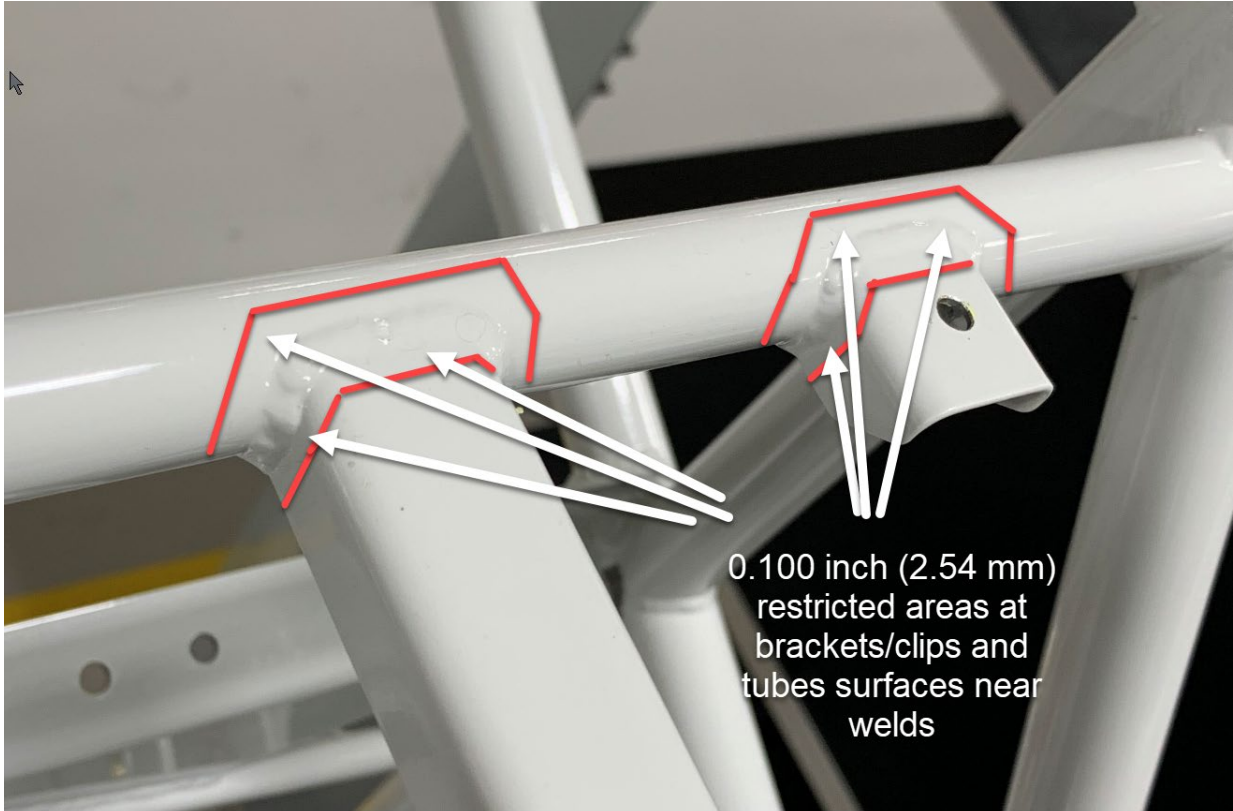
**Figure 3 – Restricted Areas at Tube-to- Brackets/Clips Welds (Typical)**

Restricted areas where rework is not allowed are adjacent to welds attaching brackets/clips to a mating tube and are limited to 0.100 inch (2.54 mm) as seen in Figure 3. Go to step 9 if corrosion is seen in these restricted areas.

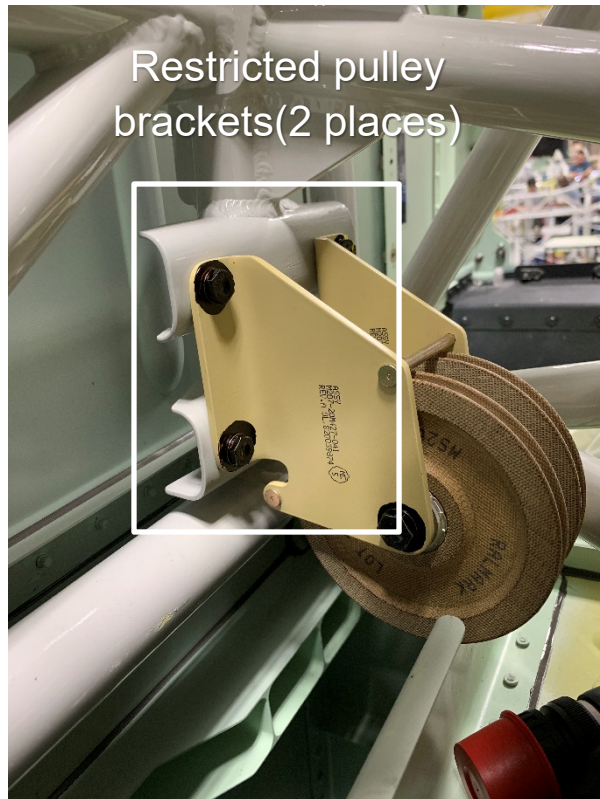
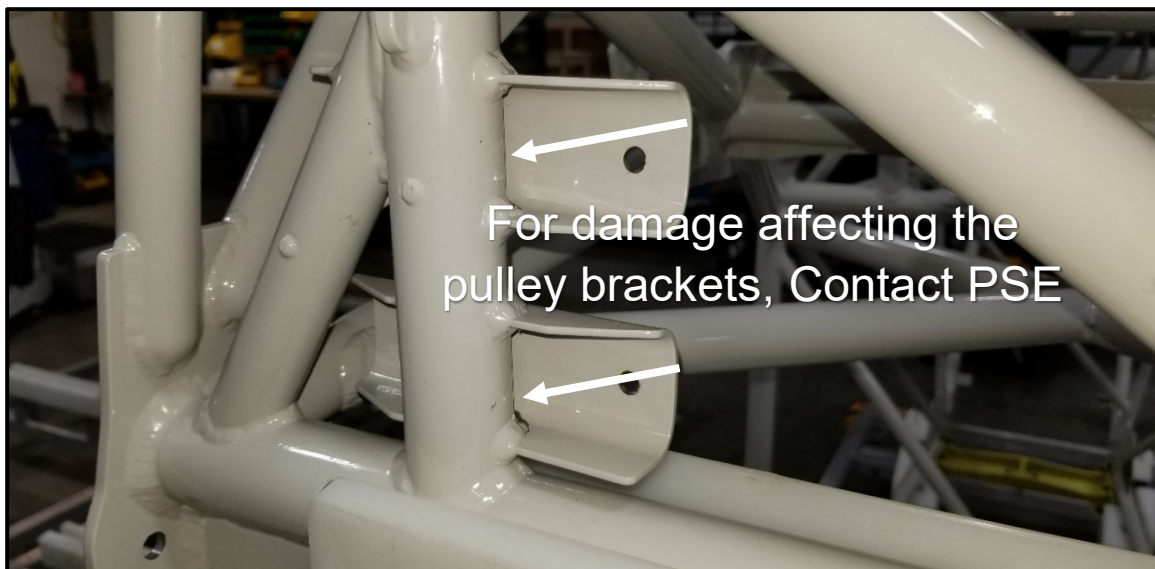
**Figure 8 – Forward Pulley Support Brackets (Restricted, 2 places)**

- e) The two forward pulley support brackets (Figure 8). Those are considered restricted. If damage is found, go to step 9.
  - f) The two aft pulley support brackets (Figure 9).

- e) If any corrosion or damage is found on restricted areas shown in Figures 8, 16 and 18, those areas are considered critical. Go to step 9.
  - j) Repair any pitting or damage 0.005 inch (0.127 mm) deep or less by using abrasive cloth (C-423) 400 Grit or finer. Sand affected bracket/clip smooth with adjacent surfaces while maintaining a 10:1 ratio. Sand defect on mating tube if affected in the longitudinal direction only while maintaining a ratio of 40:1 with adjacent surfaces. Restricted area for corrosion to a tube near a weld securing a clip or a bracket is 0.100 inch (2.54 mm) as seen in Figure 3.

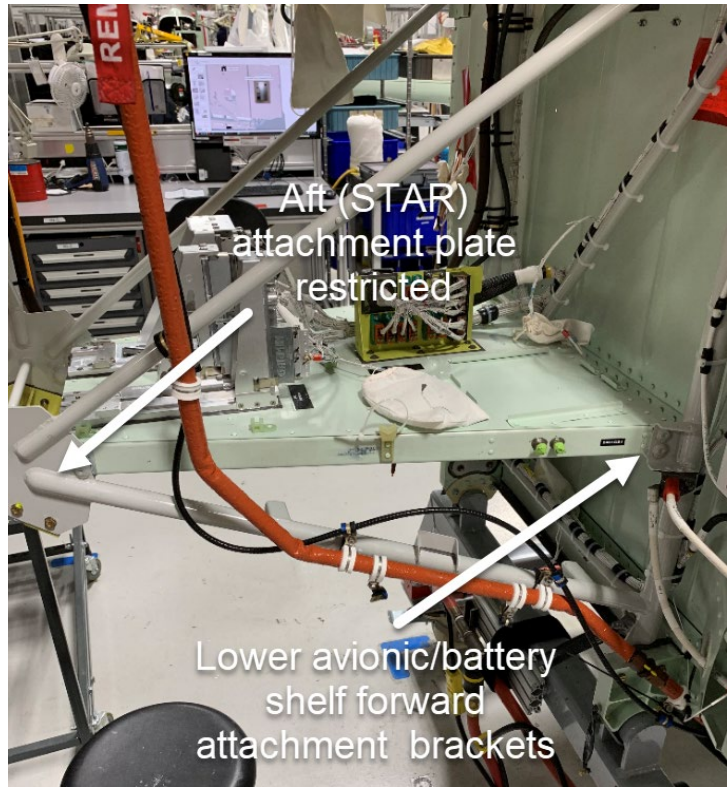
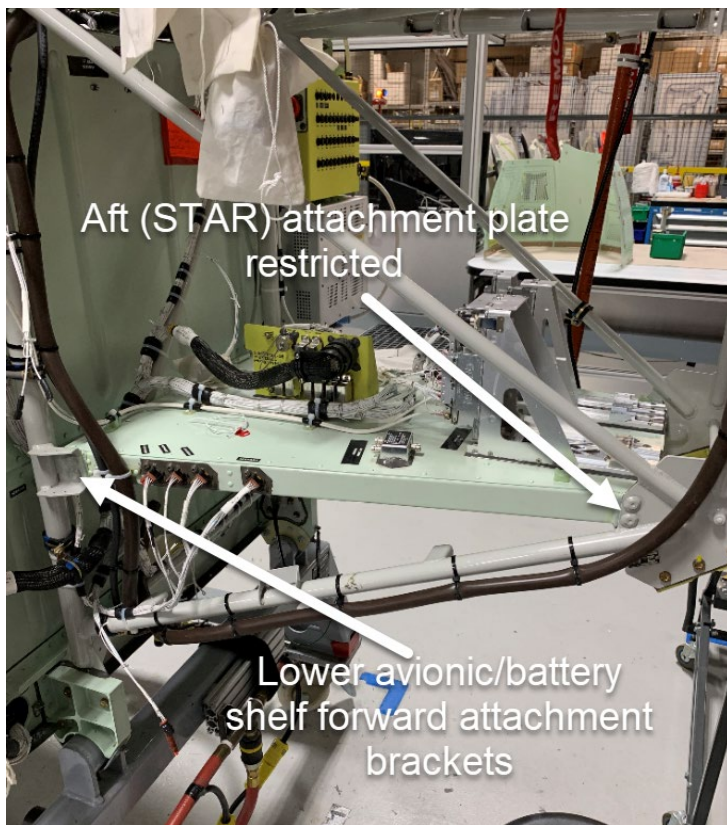
**Figure 16– Lower Avionic/Battery Shelf Attachment Brackets (2 places)**

- l) The six air conditioning condenser attachment brackets (Figure 15).
  - m) The two forward lower avionics/battery shelf attachment brackets (Figure 16). The aft attachment areas (plates) are considered restricted. If damage is found on the aft plates, go to step 9.

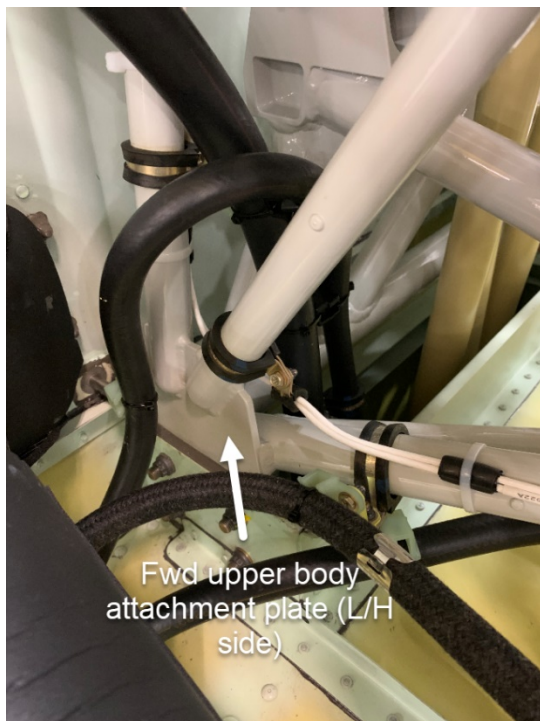
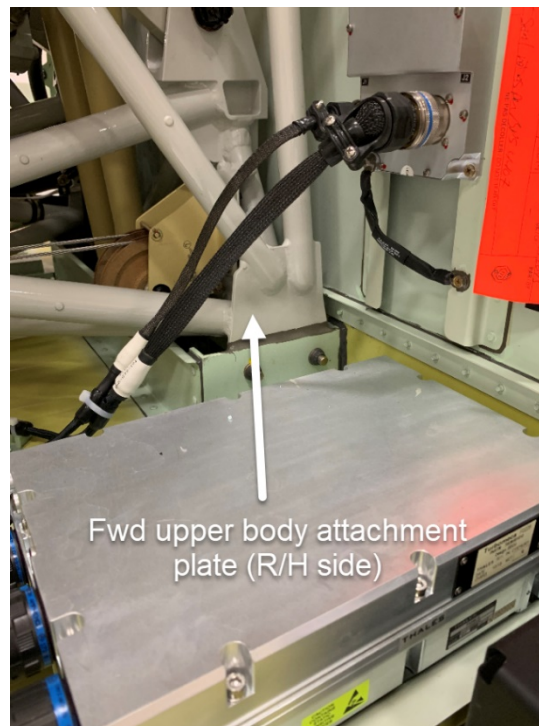
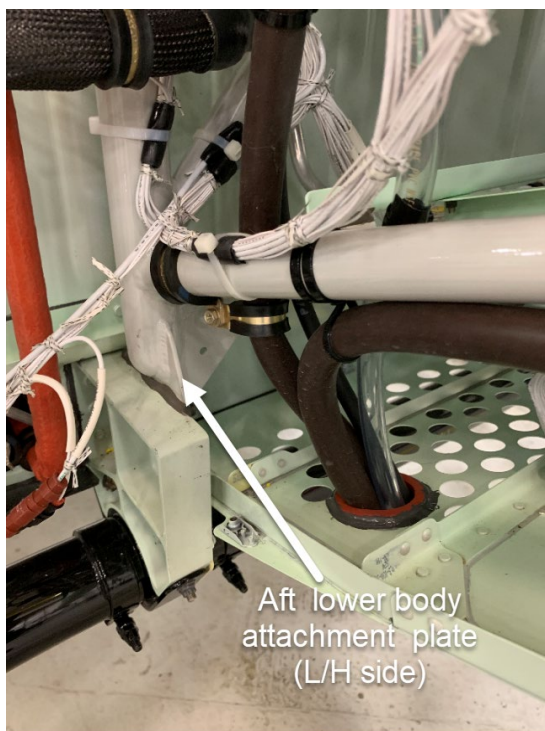
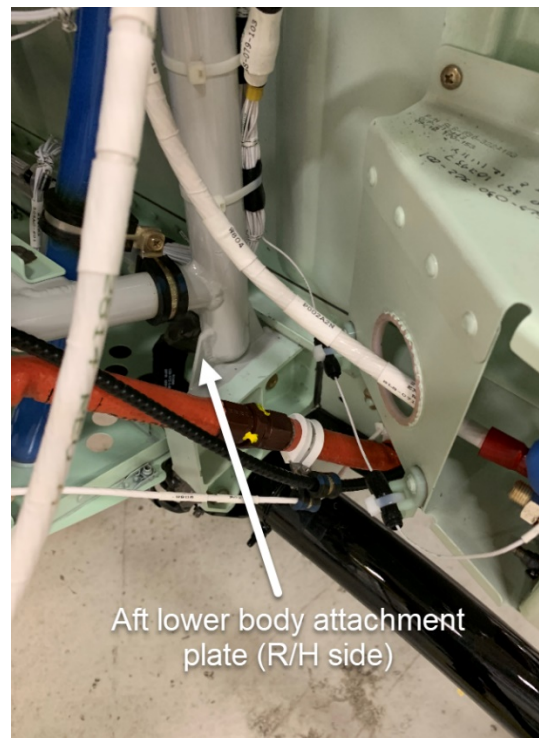
**Figure 18– Aft Body Frame Attachment Plates (Restricted, 4 places)**

- n) The two aft fuselage panels attachment frame clips (Figure 17).
  - o) The two forward upper and the two aft lower main body attachment plates. (Figure 18). Those plates are considered restricted. If damage is found, go to step 9.

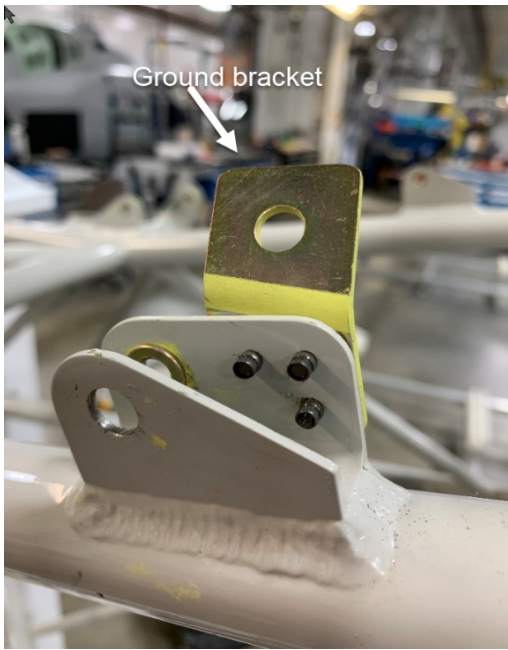
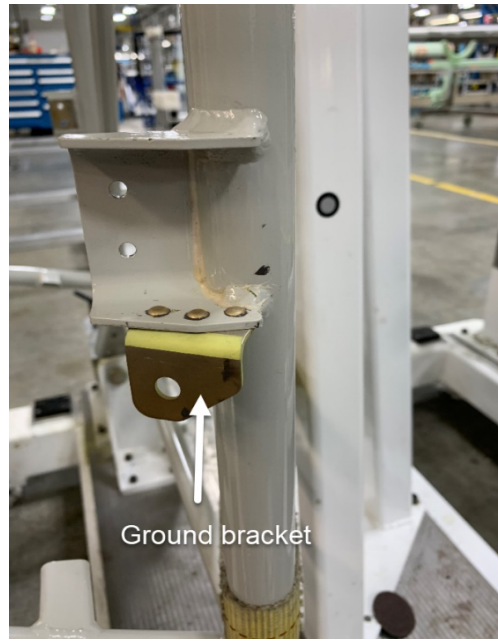
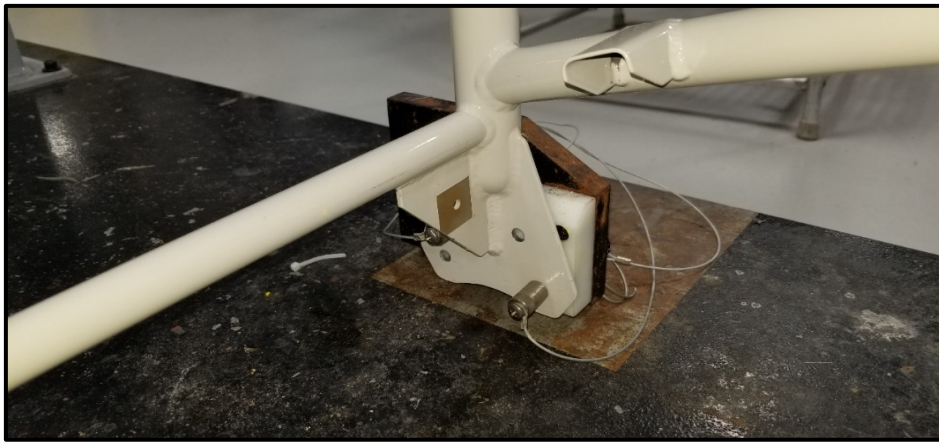
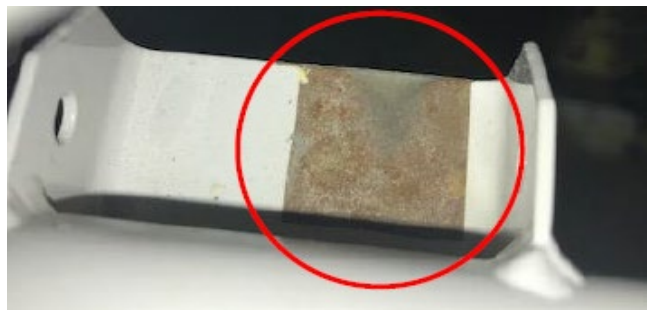
**Figure 19 – Example of Unprimed/Unpainted Areas of Truss**

- p) Pay attention to all unprimed/unpainted surfaces, including riveted grounding plane brackets (Figure 19). If corrosion exists near a ground lug attached to any of the unprimed/unpainted area of the truss (Figure 20), omit step 6 and repair area in accordance with step 7.

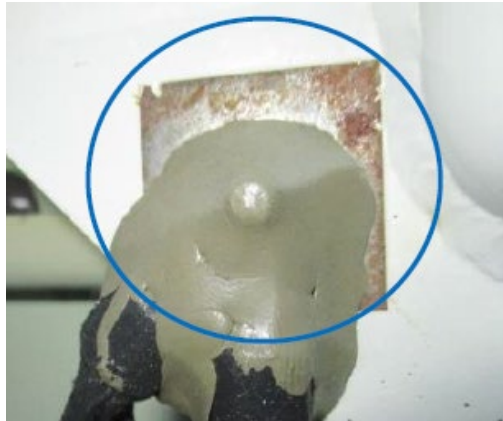
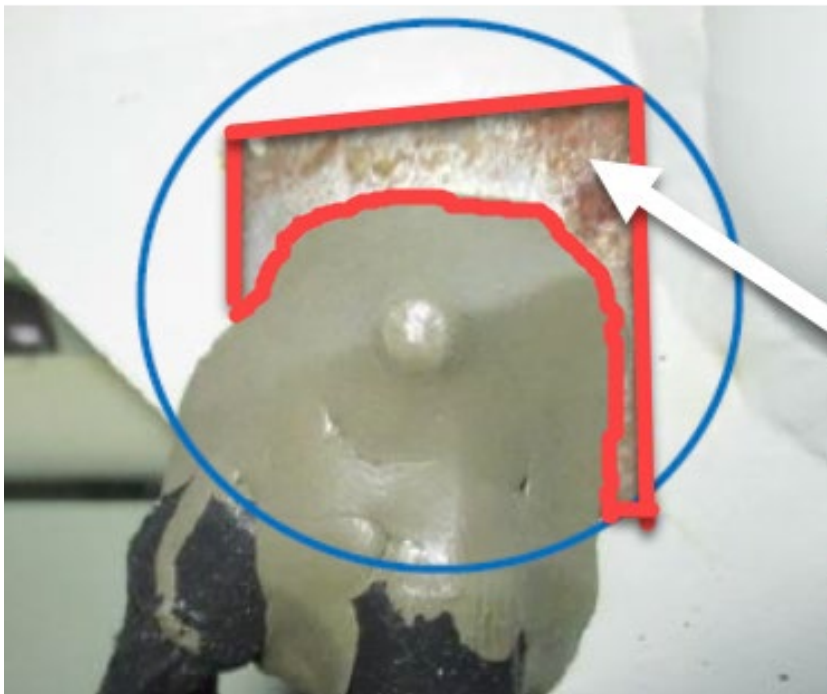
**Figure 20 – Rework Around Ground Terminal Lug**

Rework  
corroded  
area  
around  
ground  
lug only

- 7) Repair any unprimed/unpainted area where a ground lug is attached (Figure 20) as follows;

- d) Do not remove ground terminal lug but repair around it any pitting or damage 0.005 inch (0.127 mm) deep or less by using abrasive cloth (C-423) 400 Grit or finer. Sand smooth with adjacent surfaces while maintaining a 10:1 ratio. Do not sand in any of the restricted area described in this bulletin.
