## **ALERT SERVICE BULLETIN**

**206L-20-184**

**MODEL AFFECTED:** 206L, 206L-1, 206L-3 and 206L-4

**SUBJECT:** SEGMENTED TAIL ROTOR DRIVESHAFTS 206-040-369-001/-101, 206-040-365-001/-117/-125 WITH BONDED ADAPTERS, PROOF LOAD TEST OF.

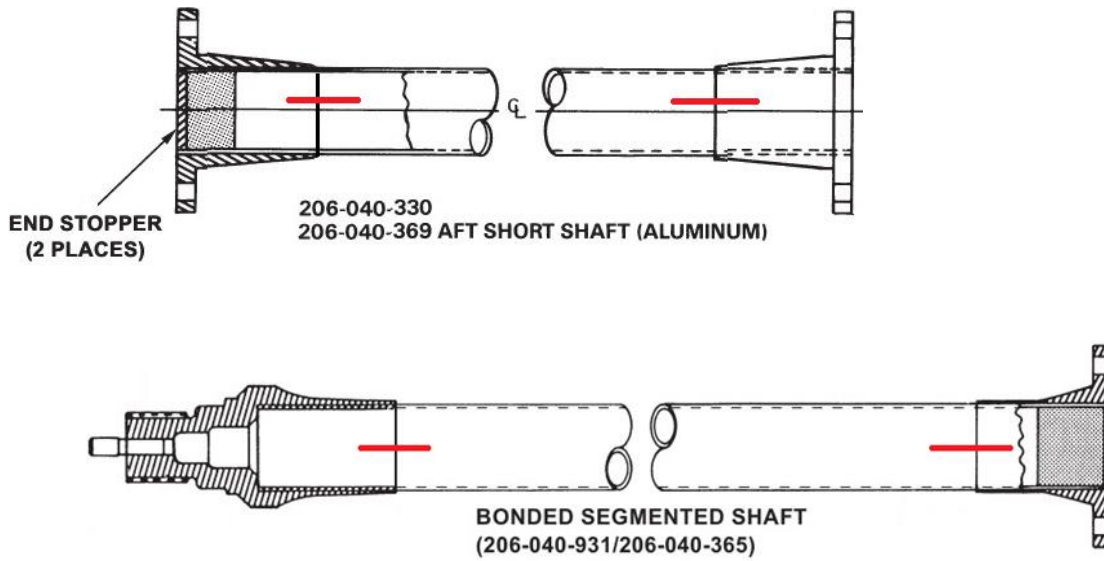
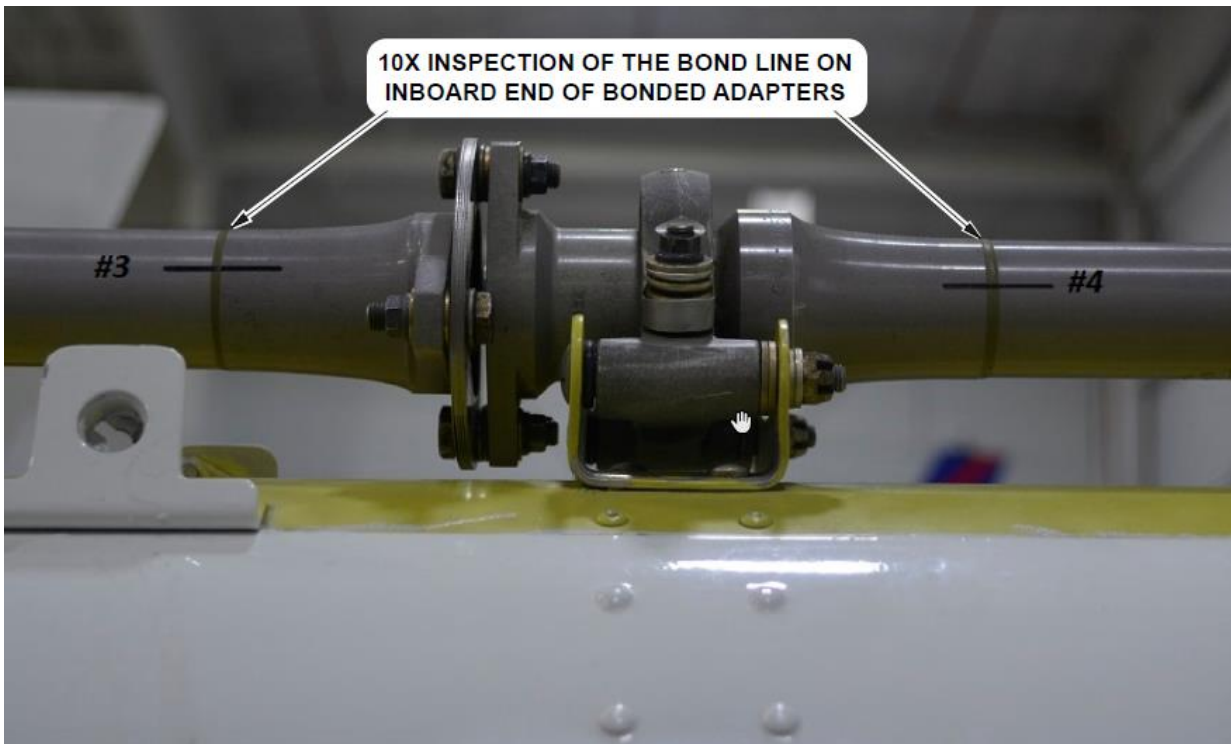
**Figure 1 – Example of Tail Rotor Driveshaft Numbering and Index Marking**

3. Carry out a detailed visual inspection of the bond line on the inboard end of the flange of the bonded tail rotor driveshafts using a 10X magnifying glass (Figure 1). If the bond line area shows damage such as cracked or missing adhesive or evidence of corrosion, the affected shaft is deemed un-repairable and must be removed from service and scrapped. Replace affected driveshaft(s) with a riveted tail rotor driveshaft(s) (TB 206L-02-207).

4. Index-mark each bonded tail rotor driveshaft and adapters with a fine tip felt marker (Figure 1) and number the shafts (example: Aft SS, 1, 2, 3, 4 and, 5. Driveshaft #5 being the closest to the tail rotor gearbox).

13. Following the proof load testing, carry out a detailed visual inspection of the bond line on the inboard end of the flange of the tail rotor driveshafts using a 10X magnifying glass to ensure there was no movement of the bonded adapter during the proof load testing.

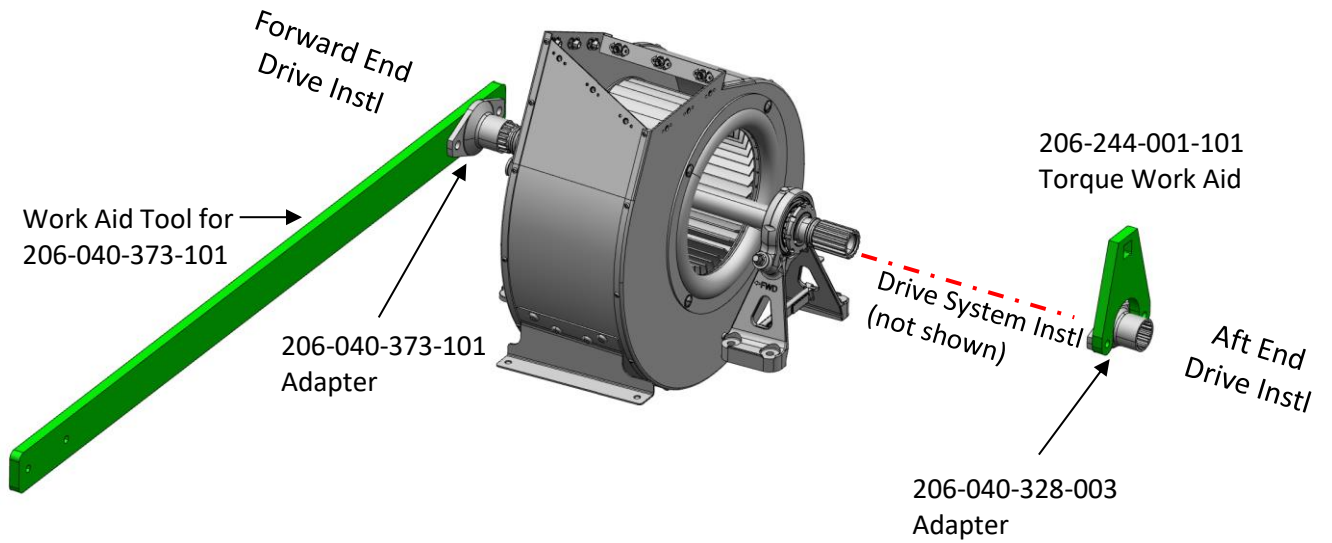
**Figure 4 – Bonded Shaft Work Aid Installation**

- a. Remove forward short shaft 406-040-315-111 (applicable Maintenance Manual).
  - b. Attach the 206-040-373 / 206-040-328 sliding adapter work aid on the forward face of the fan shaft sliding adapter (206-040-373) using two (2) AN175-12 or NAS6605-12 bolts, washers AN960-516L, and MS35650-3312 nuts, or equivalent (Figure 4).

- a. If the forward short shaft (206-040-325) has been removed, install the bonded shaft tool 206-244-001-101, or the 206-040-373 / 206-040-328 sliding adapter work aid, on the forward face of the sliding adapter (206-040-328) on the forward splines of the oil cooler blower shaft using two (2) AN174-12 or NAS6604-12 bolts, current washers AN960-416L, and nuts MS21042L4, NAS9926-4L or a MS35650-3252 nut, or equivalent (Figure 4 or 5).

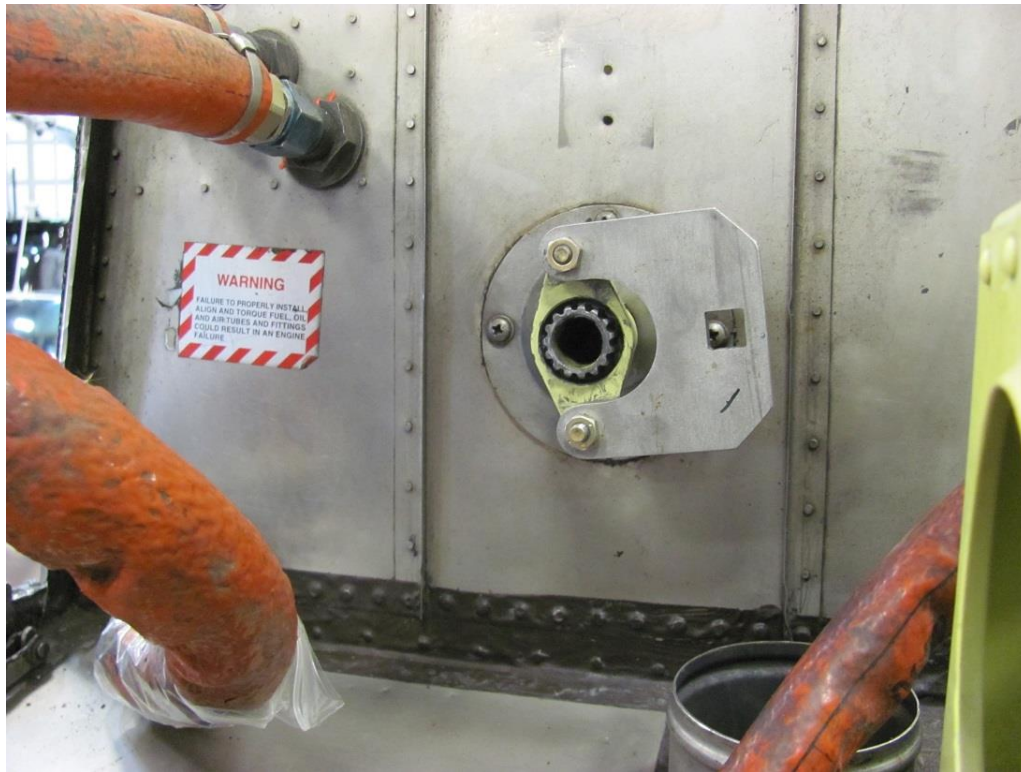
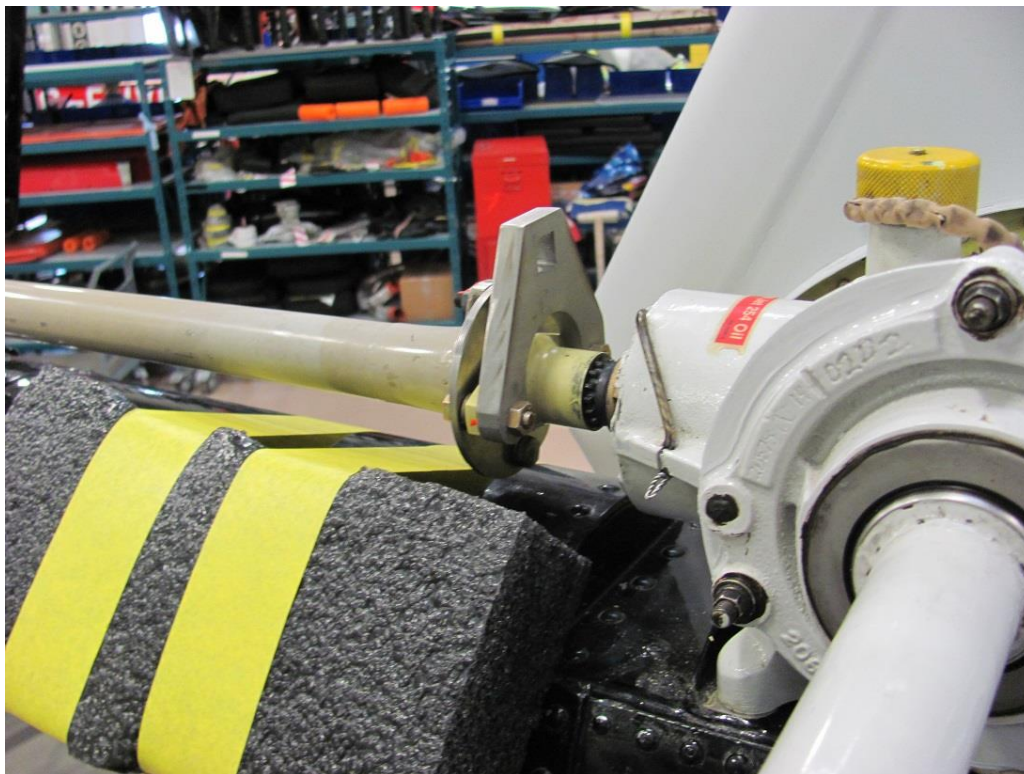
**Figure 5 - Examples of Bonded Shaft Tool Installations**

8. Install the second bonded shaft tool on the aft face of the sliding adapter (206-040-328) of the input pinion of the tail rotor gearbox using two (2) AN174-12 of NAS6604-12 bolts, current washers AN960-416L, and nuts MS21042L4, NAS9926-4L or a MS35650-3252 nut, or equivalent (Figure 5).

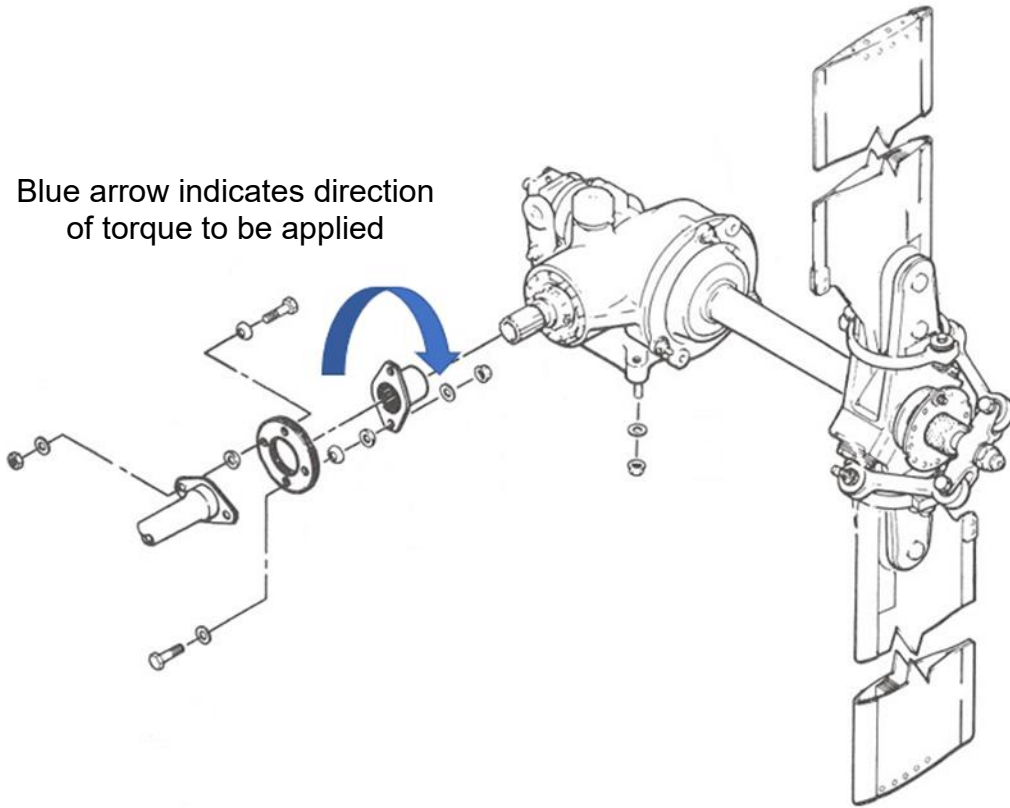
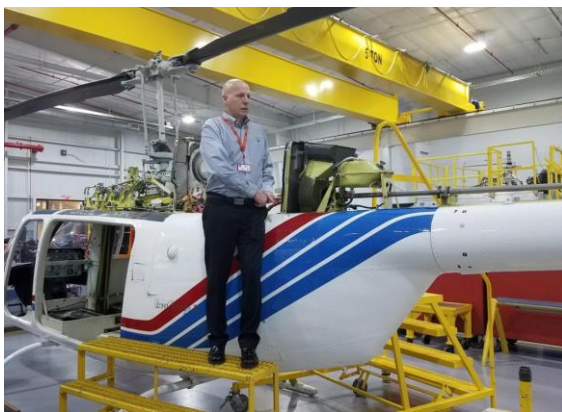
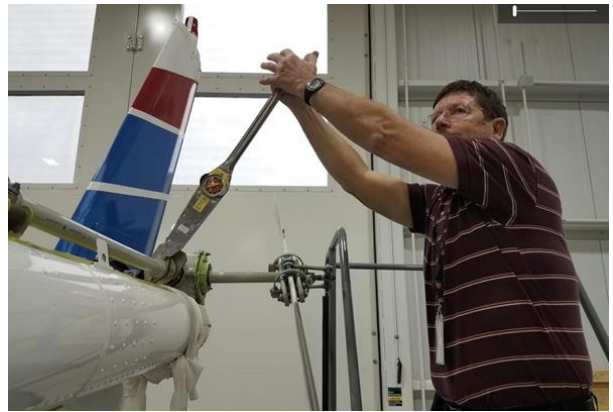
**Figure 6 – Proof Load Testing**

9. One person is required to hold the bonded shaft tool 206-244-001-101 with a ½-inch square drive breaker bar, or the 206-040-373 / 206-040-328 sliding adapter work aid, on the splines of the forward end of the oil cooler blower shaft (Figure 6).

10. One person is required to hold the torque wrench on the bonded shaft tool installed on the sliding adapter (206-040-328) of the tail rotor gearbox input pinion (Figure 6).

Blue arrow indicates direction of torque to be applied

11. Carry out the proof load testing of the installed tail rotor driveshafts by applying the equivalent of 123 foot-pounds (167 Newton-meters) of torque to the 1.25-inch diameter shafts 206-040-369-001/-101 and 206-040-365-001/-117/-125.
