OPERATION SAFETY NOTICE

206-18-41
206L-18-53
230-18-09
407-18-22
430-18-07
27 February 2018

SUBJECT: ENHANCED AWARENESS OF LOOSE OR BROKEN ENGINE COMPRESSOR SPLIT LINE BOLTS/STUDS

ENHANCED AWARENESS OF LOOSE OR BROKEN SPLIT LINE BOLTS/STUDS

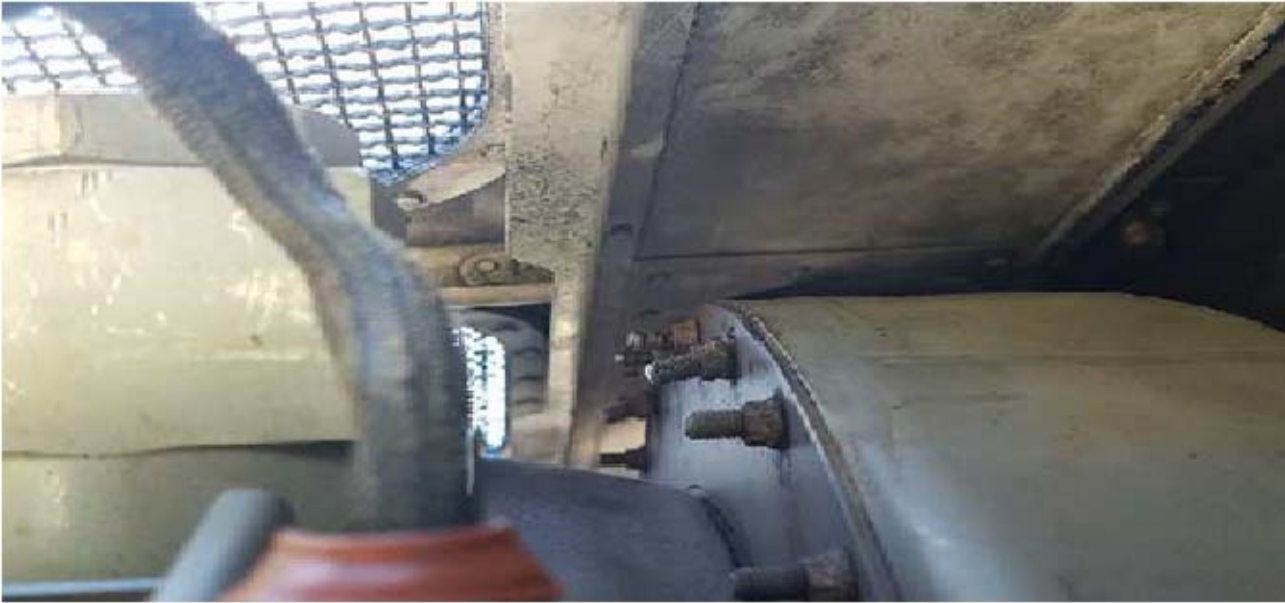
This Commercial Service Letter (CSL) has been released by Rolls-Royce to address some recent events where operators have discovered loose or broken split line studs on the compressor diffuser. Rolls-Royce would like to heighten the operator's awareness of detecting these issues.

Example of Broken Compressor Diffuser Studs
Figure 1

Each M250[®] Operations and Maintenance Manual (OMM) has pre-flight, post-flight, and scheduled inspections. Item #1 of these inspections discusses the general visual review of the entire engine looking for loose bolts, broken or loose connections, and the security of components. [Figures 1](#) and [2](#) show examples of broken studs on a compressor diffuser.

WARNING: It is the owner/operator's sole responsibility to comply with these inspections or risk a potential for loss of aircraft or loss of life. Rolls-Royce is not responsible for an owner/operator's failure to comply.

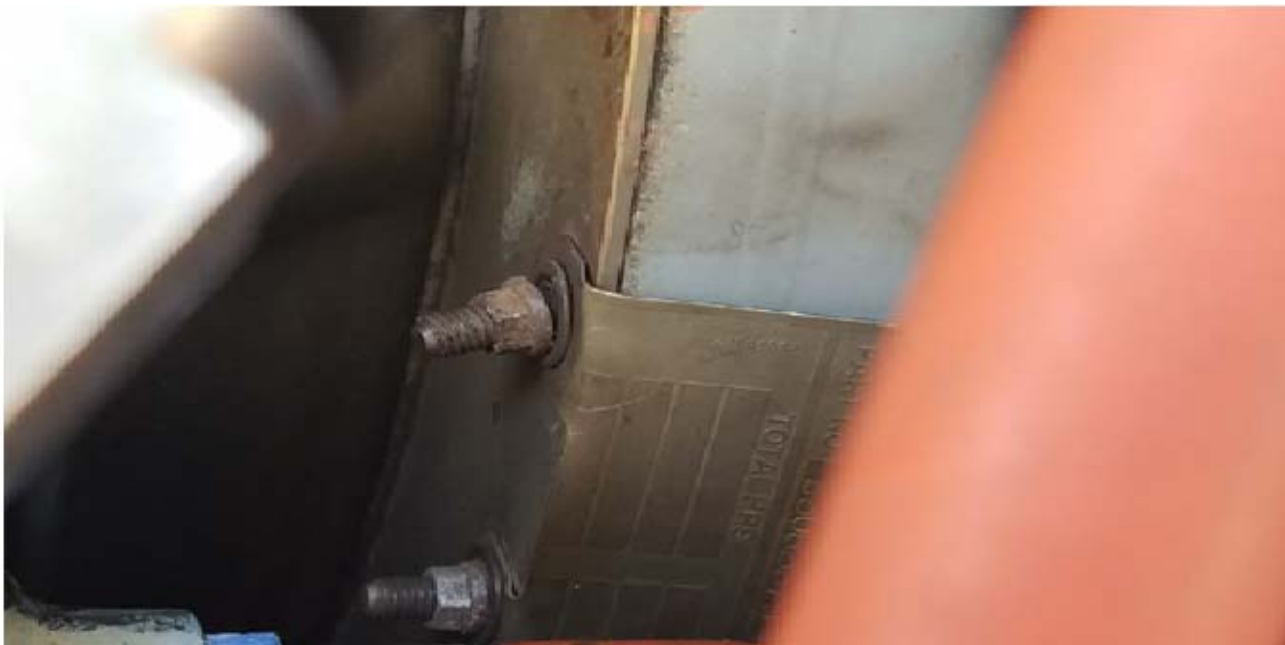
Example of Broken Compressor Diffuser Stud
Figure 2
