**ALERT SERVICE BULLETIN**  
**Bell Helicopter** **TEXTRON**

NO. 412-07-121

**SUBJECT:** ENGINE, P3 FILTER AND PNEUMATIC SYSTEM  
– INSPECTION OF

P&WC S.B. No. A5490

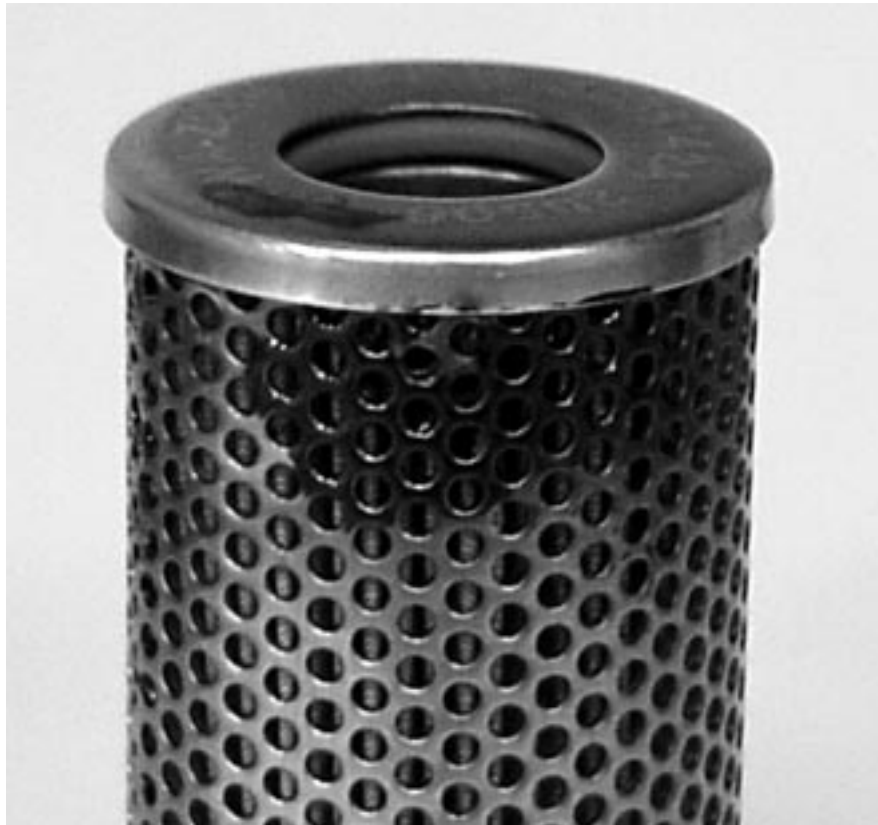
Oil Deposit on Filter Element  
Figure 1

- (1) When you remove the filter element from the cover, inspect the filter element, inside and outside, for black deposit.
- (2) If there is no black deposit on the filter element and there is no loose debris inside the filter housing assembly and cover, reinstall the P3 air filter housing cover and filter element (Ref. MM 73-10-07). No further action is required.

- (3) If the filter has a black deposit that is dark and smooth and if it is baked on the filter element with no build-up or lumps and there is no loose debris in the filter housing and cover (Ref. Fig. 1 and 2), install a new filter element. No further action is required.

- (1) Remove the P3 air filter cover and filter element (Ref. 73-10-07).
- (2) Remove the filter element from the cover.
- (3) Inspect inside and outside the filter element for black deposit (Ref. Fig. 1).
- (4) Inspect inside the filter cover for loose debris (Ref. Fig. 2).
- (5) If no black deposit and no loose debris are found, reinstall the P3 filter (Ref. MM 73-10-07). No further action is required.

- (6) If the filter has a black deposit that is dark and smooth and if it is baked on the filter element with no build-up or lumps and there is no loose debris in the filter housing and cover, install a new filter element (Ref. Fig. 1 and 2). No further action is required.
