## **INFORMATION LETTER 407-00-55**

**SUBJECT: AIR CONDITIONER COMPRESSOR DRIVE PULLEY**

**Service Bulletin:** SB407-101; Bell 407 Air Conditioner Compressor Drive Pulley.

**Subject:** Inspection & Torquing Procedure for the Air Conditioner Compressor Drive Pulley Installation.

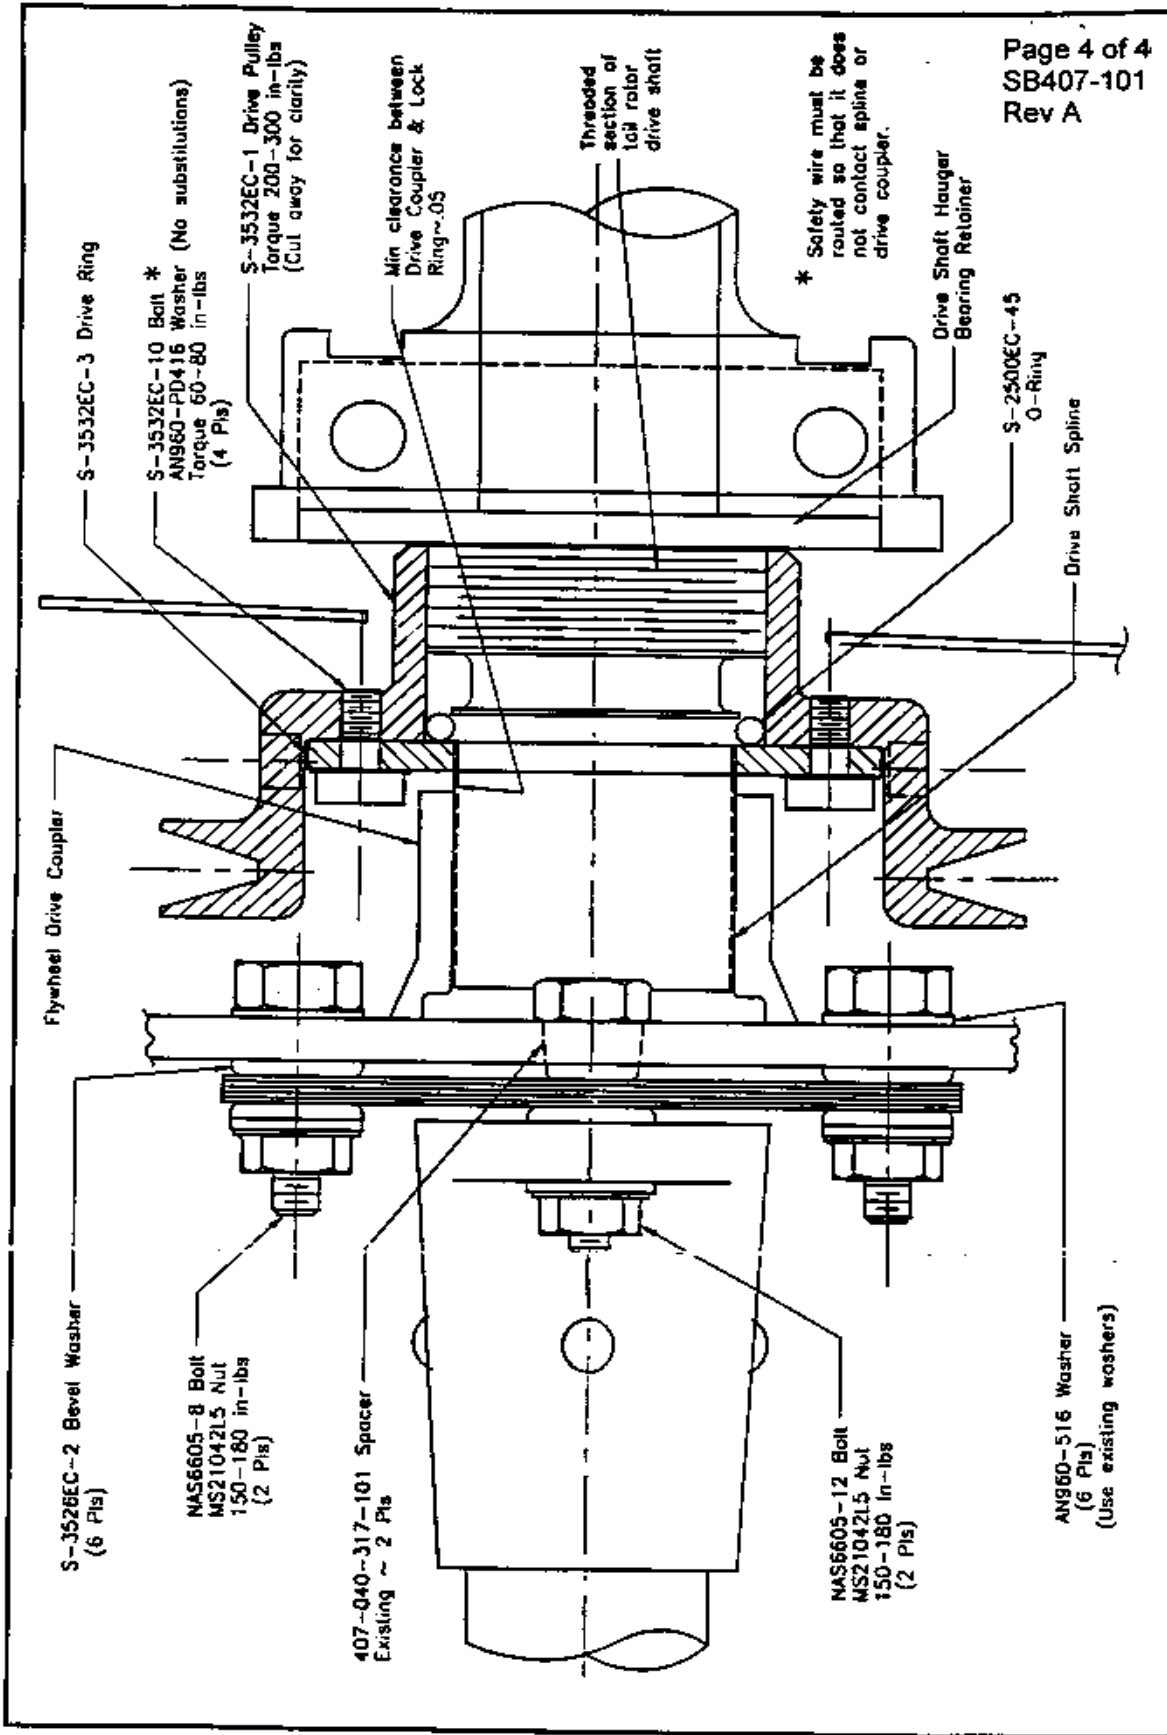
Figure 1 Compressor Drive Pulley Installation Details

2. Install Compressor Drive Pulley and Drive Ring as follows.
  - a. Install the Compressor Drive Pulley (P/N S-3532EC-1) on the forward end of the Tail Rotor Driveshaft, thread the pulley tightly against the face of the Driveshaft Hanger Bearing Retainer.
  - b. Torque Compressor Drive Pulley to 200 – 300 in lbs., using a .257 Dia X .13 Deep Spanner wrench, utilizing one of the four available holes on the pulley body. (See note page 3 of 4).
  - c. Install the Drive Ring (P/N S-3532EC-3) on the Driveshaft Spline, and slide into place. Align four of the twelve holes provided in the drive ring with the four threaded holes in the Compressor Drive Pulley.

- d. Once the correct hole alignment is achieved between the Drive Ring and the Compressor Drive Pulley, Install the four retaining Bolts (P/N S-3532EC-10) and Washers (P/N AN960-PD416) torque to 60 – 80 in lbs., and safety the bolts in pairs using .032 safety wire.

- e. Install Flywheel Drive Coupler, Flywheel and existing Drive Shaft mounting hardware as shown on Page 4 of 4, torque nuts to 150 –180 in lbs.

Minimum clearance between the Flywheel Drive Coupler, and the Drive Ring is .050 inch.
