TECHNICAL BULLETIN

No. 214-99-89

MODEL AFFECTED: 214B/214B-1

SUBJECT: INTRODUCTION OF IMPROVED TRANSMISSION OIL FILLER CAP ASSEMBLY, P/N F502SC

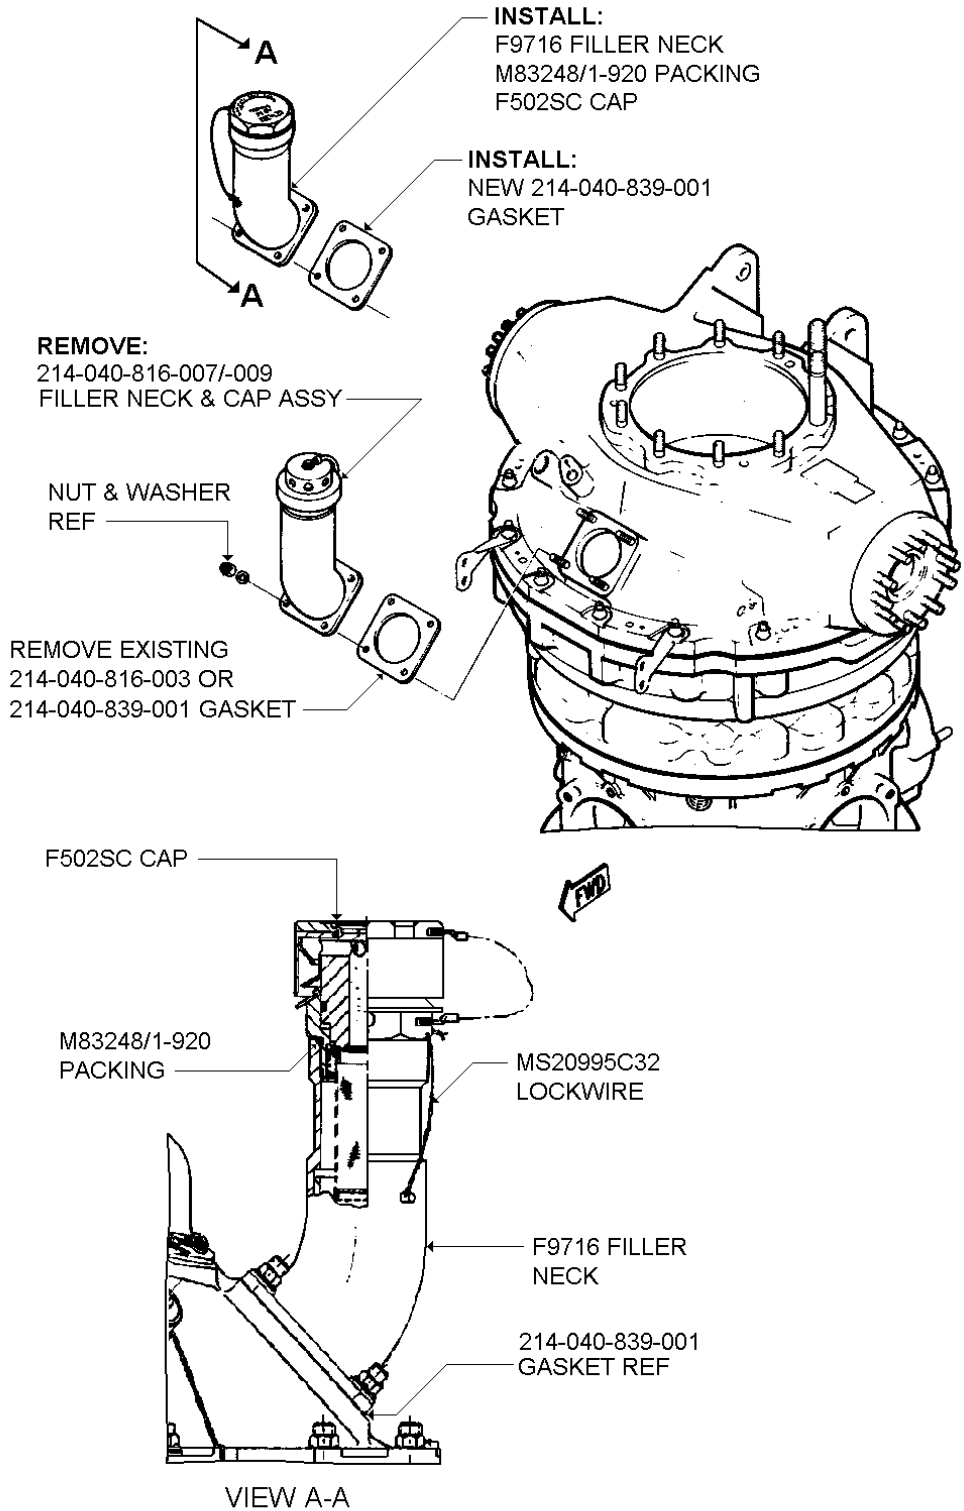
The P/N F502SC Filler Cap Assembly has an improved internal baffle design which greatly reduces the possibility of water ingestion through the cap's vent holes. Installation of the P/N F502SC Filler Cap Assembly on the 214B/B-1 helicopters will also require replacement of the existing filler neck and cap assembly with P/N F9716 Filler Neck.

1. Refer to Figure 1. Gain access to the transmission assembly oil filler neck and cap assembly.
2. Remove existing filler neck and cap assembly, P/N 214-040-816-007 or -009, and the P/N 214-040-816-003 or 214-040-839-001 Gasket as noted in BHT-214B-CR&O-1, Chapter 66. Use caution to ensure the transmission is not contaminated with debris or foreign objects. Retain washers and nuts for reinstallation if they are serviceable.
3. Locate a new P/N 214-040-839-001 Gasket in place, install the P/N F9716 Filler Neck and secure with four serviceable P/N AN960-516 washers and MS21042L5 nuts. Torque nuts 30 to 50 IN-LB.
4. Install a P/N M83248/1-920 Packing in the top of the F9716 Filler Neck and thread the P/N F502SC Filler Cap Assembly into the filler neck; torque 50 to 75 FT-LB. Secure with P/N MS20995C32 Lockwire.
