TECHNICAL BULLETIN

407-12-96

MODEL AFFECTED: 407

SUBJECT: AFT FUSELAGE UPPER LEFT LONGERON
ASSEMBLY P/N 206-031-314-237B,
INTRODUCTION OF.

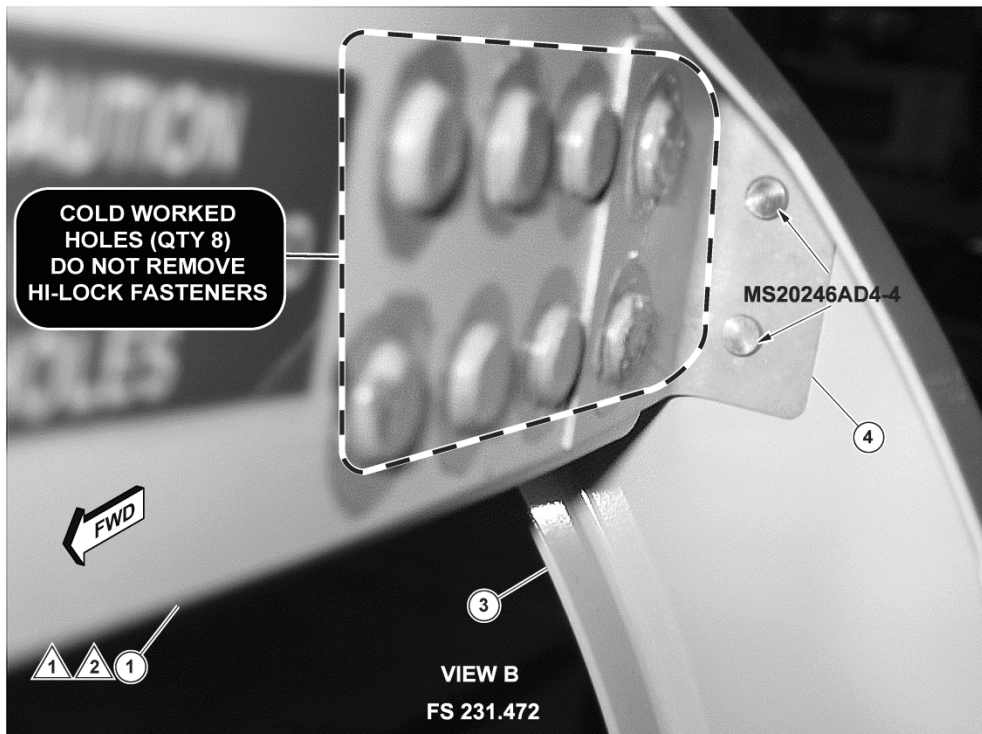
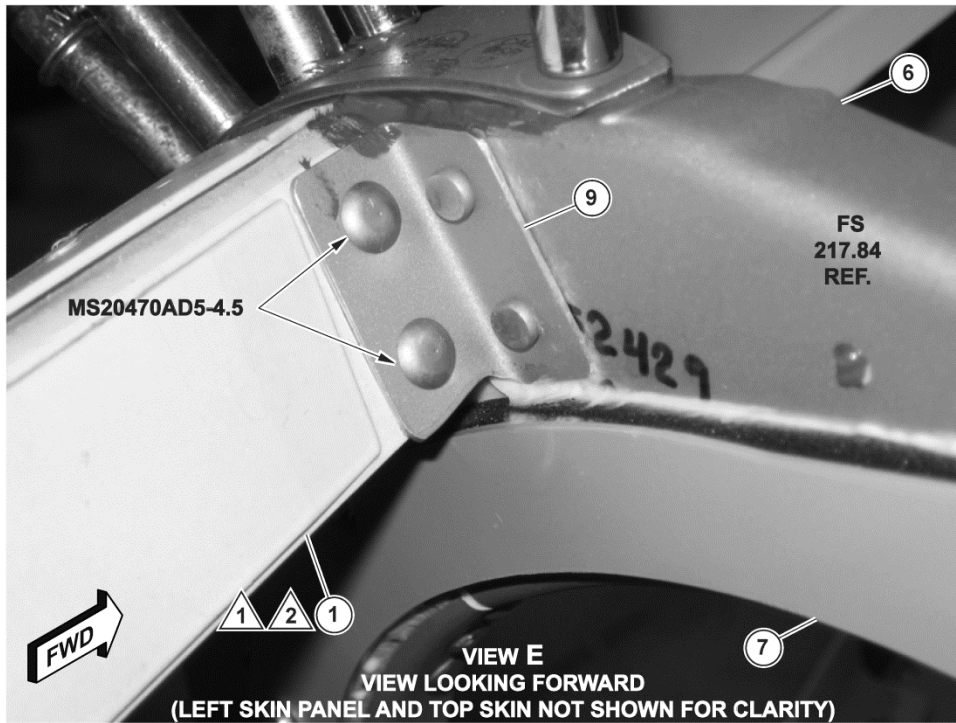
Figure 7- Removal/Installation of Left Upper Longeron (Sheet 1 of 8)

| 1. Longeron / fitting assembly (Ref.) | 13. Forward longeron (Channel) (Ref.) | 11549_004m |
| 2. Frame (FS 217.84) (Ref.) | 14. Lower splice doubler (FS 192.00) (Ref.) | |
| 3. Aft fuselage bulkhead (Ref.) | 15. Aft fuselage top skin | |
| 4. Outboard clip (FS 231.472) (Ref.) | 16. Left fuselage skin panel (Ref.) | |
| 5. Inboard clip (FS 231.472) (Ref.) | 17. Oil cooler fairing retainer | |
| 6. Frame (FS 217.84) | 18. External strap doubler 407-530-020-119 or 407-030-700-195 | |

11. Remove all fasteners securing the aft fuselage top skin (1, Figure 6) to the aft fuselage. Break sealant between faying surfaces using a thin blade warm putty knife. Remove the top skin.
12. Drill all remaining rivets securing the longeron assembly (1, Figure 7) to the aft fuselage. Remove existing splices joining bulkhead sections as required and retain for reinstallation later.
13. Use a thin blade warm putty knife to break sealant between the upper flange of the longeron assembly (1) and between each bulkhead interface. Remove longeron assembly (1) from aft fuselage assembly by gently sliding (pulling) out of position toward the aft of the aircraft.

18. Position the forward portion of the longeron (1, Figure 7) tight against the lower surface of the oil cooler blower support panel (21). Temporarily clamp the new longeron assembly (1) to the forward longeron assembly (13). Mark all rivet holes using a felt pen, including the lower splice (14) at fuselage station 192.00 as shown in View I.

- c. Minimum thickness of a tapered shim could not be less than 0.005 inch (0.127 mm) thick.
 - d. Secure shim(s) in place between skin panel (16, Figure 7) and upper flange of longeron (1) before drilling affecting holes.

26. Remove 3/16" diameter bolt washers and nut (or C-clamp if used), from upper L/H longeron assembly (1, Figure 7) and use appropriate drill bushings as required to increase size between 0.4385 inch to 0.4405 inch (11.13 mm to 11.18 mm) through longeron fitting assembly (2, Figure 10) and radius block (4).
27. Remove drill plate (8, Figure 5) from aft fuselage.
