## ALERT SERVICE BULLETIN

**412-20-182**

**MODEL AFFECTED:** 412/412EP

**SUBJECT:** ENGINE OIL CHECK VALVE P/N 209-062-520-001,  
INSPECTION AND REPLACEMENT OF.

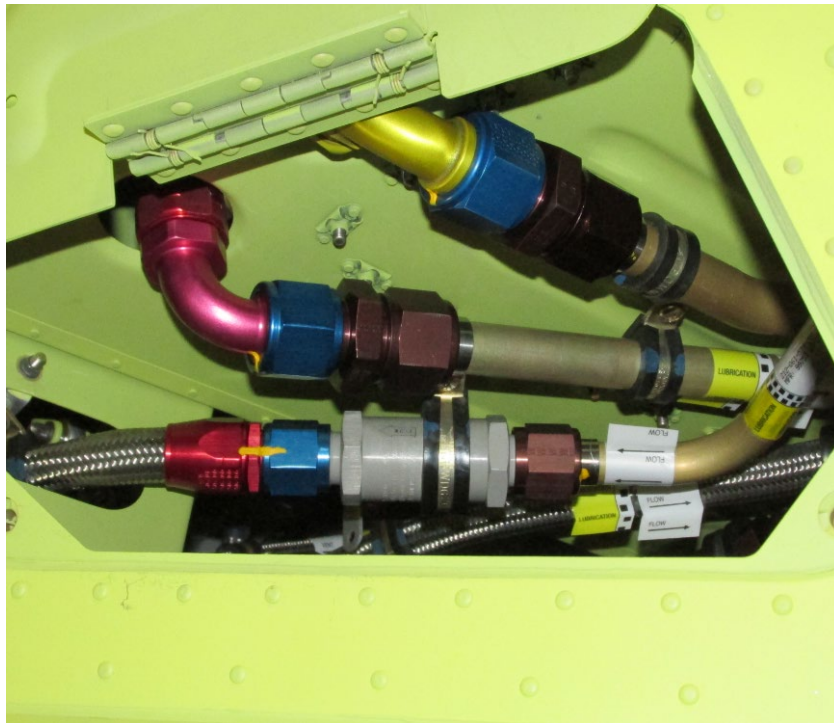
Figure 1. Engine Oil Check Valves Locations

Detail A. Engine Number 2 (Right Side)

1. Prepare the helicopter for maintenance and gain access to the engine oil check valves. The engine oil check valves are located in the engine reduction gearbox compartment under the oil coolers (Figure 1, Details A and B).

1. Prepare the helicopter for maintenance and gain access to the engine oil check valves (Figure 1, Details A and B).
2. Using a strong light source, visually inspect the oil check valves for general condition and oil leaks. Inspect for cracks at the inlet end where the threaded fitting is installed (Figure 3).
3. If a crack is found, replace the check valve prior to next flight. Figure 4 shows an example of a cracked check valve.
4. If no cracks or any other defects that would cause the valve to be unserviceable are found, make an entry in the helicopter logbook and historical service records indicating the findings and that Part II will require accomplishment until Part III is accomplished.

1. Prepare the helicopter for maintenance and gain access to the engine oil check valves (Figure 1, Details A and B).
2. Refer to the applicable Maintenance Manual and replace defective oil check valve(s) (BHT-412-MM, Chapter 79).
3. Make an entry in the helicopter logbook and historical service records indicating compliance with this Alert Service Bulletin.

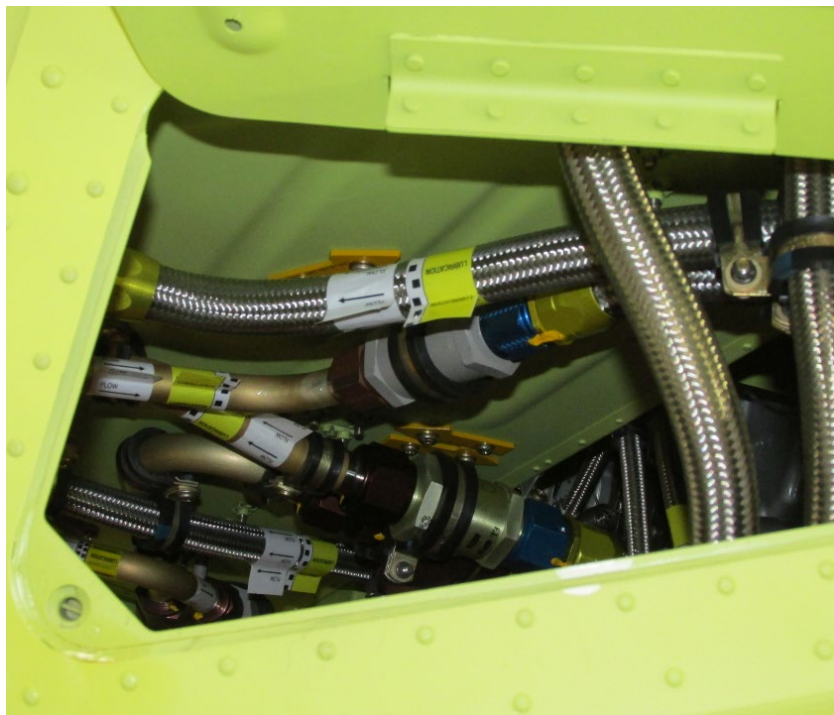
Detail B. Engine Number 1 (Left Side)

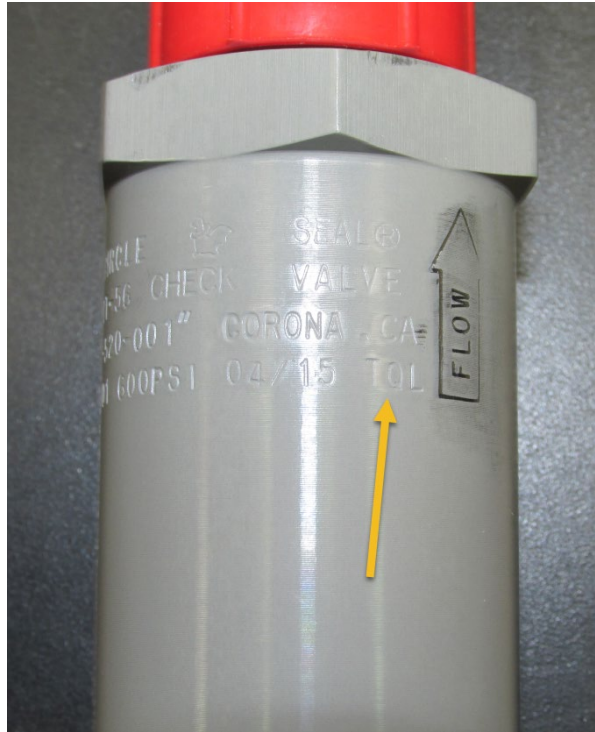
Figure 2. Engine Oil Check Valves not Affected.

Detail A. Circor Aerospace Engine Oil Check Valve Marked "TQL"

It is not necessary to remove the oil check valve for inspection however some clamping may require removal for better access. Regardless of manufacturing date, any oil check valves with the "TQL" marking are not affected by this bulletin. Oil check valves manufactured by other suppliers are also not affected by this bulletin. Oil check valves with the "CORONA CA" marking and without the "TQL" marking are affected by this bulletin. (Figure 2, Details A and B).

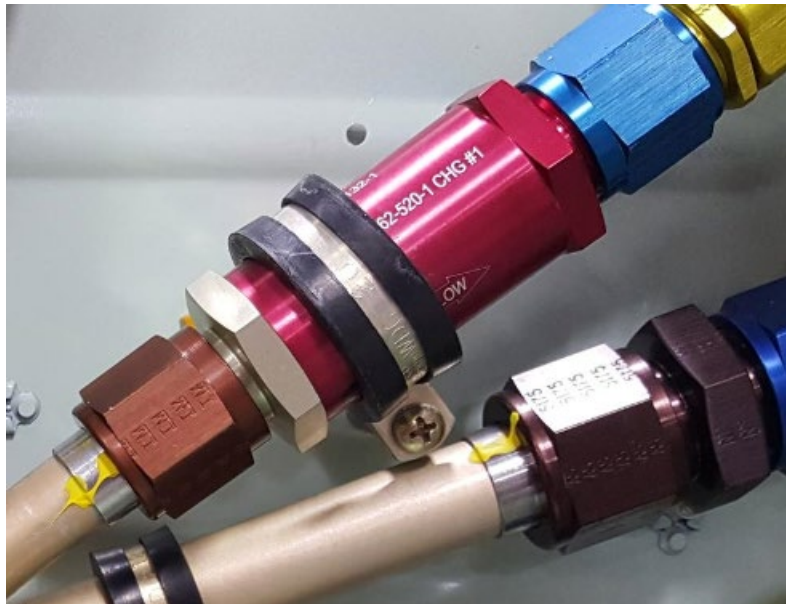
Detail B. Engine Oil Check Valve not Manufactured by Circor Aerospace.

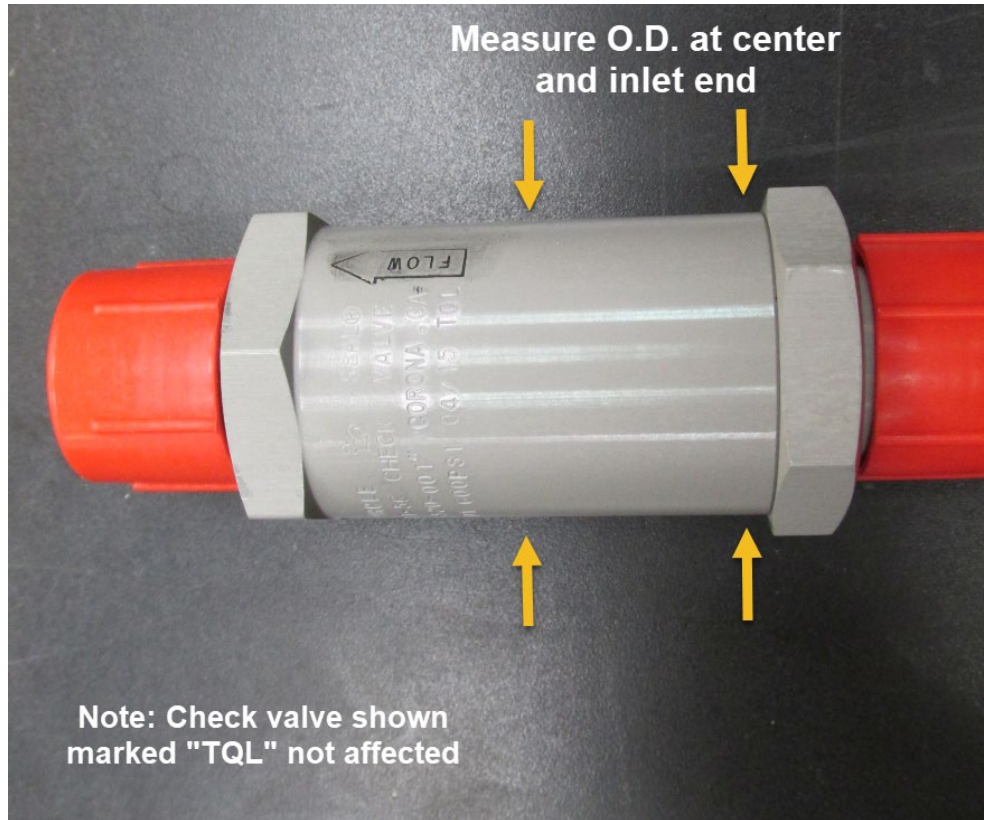
Figure 3. Engine Oil Check Valve Outside Diameter Measurement

- d. If the dimension measured at the inlet end is greater than 0.003 inch (0.0762 mm) when compared to the measurement at the center, the valve will require replacement. Part III can be accomplished immediately, or Part II can be accomplished until the defective valve can be replaced in accordance with Part III.
- e. If the defective check valve is not replaced immediately, make an entry in the helicopter logbook and historical service records indicating the findings and that Part II must be accomplished every 25 flight hours or 30 days whichever comes first until Part III is accomplished.

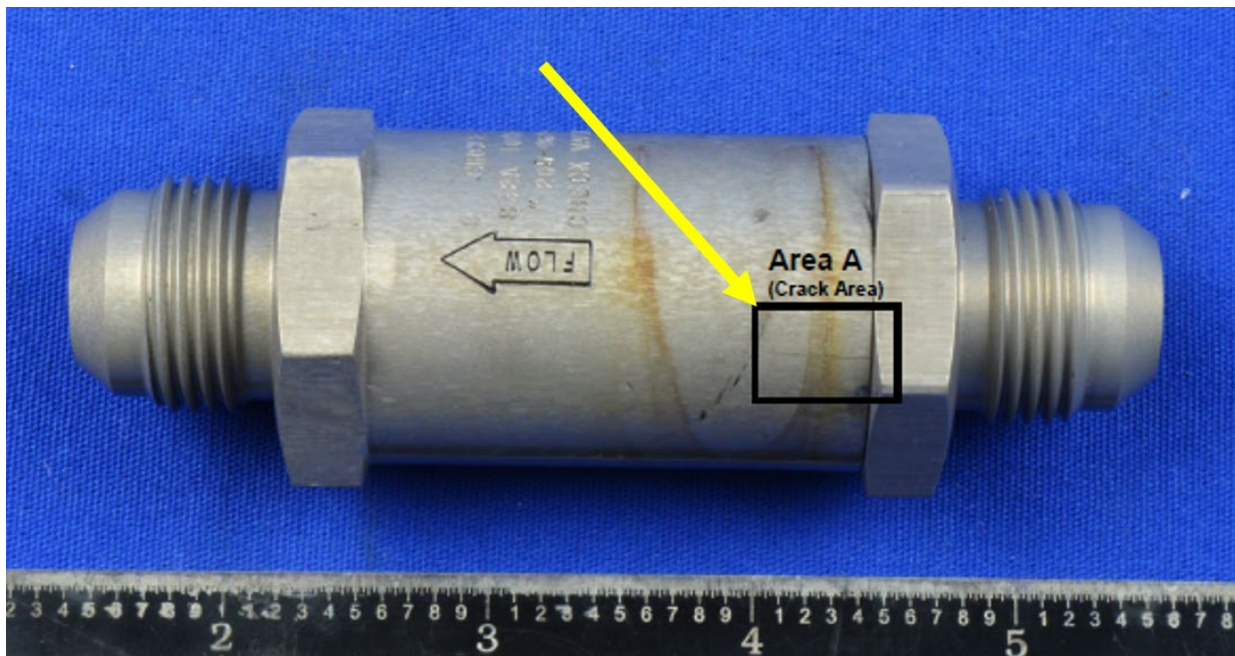
Bell recently received a report of a cracked check valve manufactured by Circor Aerospace (Circle Seal). This check valve was manufactured in 2009 which is outside of the manufacturing date range (October 2011 – March 2015) addressed by the ASB 412-15-165 Rev A. Corrective actions implemented in 2015 by Circor Aerospace to prevent cracking of the check valve housings are indicated by the “TQL” marking.

This recent check valve cracking report indicates that additional oil check valves P/N 209-062-520-001 manufactured by Circor Aerospace (Circle Seal) not having the “TQL” marking may be susceptible to cracking with time in service.

Figure 4. Cracked Engine Oil Check Valve
