## ALERT SERVICE BULLETIN

**412-20-183**

**MODEL AFFECTED:** 412/412EP

**SUBJECT:** FUEL CHECK VALVE P/N 209-062-607-001,  
INSPECTION AND REPLACEMENT OF.

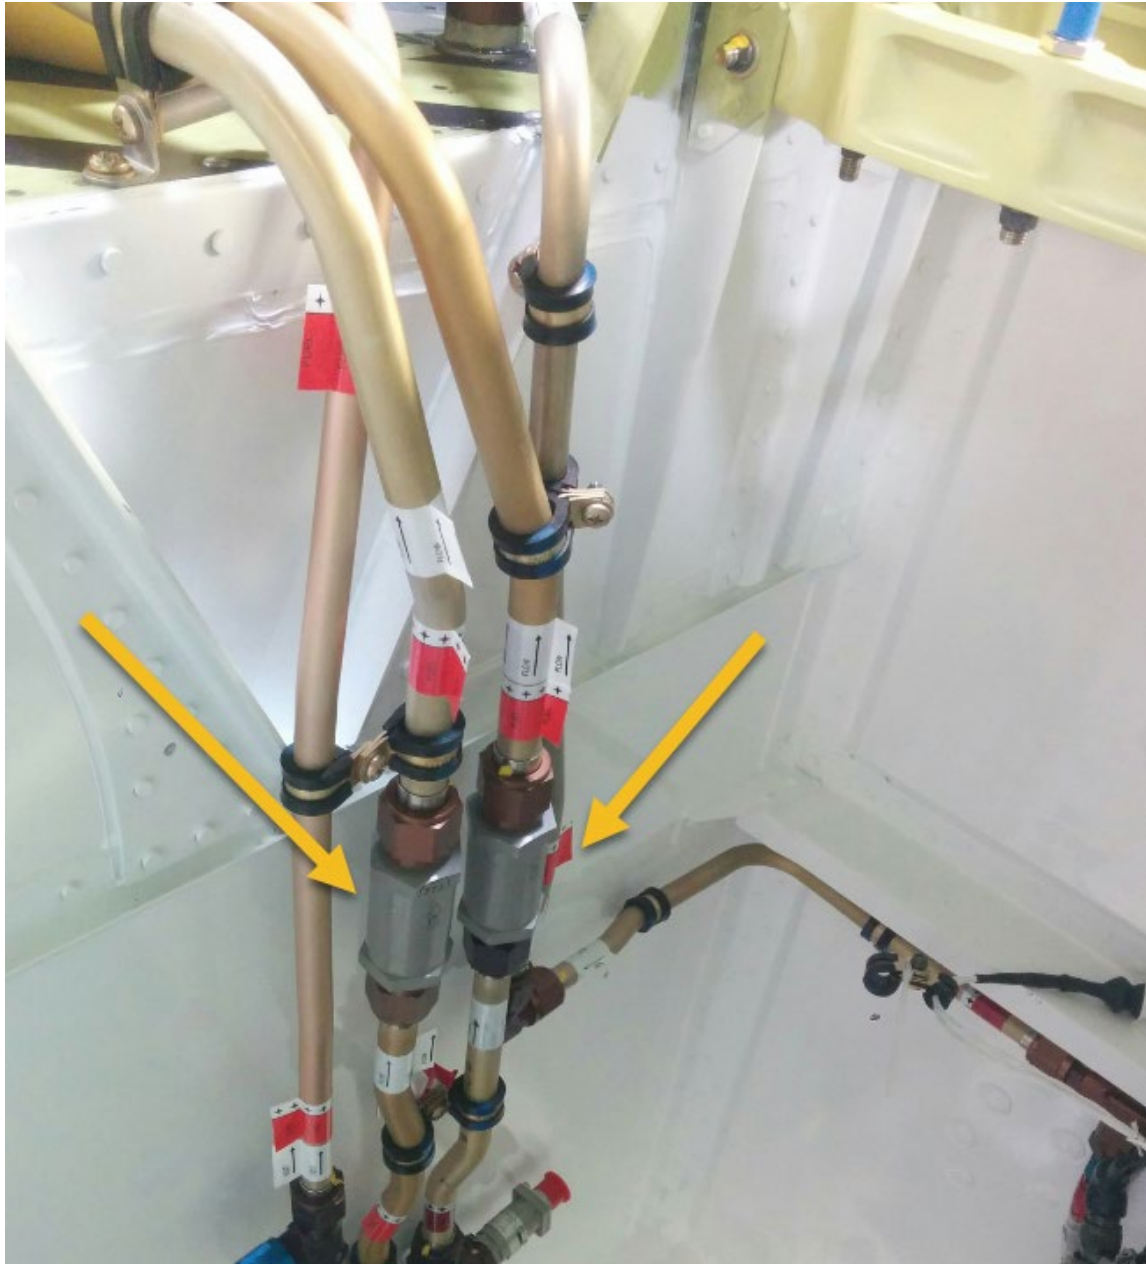
Figure 1. Fuel Check Valves Location

1. Prepare the helicopter for maintenance and gain access to the fuel check valves. The check valves are located in the aft pylon area (Figure 1).

5. Prepare the helicopter for maintenance and gain access to the fuel check valves (Figure 1).
6. Using a strong light source, visually inspect the fuel check valves for general condition and fuel leaks. Inspect for cracks at the inlet end where the threaded fitting is installed (Figure 3).
7. If a crack is found, replace the check valve prior to next flight. Figure 4 shows an example of a cracked check valve.
8. If no cracks or any other defects that would cause the valve to be unserviceable are found, make an entry in the helicopter logbook and historical service records

1. Prepare the helicopter for maintenance and gain access to the fuel check valves (Figure 1, Details A and B).
2. Refer to the applicable Maintenance Manual and replace defective fuel check valve(s) (BHT-412-MM, Chapter 28).
3. Make an entry in the helicopter logbook and historical service records indicating compliance with this Alert Service Bulletin.

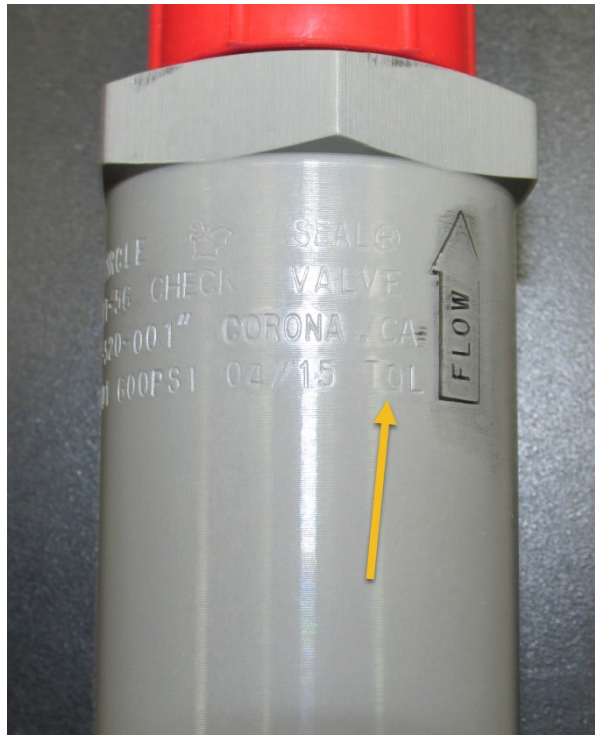
Detail A. Circor Aerospace Fuel Check Valve Marked "TQL"

It is not necessary to remove the fuel check valve for inspection. Regardless of manufacturing date, any fuel check valves with the "TQL" marking are not affected by this bulletin. Fuel check valves manufactured by other suppliers are also not affected by this bulletin. Fuel check valves with the "CORONA CA" marking and without the "TQL" marking are affected by this bulletin. (Figure 2, Details A and B).

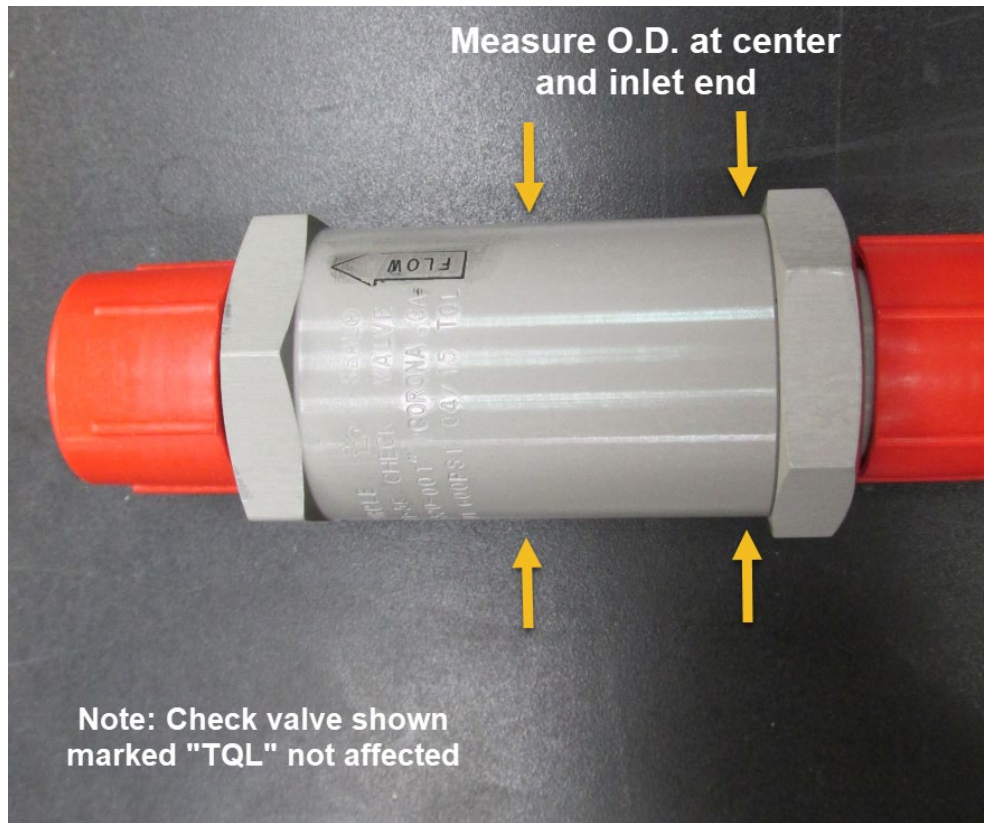
Figure 3. Fuel Check Valve Outside Diameter Measurement

4. If one or both check valves are affected, proceed as follows:
  - a. Using a caliper or equivalent, measure the check valve housing at the center and record dimension (Figure 3).
  - b. Measure the housing at the inlet end where the threaded fitting is installed and record dimension.
  - c. If the dimension measured at the inlet end is no more than 0.003 inch (0.0762 mm) greater than the measurement at the center, the valve is serviceable and does not require further inspection or replacement. Make an entry in the helicopter logbook and historical service records indicating the findings and compliance with this Alert Service Bulletin.

- d. If the dimension measured at the inlet end is greater than 0.003 inch (0.0762 mm) when compared to the measurement at the center, the valve will require replacement. Part III can be accomplished immediately, or Part II can be accomplished until the defective valve can be replaced in accordance with Part III.
- e. If the defective check valve is not replaced immediately, make an entry in the helicopter logbook and historical service records indicating the findings and that Part II must be accomplished every 25 flight hours or 30 days whichever comes first until Part III is accomplished.

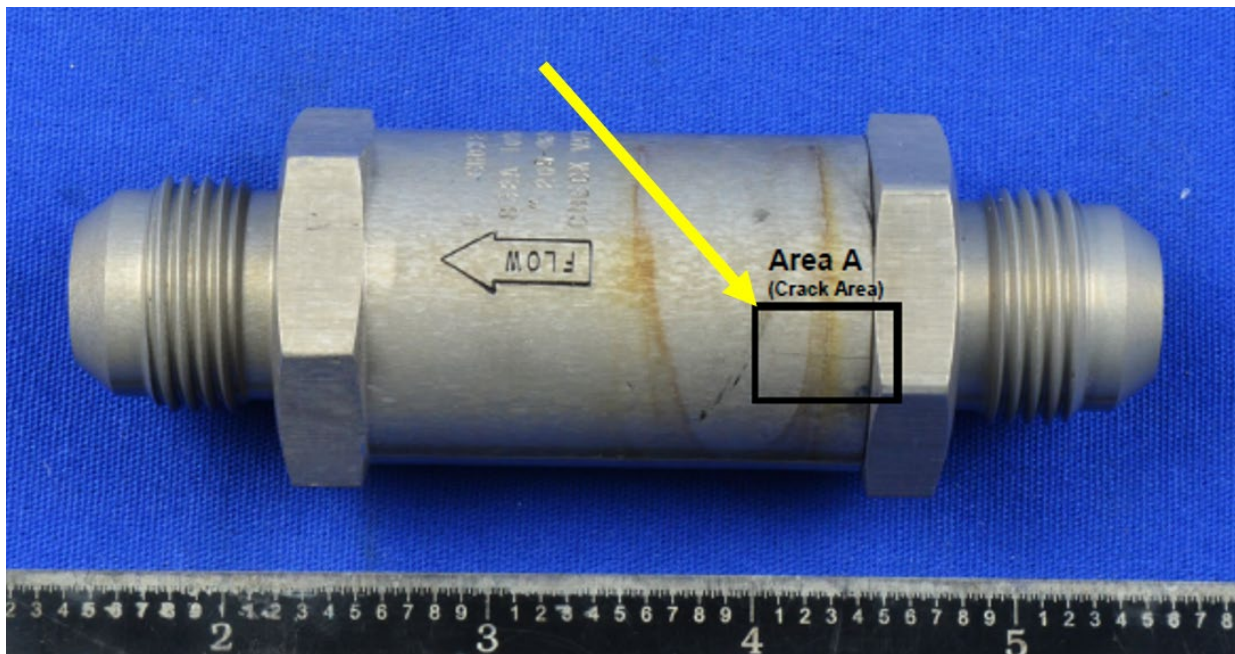
Figure 4. Cracked Fuel Check Valve

Bell recently received a report of a cracked check valve manufactured by Circor Aerospace (Circle Seal). This check valve was manufactured in 2009 which is outside of the manufacturing date range (October 2011 – March 2015) addressed by the ASB 412-15-168 Rev A. Corrective actions implemented in 2015 by Circor Aerospace to prevent cracking of the check valve housings are indicated by the “TQL” marking.

This recent check valve cracking report indicates that additional fuel check valves P/N 209-062-607-001 manufactured by Circor Aerospace (Circle Seal) not having the “TQL” marking may be susceptible to cracking with time in service.
