**ALERT SERVICE BULLETIN**  
**Bell Helicopter** **TEXTRON**

NO. 407-07-80

DATE AUG 27, 2007

**SUBJECT:** TAILBOOM ASSEMBLY 407-030-801-107, AND 407-530-014-101/-103, NEW INSPECTION REQUIREMENTS.

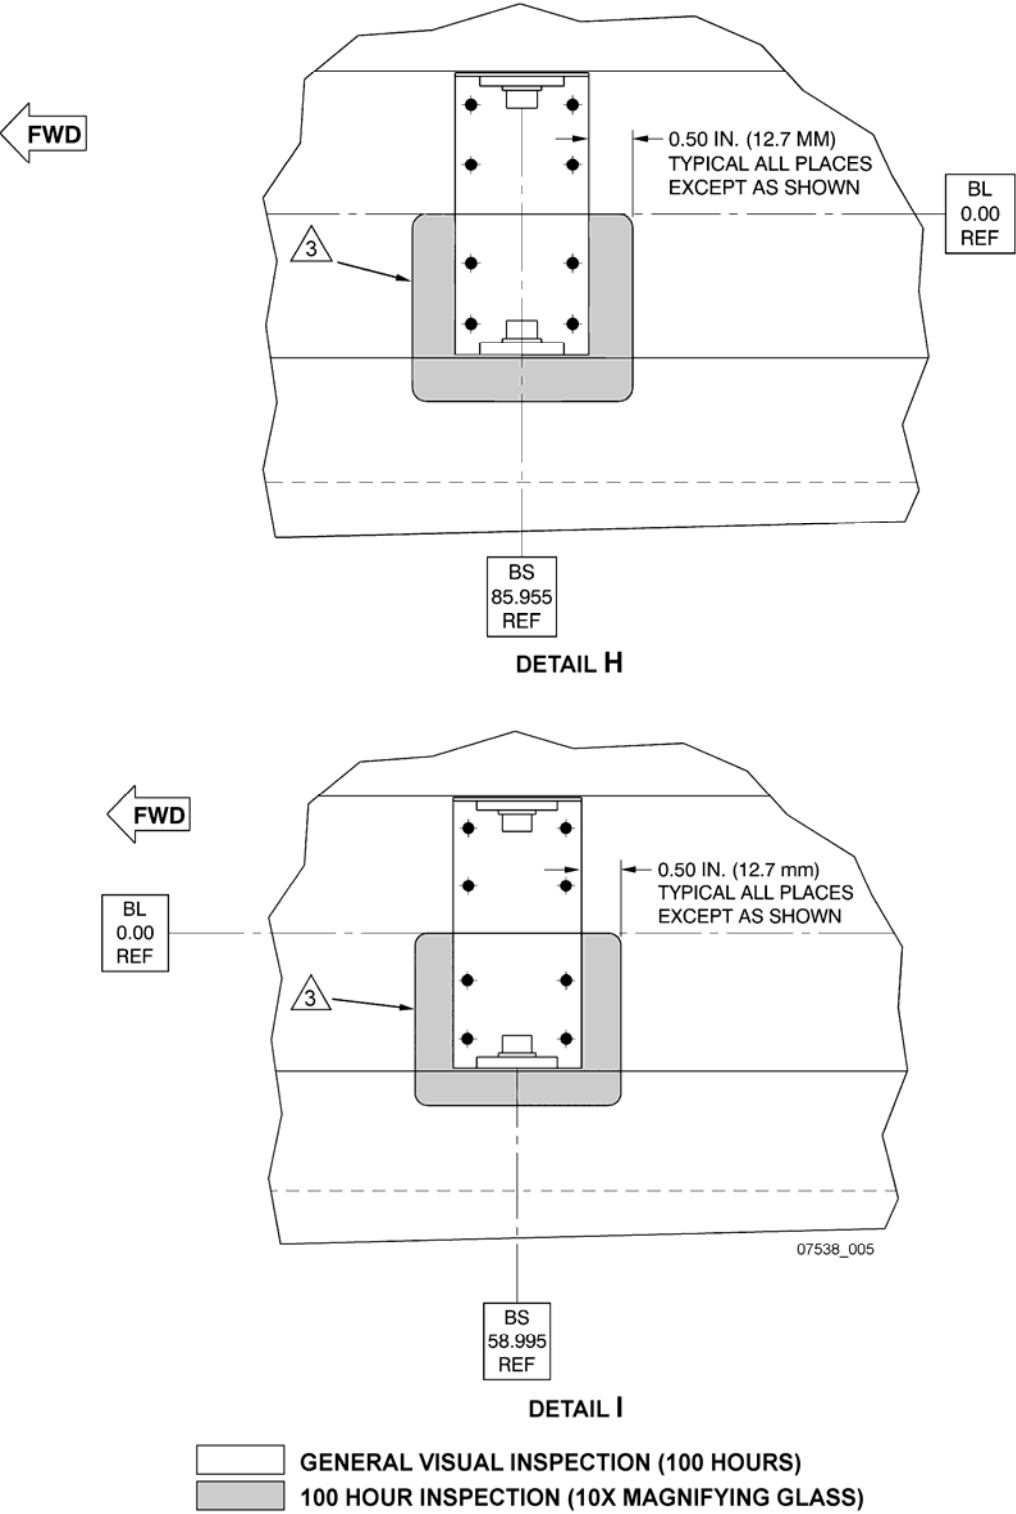
Figure 3. 100 Hour inspection of tailbooms 407-530-014-101, 407-530-014-103 and 407-030-801-107 (Sheet 4 of 7).

5. If no loose rivets or fasteners are found loose, use a 10X magnifying glass and examine tailboom skin at edge of mating supports/brackets and around fasteners shown in Figure 3, Details "E", "F", "G", "H", "I" and View "D".

6. On left side of tailboom, use a 10X magnifying glass and examine tailboom skin at edge of mating supports/brackets and around fasteners shown in Figure 3 Area "C" and View "J".
