**SUBJECT: REVISION "B" TO TECHNICAL BULLETIN 212-78-15:
REPAIR OF ENGINE SERVICE DECK CENTER PANEL P/N 212-
030-009-007 AND -097**

No. 212-78-15

MODEL AFFECTED: 212

SUBJECT: REPAIR OF ENGINE SERVICE DECK CENTER
PANEL P/N 212-030-009-007 AND -097

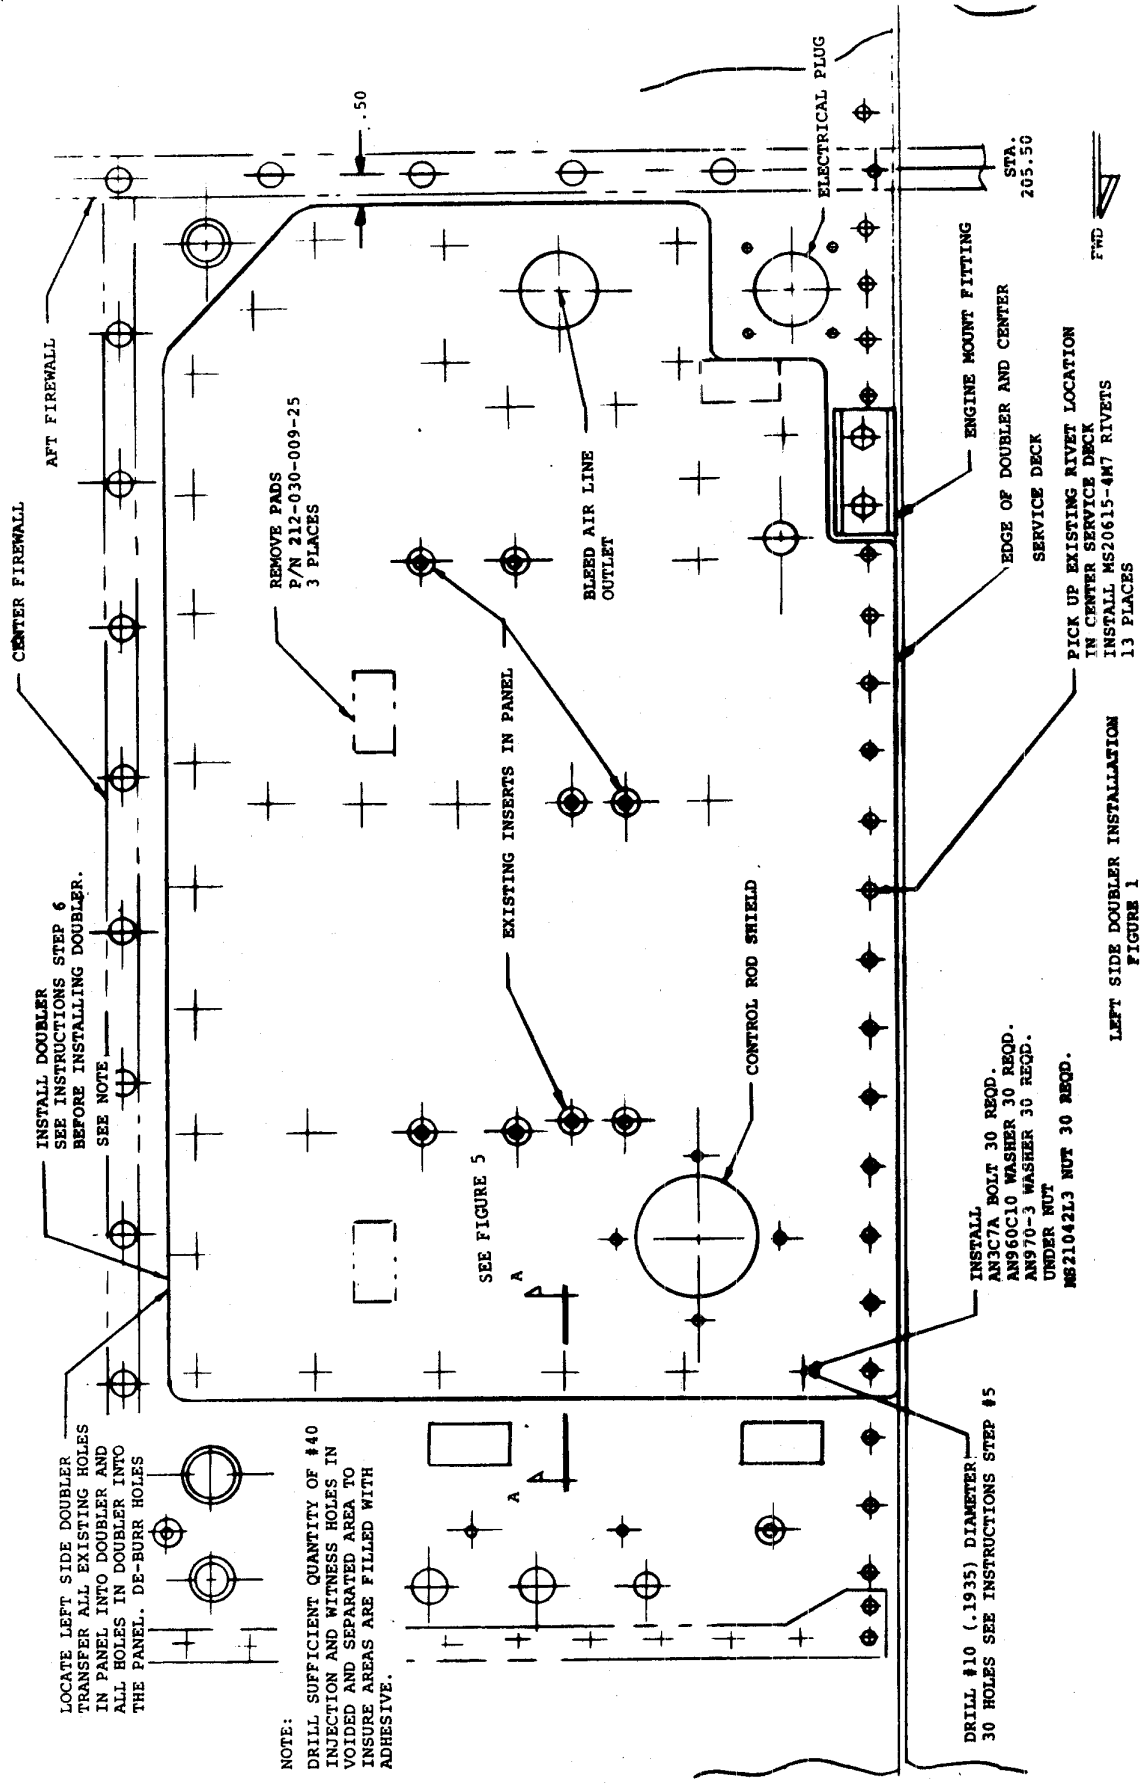
Field reports of voids and skin separation in the engine service center deck. These voids and separations may have been repaired by injection of adhesive and the addition of doublers to the engine service deck. Bell Helicopter does not authorize this repair any more. Original procedure is still provided to allow conformity inspection on aircraft already repaired. | B

3. Refer to Figure 3 and 4. Fabricate the two doublers as detailed from 0.040"-thick 301, ¼ hard stainless steel.
4. Refer to Figure 1 and 2. Locate the doublers and drill holes in the panel from the doublers and pick-up existing holes in the panel into the doublers. Use sharp cobalt drills.

Fill the void or delaminated area with adhesive prior to installing the doubler. Install the doublers, refer to Figure 1 and 2. Clean excessive adhesive from the panel and doublers. Apply a bead of Proseal 700 around the edges of the doublers.
