INFORMATION LETTER

206L-14-97
24 February 2014

**SUBJECT: TACTAIR HYDRAULIC SERVO ACTUATOR (HSA) CYLINDER
EXTENSION ASSEMBLY P/N C42642-88 PRODUCT IMPROVEMENT**

SB42C42642-67-04

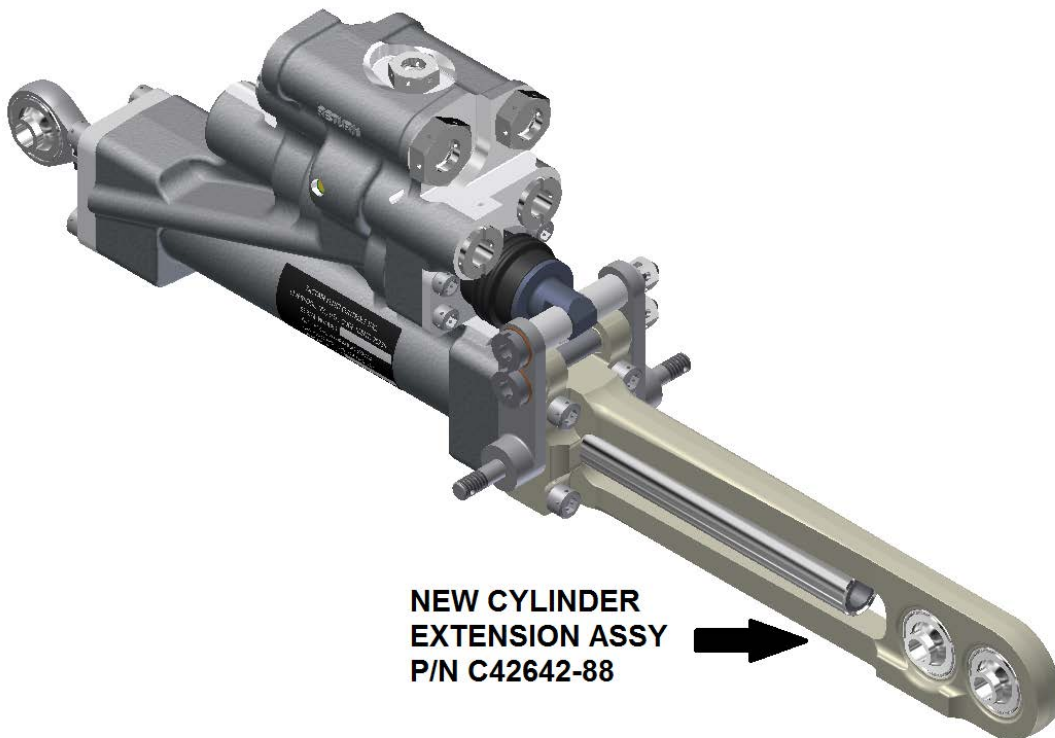
The purpose for this Service Bulletin is to document the maintenance procedures required to replace the current Cylinder Extension Assembly P/N C42642-69 during the HSA Repair or Overhaul with the new Cylinder Extension Assembly P/N C42642-88 to improve the HSA P/N 42C42642-1 and 42C42642-101 configurations. The improvements of this new Cylinder Extension Assembly P/N C42642-88 are designed to prevent bending of the old Cylinder Extension Assembly P/N C42642-69, which can occur during helicopter hard landings and to increase service life of the HSA.

- D. Repair HSA in accordance with Overhaul Manual referenced in paragraph 1.K except Cylinder Extension Assembly P/N C42642-69.
- E. Assemble HSA in accordance with Overhaul Manual referenced in paragraph 1.K except install new Cylinder Extension Assembly P/N C42642-88, as shown in figure 1, in place of old Cylinder Extension Assembly P/N C42642-69.
