TECHNICAL BULLETIN

505-18-13

MODEL AFFECTED: 505

SUBJECT: AFT ROOF PANELS AND CEILING AREA,
INSPECTION AND PROTECTION OF.

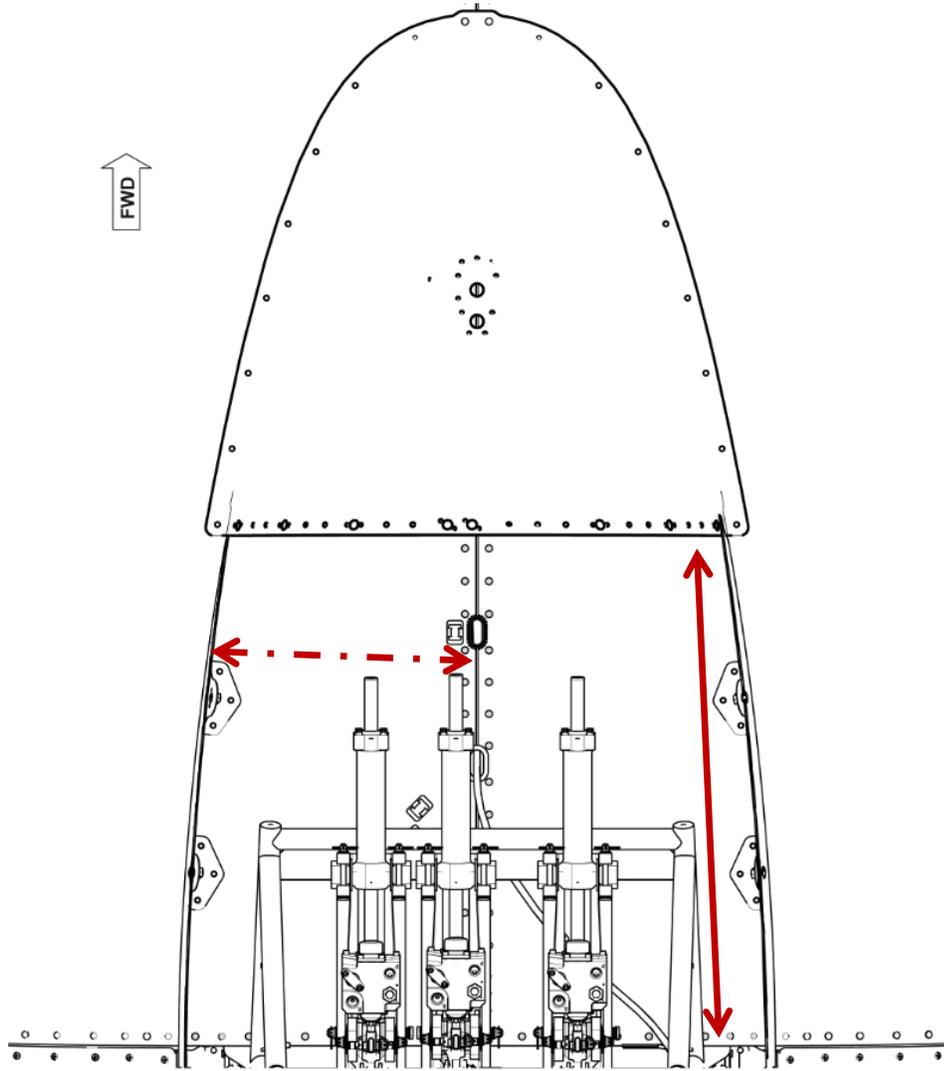
Figure 2 – Roof Panel Repair Area

The repair area for the left and right side extends from the aft rivet line up to the forward cowling (COM/GPS antenna), and from the rivet center line up to the painted line for both sides.

1. Clean and prepare the left and right upper roof panels as follows:
 - a. Clean and protect the components around the work area and the external perimeter around the roof upper surfaces (Figure 2) using protective material and masking tape (C-426), or equivalent, to hold in place the protective material.
 - b. Lay masking tape (C-426), or equivalent, around the external perimeters of the left and right upper roof panels.

2. Prepare the solvent mixture.
3. Wipe clean both upper roof panels (Figure 2) using cheesecloth (C-486), or equivalent, saturated with the solvent mixture.
4. Prepare the left upper roof panel for repair as follows:

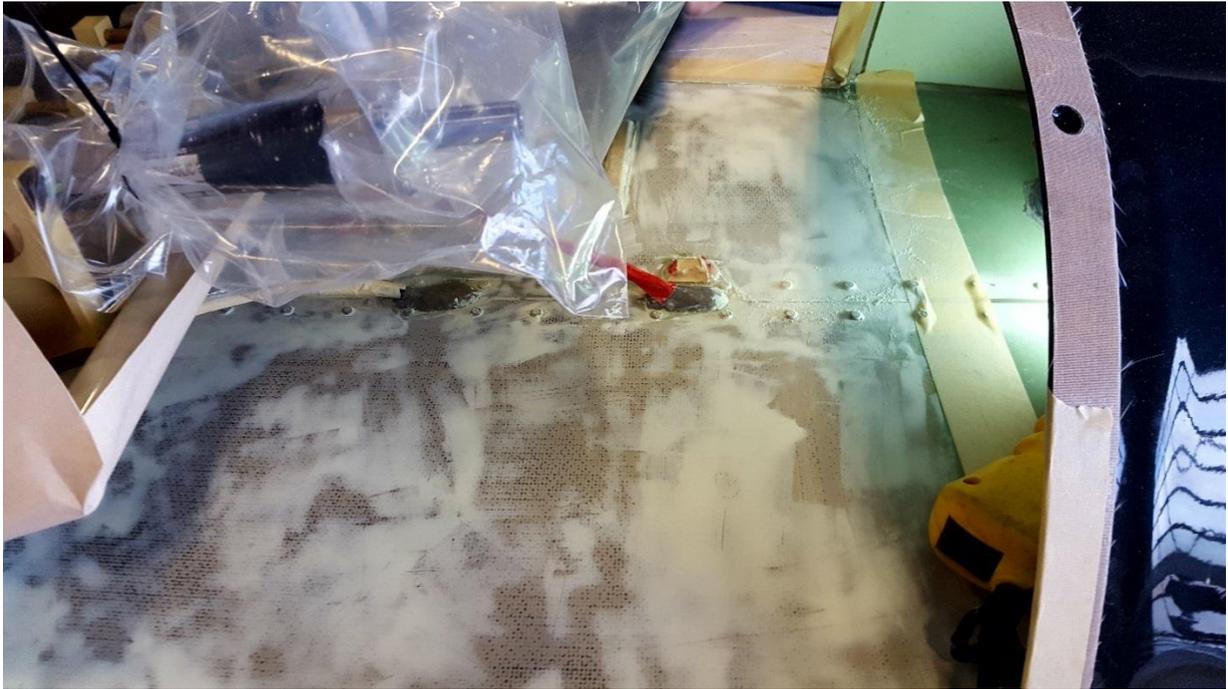
Figure 6 – Finishing glaze compound (C-266) after sanding high spots results and when pin hole filler was used during manufacturing example.

If pin hole filler compound was used during manufacturing process on the roof panel to seal pores, during the sanding of the finishing glaze compound (C-266) to remove high spots, some of finishing glaze may come off where pin hole filler compound was applied (Figure 6).

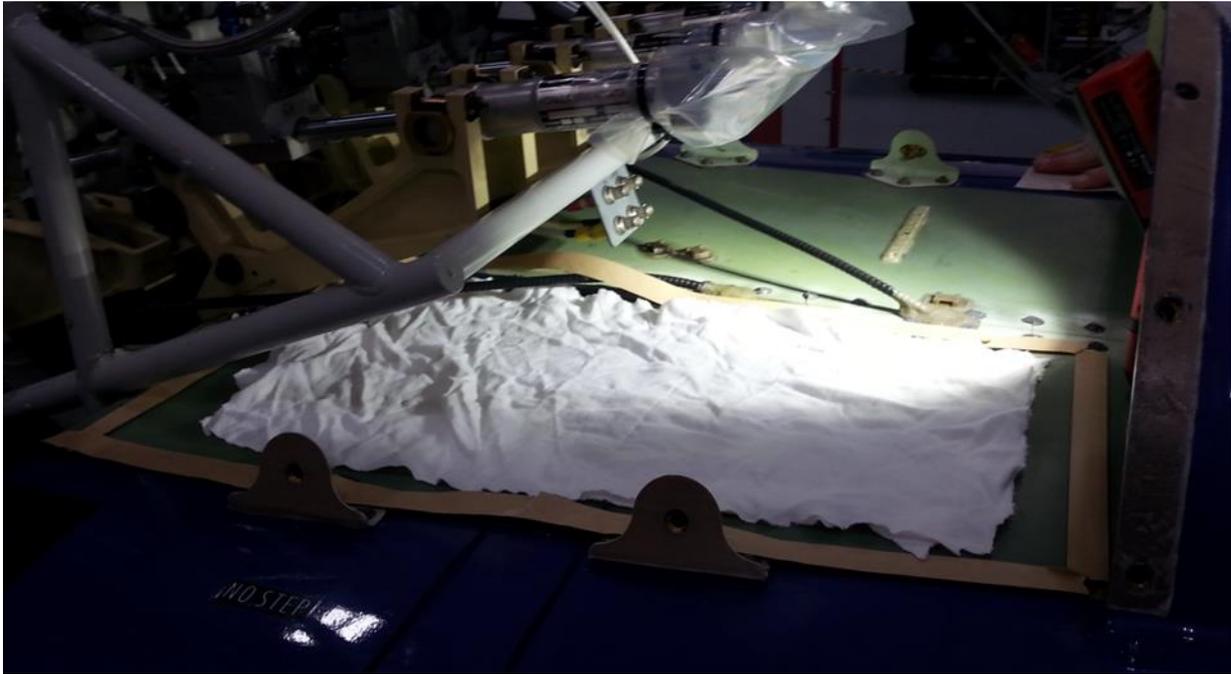
Sealant tape (C-259) and shop rag material on upper roof repair area perimeter.

- c. Place tape (C-401), or equivalent, around the perimeter (Figure 7, View A and B, Sheet 1 of 2) which needs to be vacuum bag cleaned or place sealant tape (C-259) directly on the upper panel surface around the perimeter or on top of the tape (C-401) as applicable.

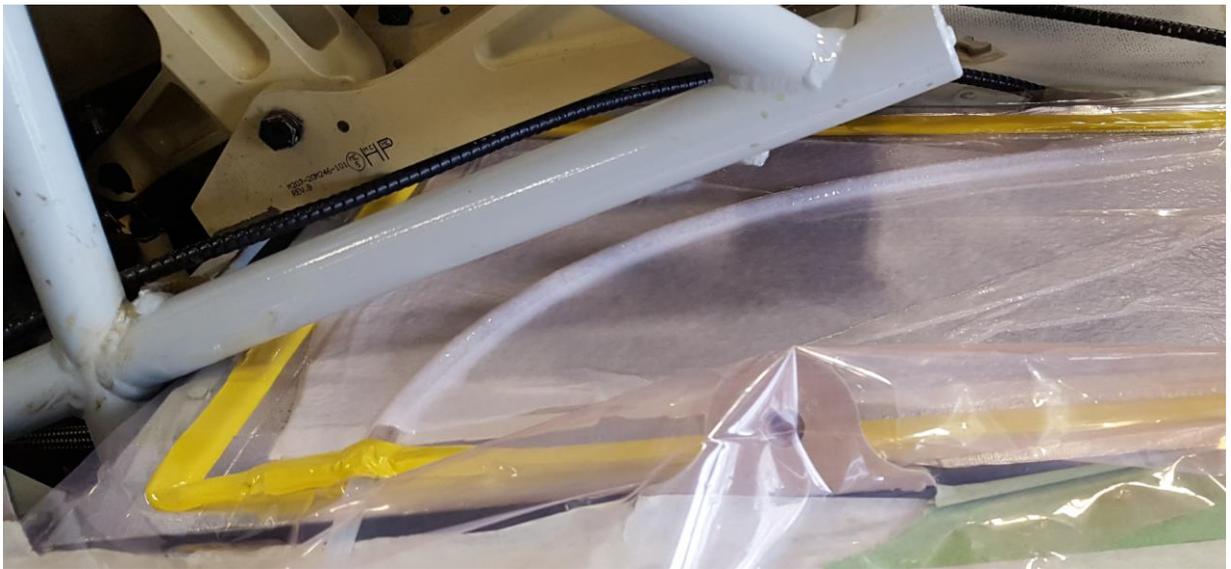
View B

Sealant tape (C-259) place on top of tape (C-401) and plastic tube inserted on top of breather material.

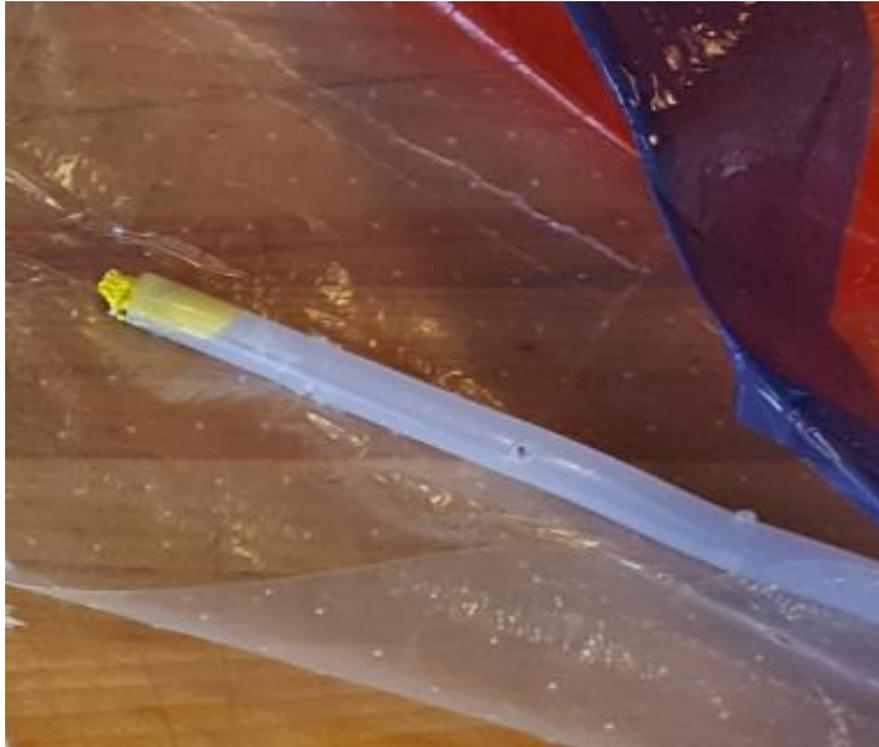
View C
Holes drilled into the plastic tube material.

- d. Cut to size a shop rag, or equivalent, to fit the repair area.
- e. Cut to size breather felt material (C-565) to fit the repair area.
- f. Prepare a plastic tube approximately (0.250 inch (6.35 mm) diameter) 36 inches (0.91 m) long. Drill small holes in the plastic tube side wall section (Figure 7, View C, Sheet 2 of 2) that will be inserted into the vacuum bag. Plug both ends of the tube with sealant tape (C-259) (Figure 7, View C and D, Sheet 2 of 2).

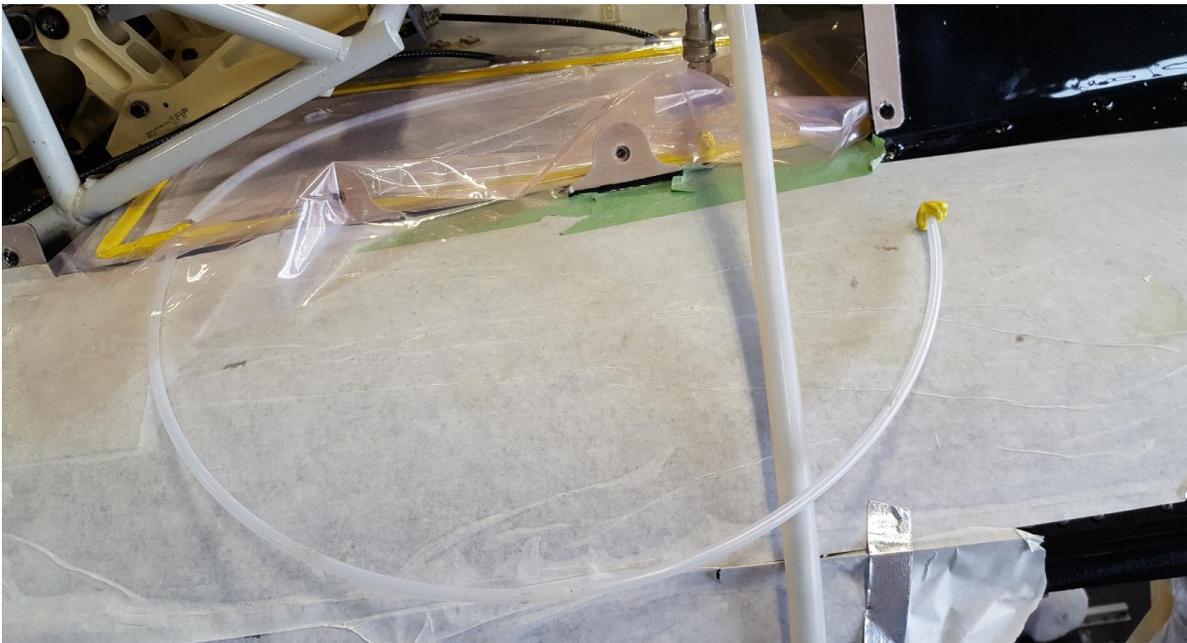
View D
Upper roof Vacuum bag and repair area perimeter.

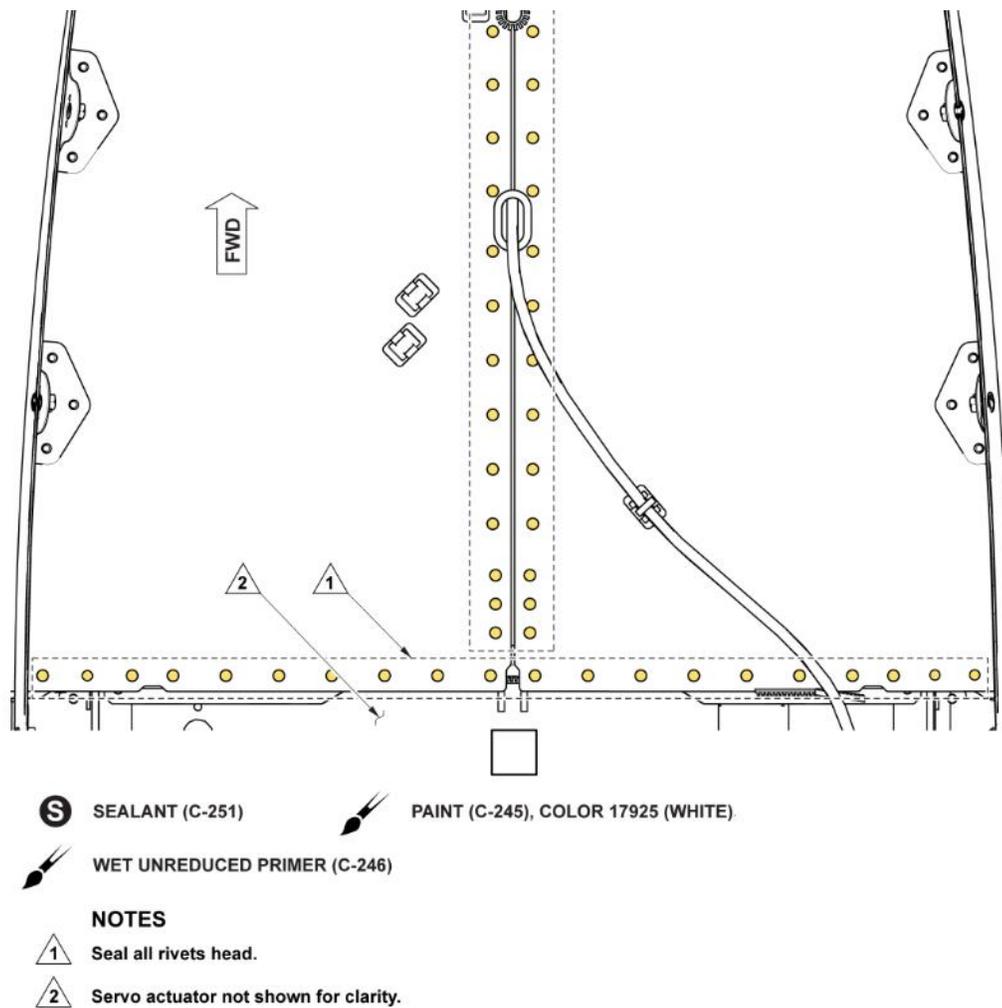
Figure 8– Sealant application (Sheet 1 of 2).

Rivet Head Sealant (C-251)

13. Apply sealant (C-251) to the rivet heads (Figure 8, Sheet 1 of 2) using an acid brush, or equivalent (Workaid, Figure 10).
14. Apply adhesive (C-322) uniformly on the repaired area (Figure 8, Sheet 2 of 2) using a spatula, or equivalent (Workaid, Figure 10).
15. Allow the adhesive (C-322) to dry and cure.
16. Apply epoxy primer (C-246) as follows:
 - a. Using a soft tip paint brush, or equivalent, apply a thin coat of epoxy primer (C-246) on the surfaces (Figure 9).
 - b. Allow the epoxy primer (C-246) to dry and cure for a minimum of 2 hours at room temperature. Heat application shall not be used.

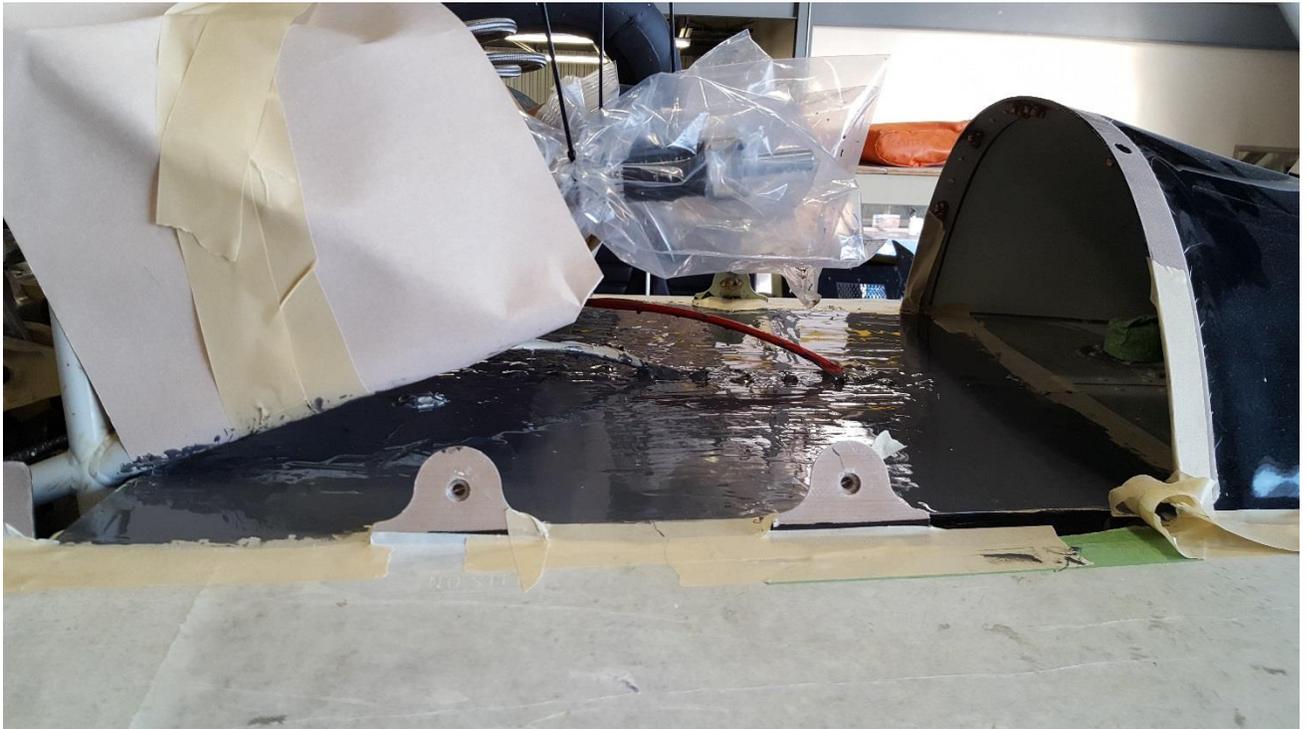
Figure 8– Sealant application (Sheet 2 of 2).

Sealant (C-322) applied on repaired surfaces.

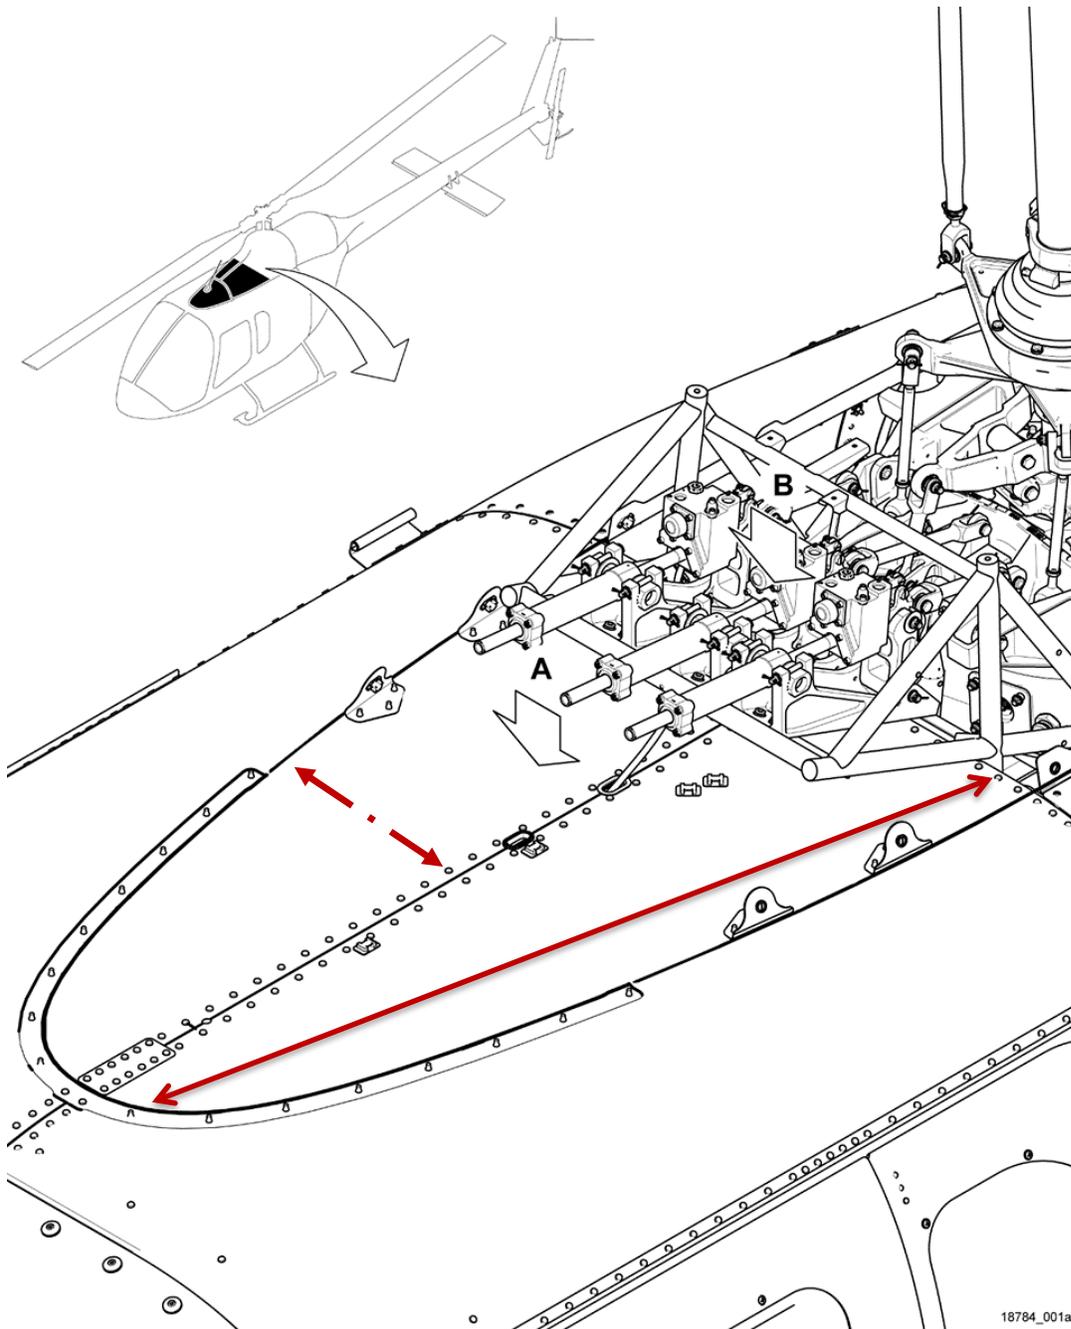
Figure 9 - Primer (C-246) and Paint (C-245) Application for Upper Roof Surfaces

1. Primer (C-246) can be applied on upper roof panel surfaces extending under the forward cowling (Antenna cowling not shown for clarity).
2. Top coat (C-245) to be applied between the aft rivets line up to the forward edge of forward cowling (Antenna cowling not shown for clarity).

17. Apply paint (C-245) on top of the epoxy primer (C-246) as follows:
 - a. Prepare the paint (C-245) per the manufacturer's instructions.
 - b. Mix enough material to have a minimum of 16.9 ounces (500 milliliters).
 - c. Using a soft tip brush, or equivalent, apply the paint (C-245) over the primed surface (Figure 9).
 - d. Allow a flash-off time of 60 minutes at room temperature.
 - e. Apply second coat of paint (C-245).
 - f. Allow the paint to dry and cure per the manufacturer's instructions.
18. Install and reconnect the COMM/GPS antenna wires (DMC-505-A-23-10-01-00A-720A-A). Install cable ties on associated wiring as applicable.
19. Reinstall air conditioning ducting if removed in **PART I**, step 4 (BHT-505-AC-120M).
20. Reinstall the left transmission fairing (DMC-505-A-53-40-01-00A-720A-A) and right transmission fairing (DMC-505-A-53-40-02-00A-720A-A).
