ALERT SERVICE BULLETIN

214-15-76
11 January 2016

MODEL AFFECTED: 214B/B-1

SUBJECT: SEAT BELT COMFORT CLIPS, REMOVAL OF.

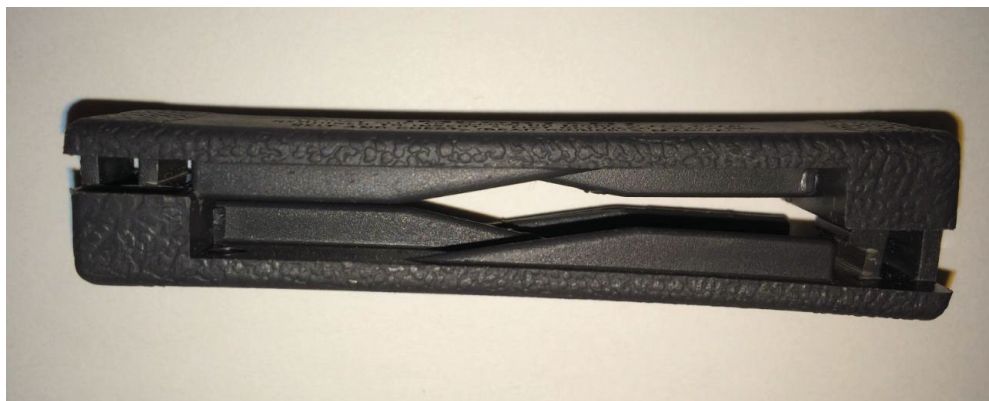
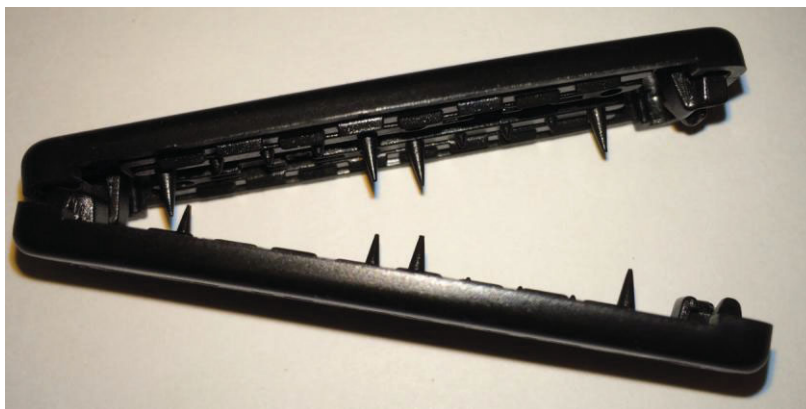
Figure 1 – Seat Belt Comfort Clips

P/N D7LZ-6560286-B

P/N 504636-401

1. Prepare helicopter for maintenance.
2. Verify if seat belt comfort clips are installed on any of the crew or passenger shoulder harness seat belts (Figure 1). If installed, remove and discard.
3. Make an entry in the helicopter logbook and historical service records indicating compliance with this Alert Service Bulletin.
