ALERT SERVICE BULLETIN

214ST-16-92
20 January 2016

MODEL AFFECTED: 214ST

SUBJECT: SEAT BELT COMFORT CLIPS, REMOVAL OF.

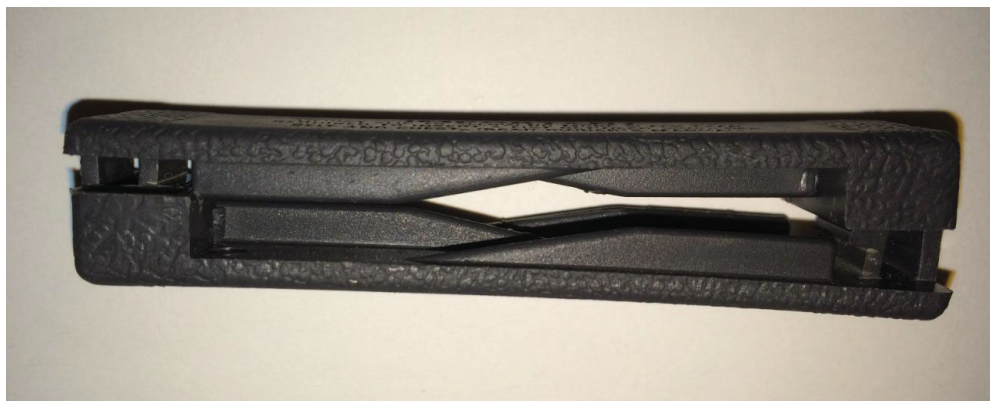
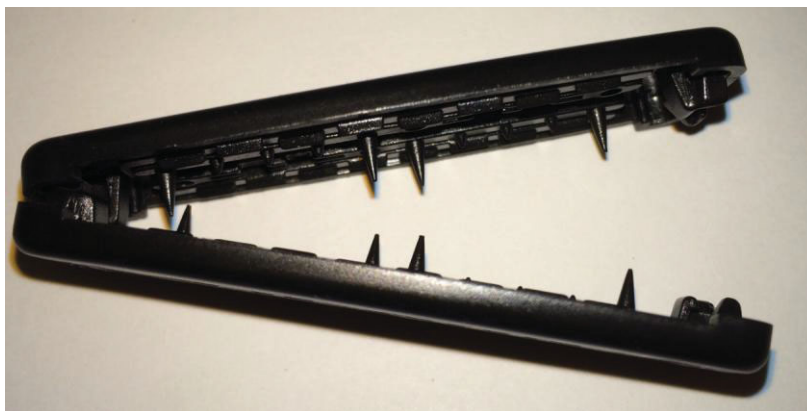
Figure 1 – Seat Belt Comfort Clips

P/N D7LZ-6560286-B

P/N 504636-401

1. Prepare helicopter for maintenance.
2. Verify if seat belt comfort clips are installed on any of the crew or passenger shoulder harness seat belts (Figure 1). If installed, remove and discard.
3. Make an entry in the helicopter logbook and historical service records indicating compliance with this Alert Service Bulletin.
