## ALERT SERVICE BULLETIN

**206-20-139**

**MODEL AFFECTED:** 206A/B and TH-67

**SUBJECT:** SEGMENTED TAIL ROTOR DRIVESHAFTS 206-040-330-003/-101, 206-040-931-009/-011/-101/-103, 206-040-365-101/-105/-121/-123 WITH BONDED ADAPTERS, PROOF LOAD TEST OF.

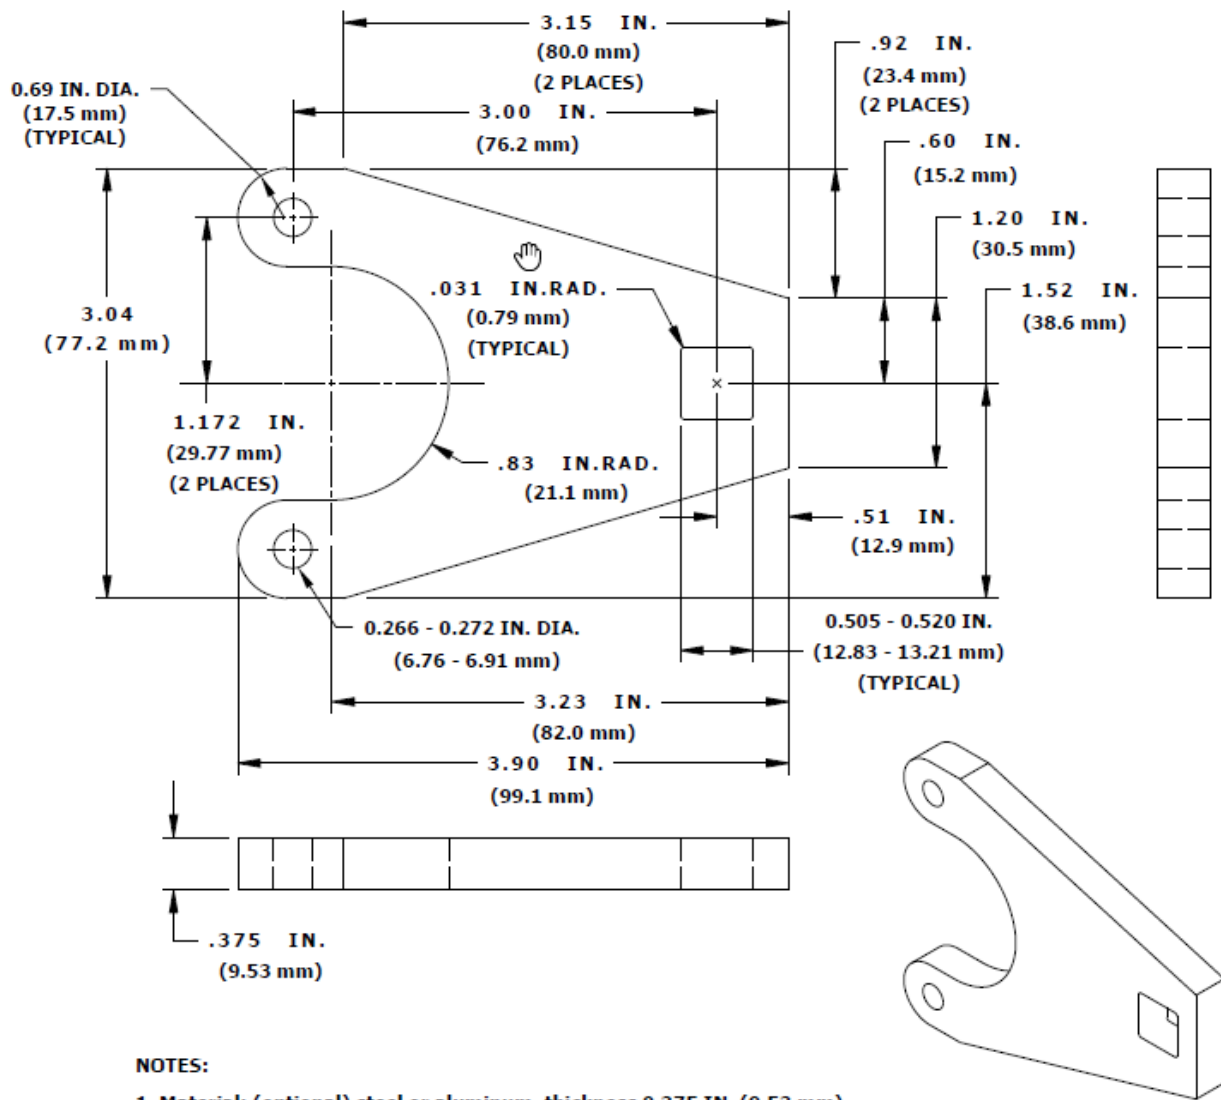
Figure 1 – Bonded Shaft Tool (206-244-001-101)

The bonded shaft tool part number 206-244-001-101 (QTY 2 required) can be procured through your Bell Supply Center or locally manufactured using the information provided on Figure 1.

If the forward short shaft is removed, install the (206-040-328) sliding adapter and work aid (Bonded Shaft Tool 206-244-001-101) on the forward splines of the oil cooler fan shaft. The bonded shaft tool 206-244-001-101 can be locally manufactured using the information in Figure 1 or can be purchased from a Bell Supply Center.
