ALERT SERVICE BULLETIN

NO. 205B-07-47

MODEL AFFECTED: 205B

SUBJECT: CYCLIC FLIGHT CONTROL BEARING, P/N MS27643-4 ONE TIME INSPECTION AND REPLACEMENT OF.

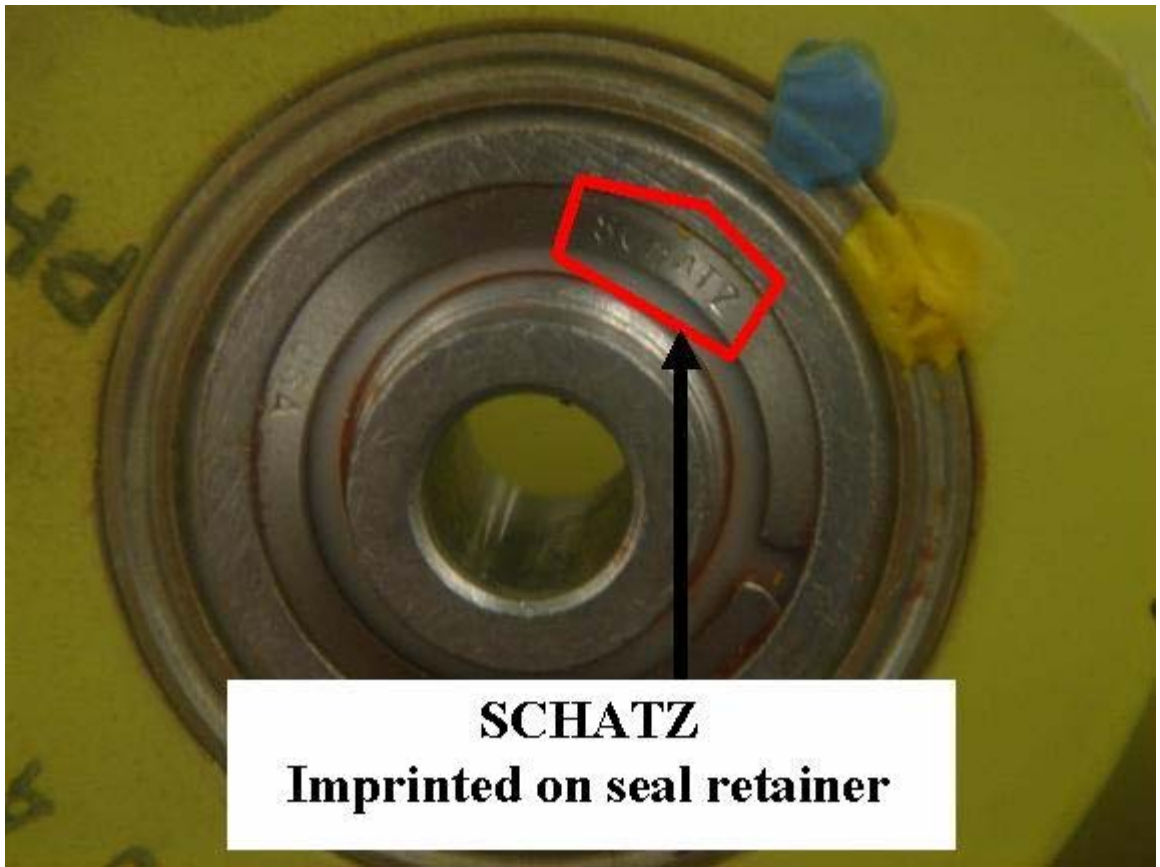
FIGURE 1

BEARING MS27643-4

2. Bearings manufactured by Schatz Bearing Corporation will have the word **SCHATZ** imprinted on the bearing seal retainer on at least one side of the bearing as shown in Figure 1.
