# ALERT SERVICE BULLETIN

NO. 206-09-120

**MODEL AFFECTED:** 206 A/B SERIES and TH-67

**SUBJECT:** MAIN ROTOR PITCH HORN TRUNNION BEARING 206-011-105-001, ONE TIME CHECK,

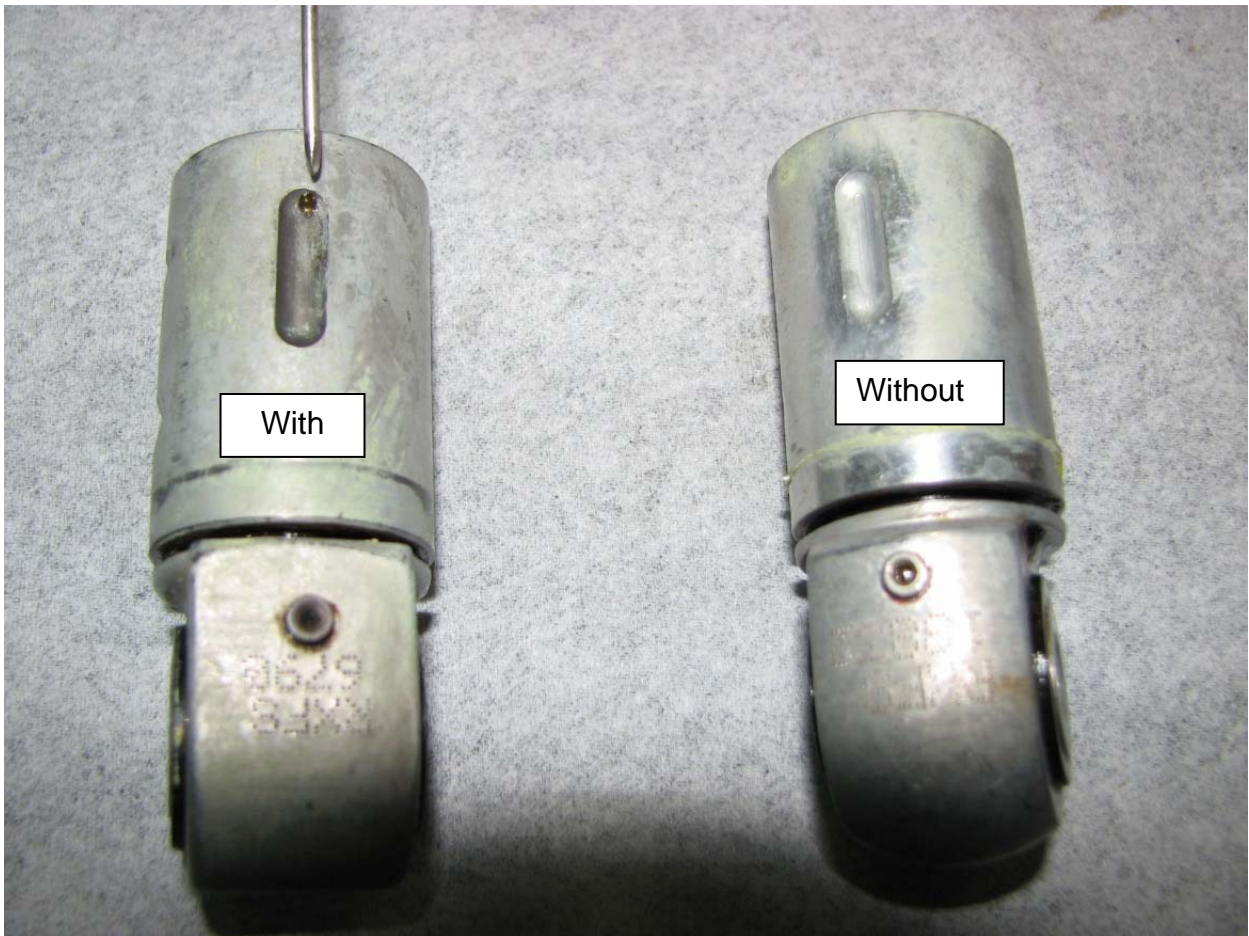
Bell Helicopter has received a report of a 206-011-105-001 bearing found with no lubrication passage drilled in the portion of the bearing that fits inside the pitch horn assembly.

**Figure 1, Trunnion Bearing 206-011-105-001 with and without lubrication passage.**

It is not necessary to remove the trunnion bearing from the pitch horn assembly to ensure the lubrication passage has been drilled.

1. Visually inspect bearings consigned in spares for evidence of a missing lubrication passage. Refer to Figure 1. If the bearing is found defective, proceed with step 3.
2. For bearings installed on a helicopter or in a pitch horn in spares stock, purge lubricates the bearing in accordance with the applicable maintenance manual.
  - a. If the bearing can be purge lubricated normally, it is serviceable. Proceed with Step 4.
  - b. If the bearing can not be purge lubricated normally, replace with a serviceable bearing. Proceed with step 3.
3. Return bearings found with a missing lubrication passage to Bell Helicopter. Refer to the Warranty Statement of this bulletin for details.
4. Annotate the helicopter records indicating compliance with this bulletin.
