# **ALERT SERVICE BULLETIN**

222-15-112

MODEL AFFECTED: 222, 222B, and 222U

SUBJECT: Seat Belt Comfort Clips, Removal of.

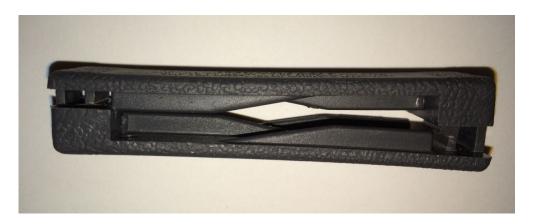
P/N D7LZ-6560286-B

Figure 1 – Seat Belt Comfort Clips

- 1. Prepare the helicopter for maintenance.
- 2. Verify if the seat belt comfort clips are installed on any of the crew or passenger shoulder harness seat belts (Figure 1). If installed, remove and discard.
