ALERT SERVICE BULLETIN

212-20-164

- MODEL AFFECTED:** 212
- SUBJECT:** FUEL CHECK VALVE P/N 209-062-607-001,
INSPECTION AND REPLACEMENT OF.
- HELICOPTERS AFFECTED:** Serial numbers 30501 through 30999, 31101 through 31311, 32101 through 32142 and 35001 through 35103 having a Circor Aerospace (Circle Seal) fuel check valve not marked "TQL".
- [Serial numbers listed above having a Circor Aerospace (Circle Seal) fuel check valve marked "TQL" are not affected by this bulletin.]
- COMPLIANCE:**
- Part I:** Within the next 25 flight hours or 30 days, whichever comes first after the release date of the revision A of this bulletin.
- Part II:** Within the next 25 flight hours or 30 days, whichever comes first after accomplishment of Part I and every 25 flight hours or 30 days thereafter until Part III is accomplished.
- Part III:** No later than 600 flight hours or 12 months, whichever comes first after accomplishment of Part I.

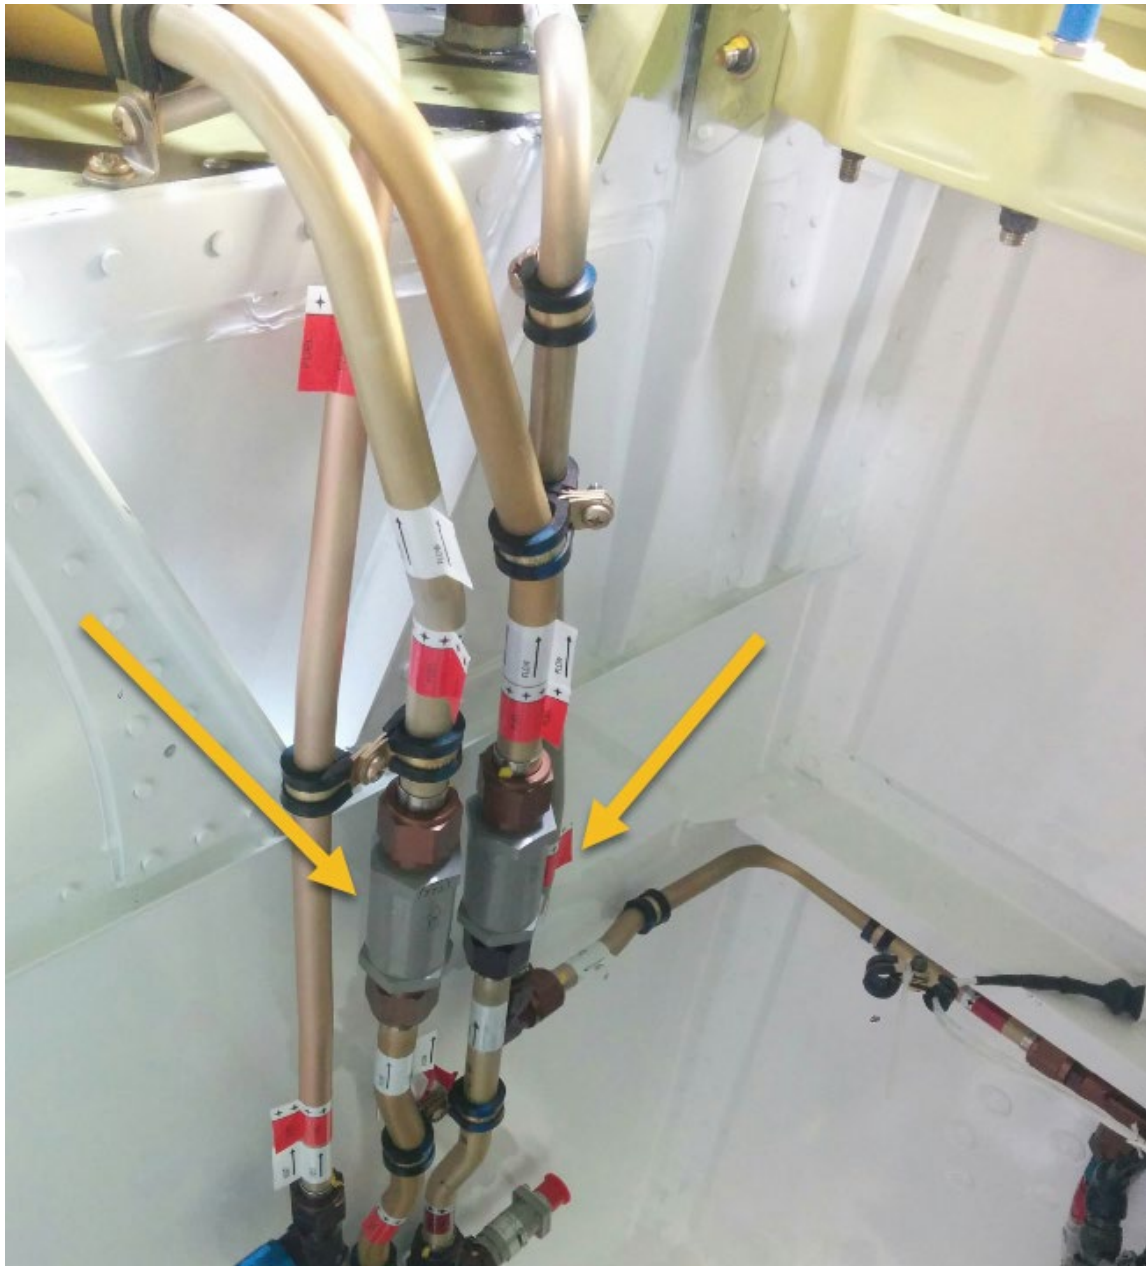
Figure 1. Fuel Check Valves Location

1. Prepare the helicopter for maintenance and gain access to the fuel check valves. The check valves are located in the aft pylon area (Figure 1).

1. Prepare the helicopter for maintenance and gain access to the fuel check valves (Figure 1).
2. Using a strong light source, visually inspect the fuel check valves for general condition and fuel leaks. Inspect for cracks at the inlet end where the threaded fitting is installed (Figure 3).
3. If a crack is found, replace the check valve prior to next flight. Figure 4 shows an example of a cracked check valve.
4. If no cracks or any other defects that would cause the valve to be unserviceable are found, make an entry in the helicopter logbook and historical service records indicating the findings and that Part II will require accomplishment until Part III is accomplished.

1. Prepare the helicopter for maintenance and gain access to the fuel check valves (Figure 1, Details A and B).
2. Refer to the applicable Maintenance Manual and replace defective fuel check valve(s) (BHT-212-MM, Chapter 28).
3. Make an entry in the helicopter logbook and historical service records indicating compliance with this Alert Service Bulletin.

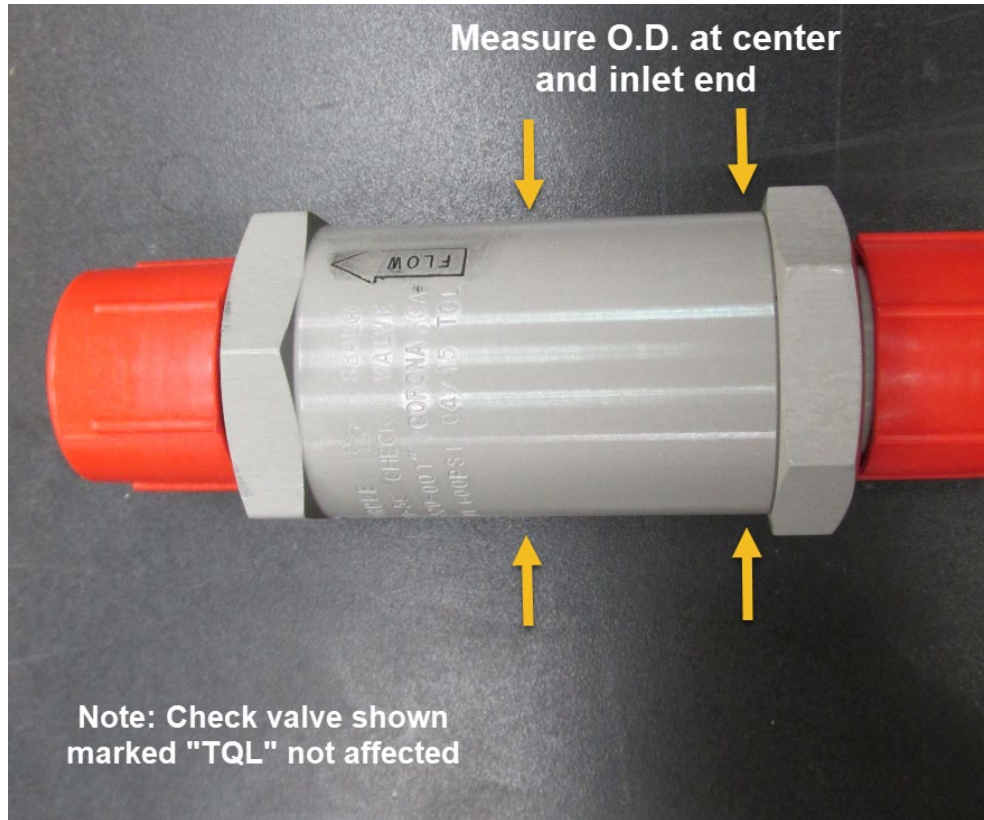
Figure 3. Fuel Check Valve Outside Diameter Measurement

- d. If the dimension measured at the inlet end is greater than 0.003 inch (0.0762 mm) when compared to the measurement at the center, the valve will require replacement. Part III can be accomplished immediately, or Part II can be accomplished until the defective valve can be replaced in accordance with Part III.
- e. If the defective check valve is not replaced immediately, make an entry in the helicopter logbook and historical service records indicating the findings and that Part II must be accomplished every 25 flight hours or 30 days whichever comes first until Part III is accomplished.

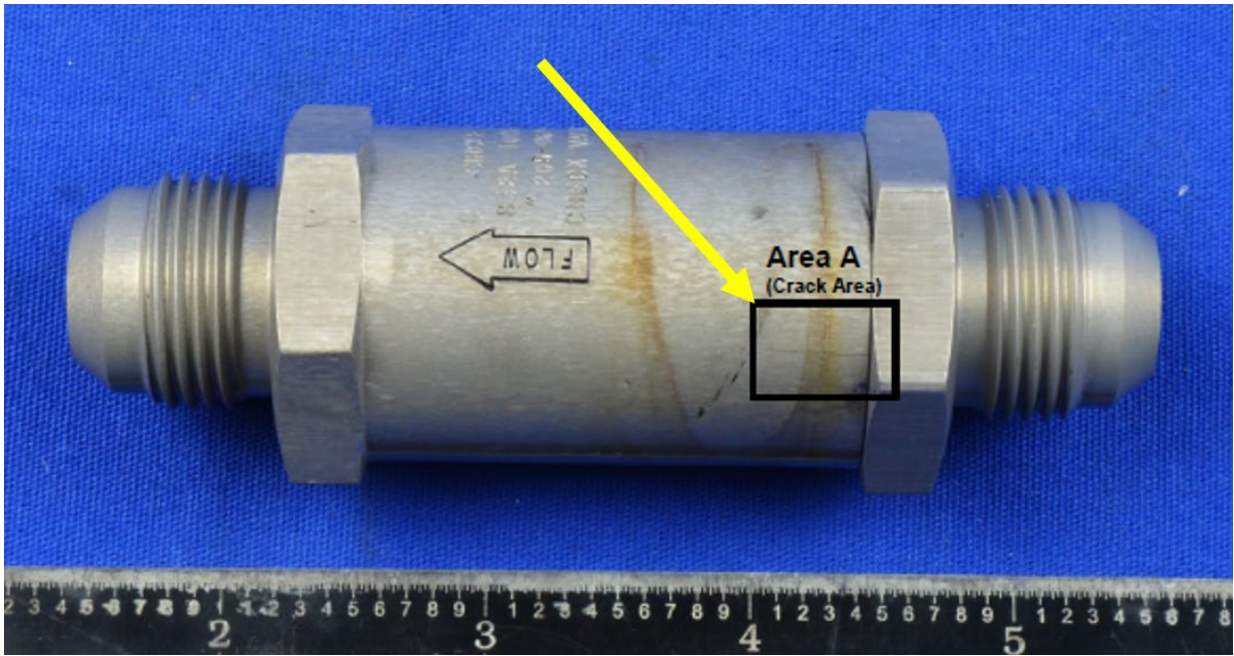
Figure 4. Cracked Fuel Check Valve

Bell recently received a report of a cracked check valve manufactured by Circor Aerospace (Circle Seal). This check valve was manufactured in 2009 which is outside of the manufacturing date range (October 2011 – March 2015) addressed by the ASB 212-15-155 Rev A. Corrective actions implemented in 2015 by Circor Aerospace to prevent cracking of the check valve housings are indicated by the “TQL” marking.
